# City Park Master Plan

CITY OF SHELDON, IOWA

CITY COUNCIL PRESENTATION - DECEMBER 3, 2025

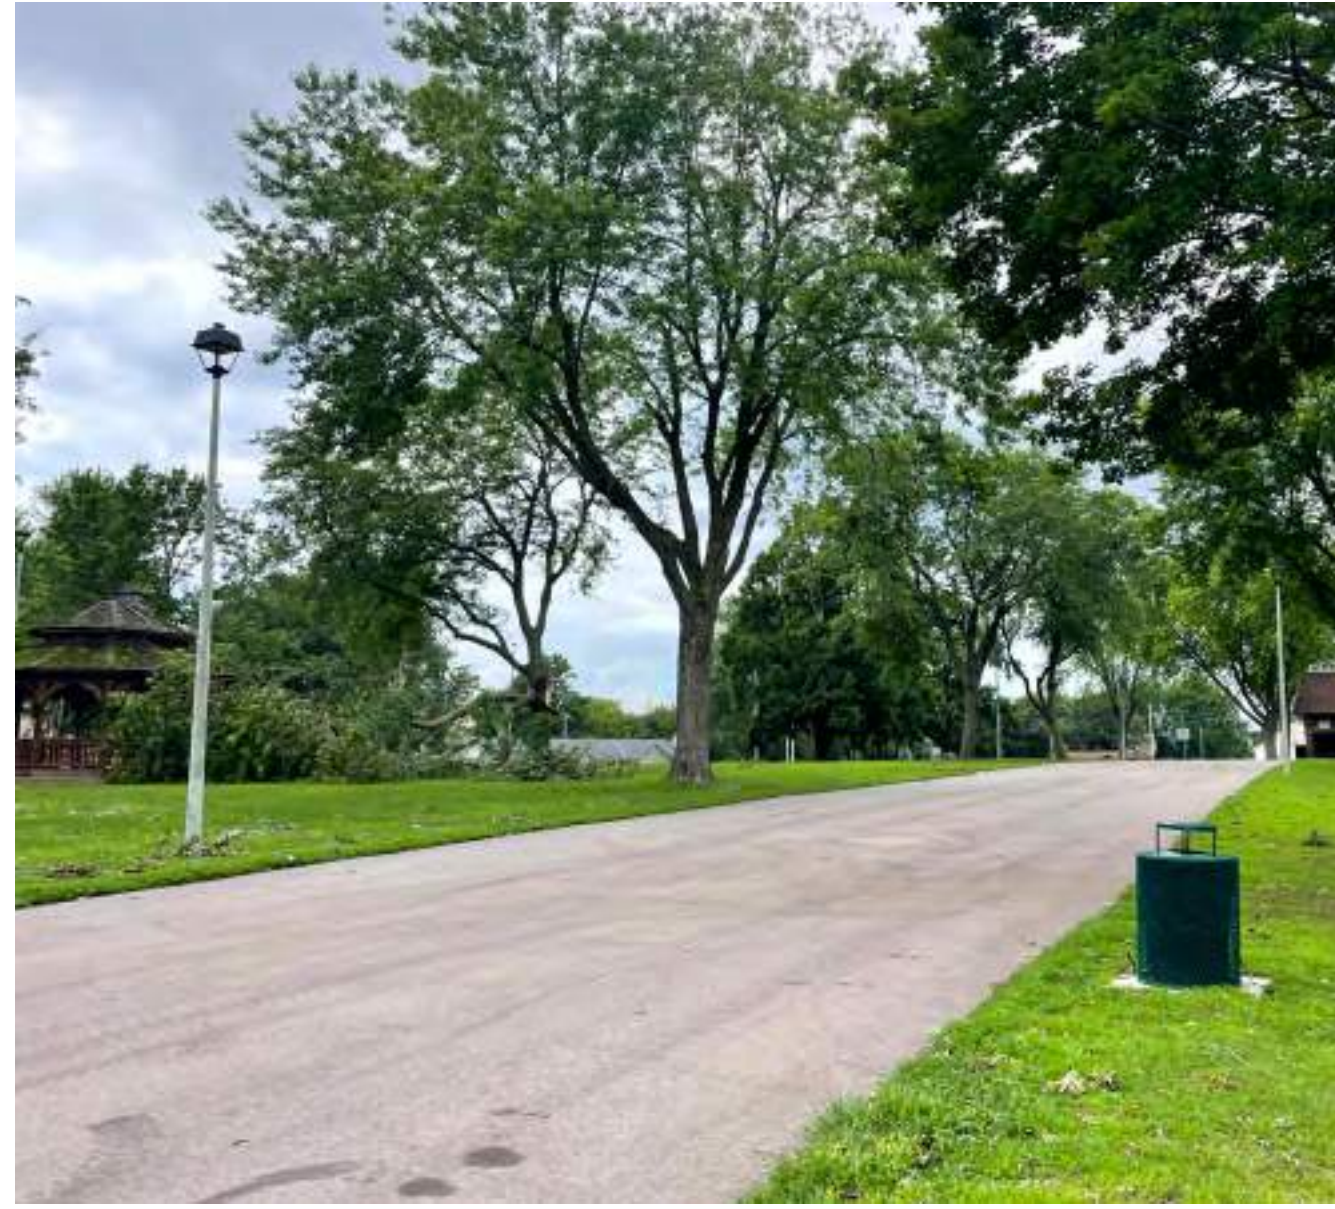
6TH AVENUE ASPHALT DRIVE

- 30' wide asphalt drive recently overlaid with good pavement condition.

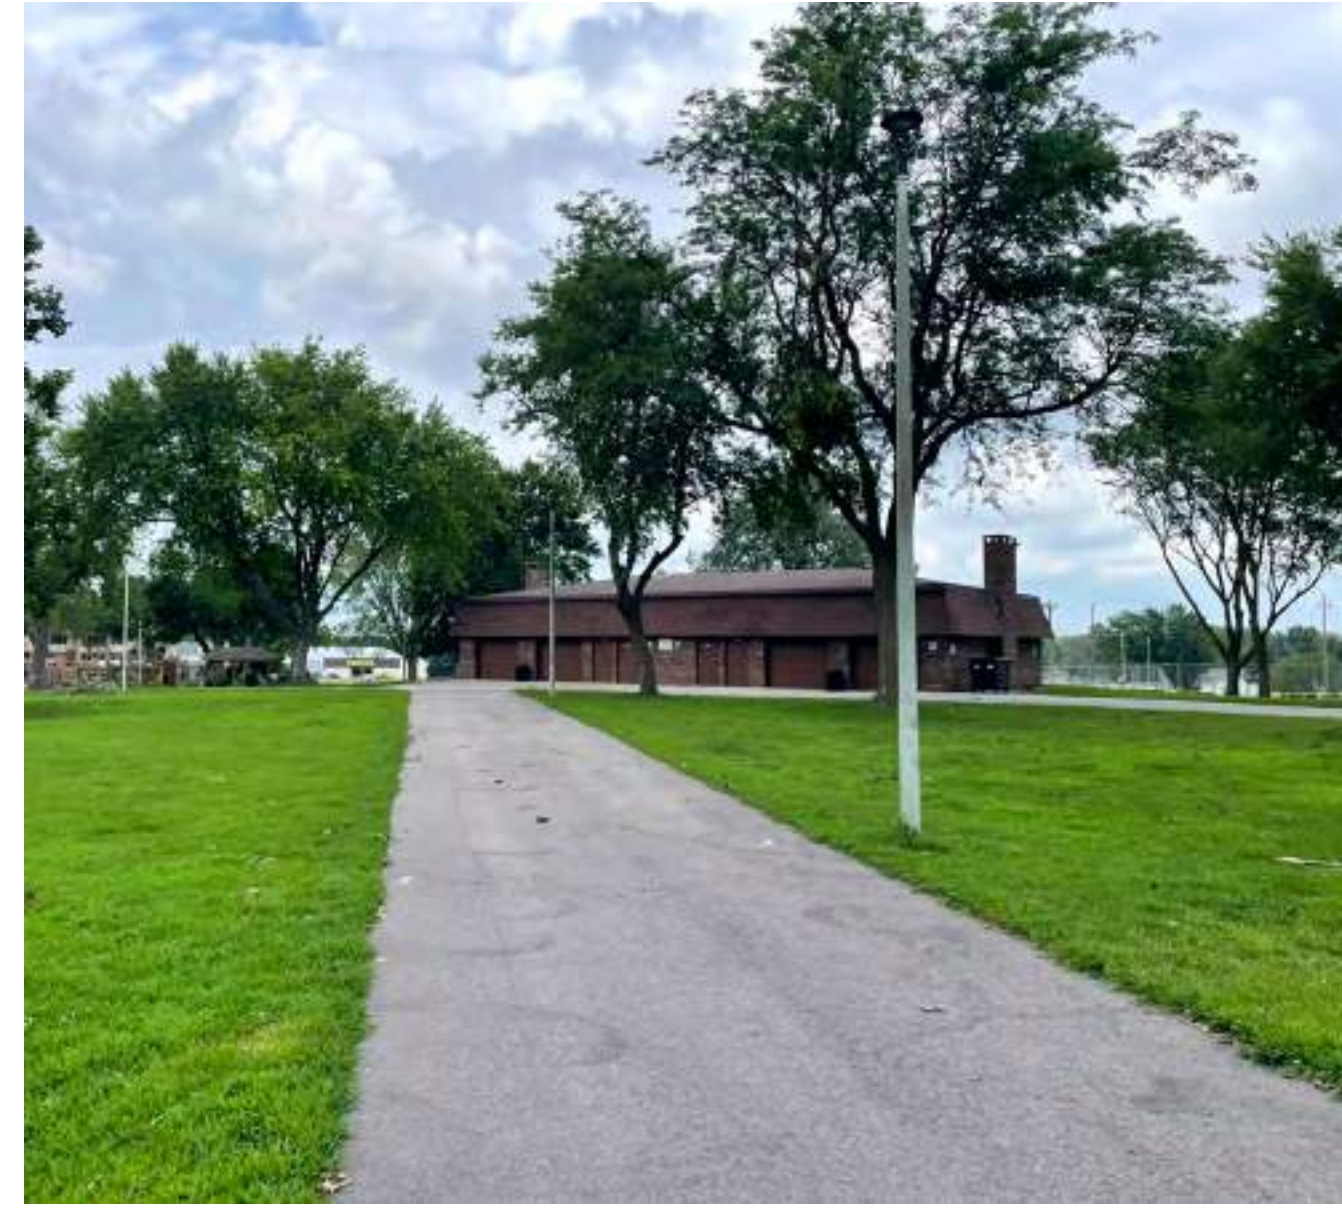
ASPHALT WALKWAY (EAST)

- 12' walkway recently overlaid with good pavement condition.

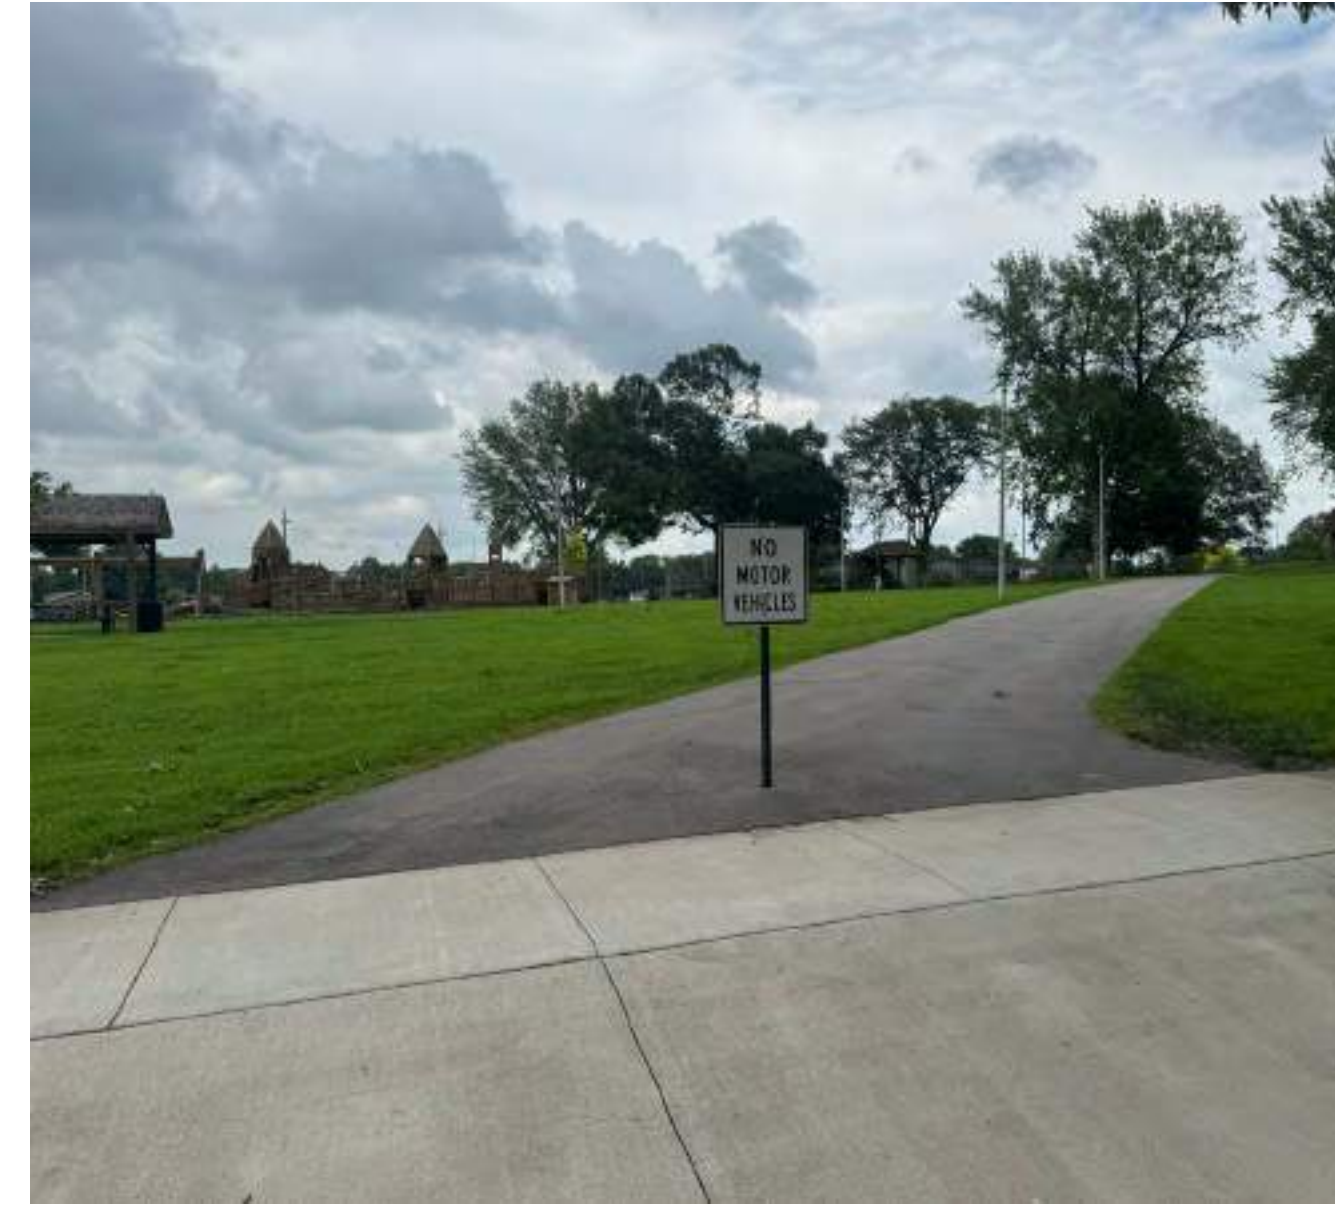
ASPHALT WALKWAY (WEST)

- 12' walkway recently overlaid is in good condition with 'No Motor Vehicles' signage. Street ramp/connection is too steep and non-compliant.

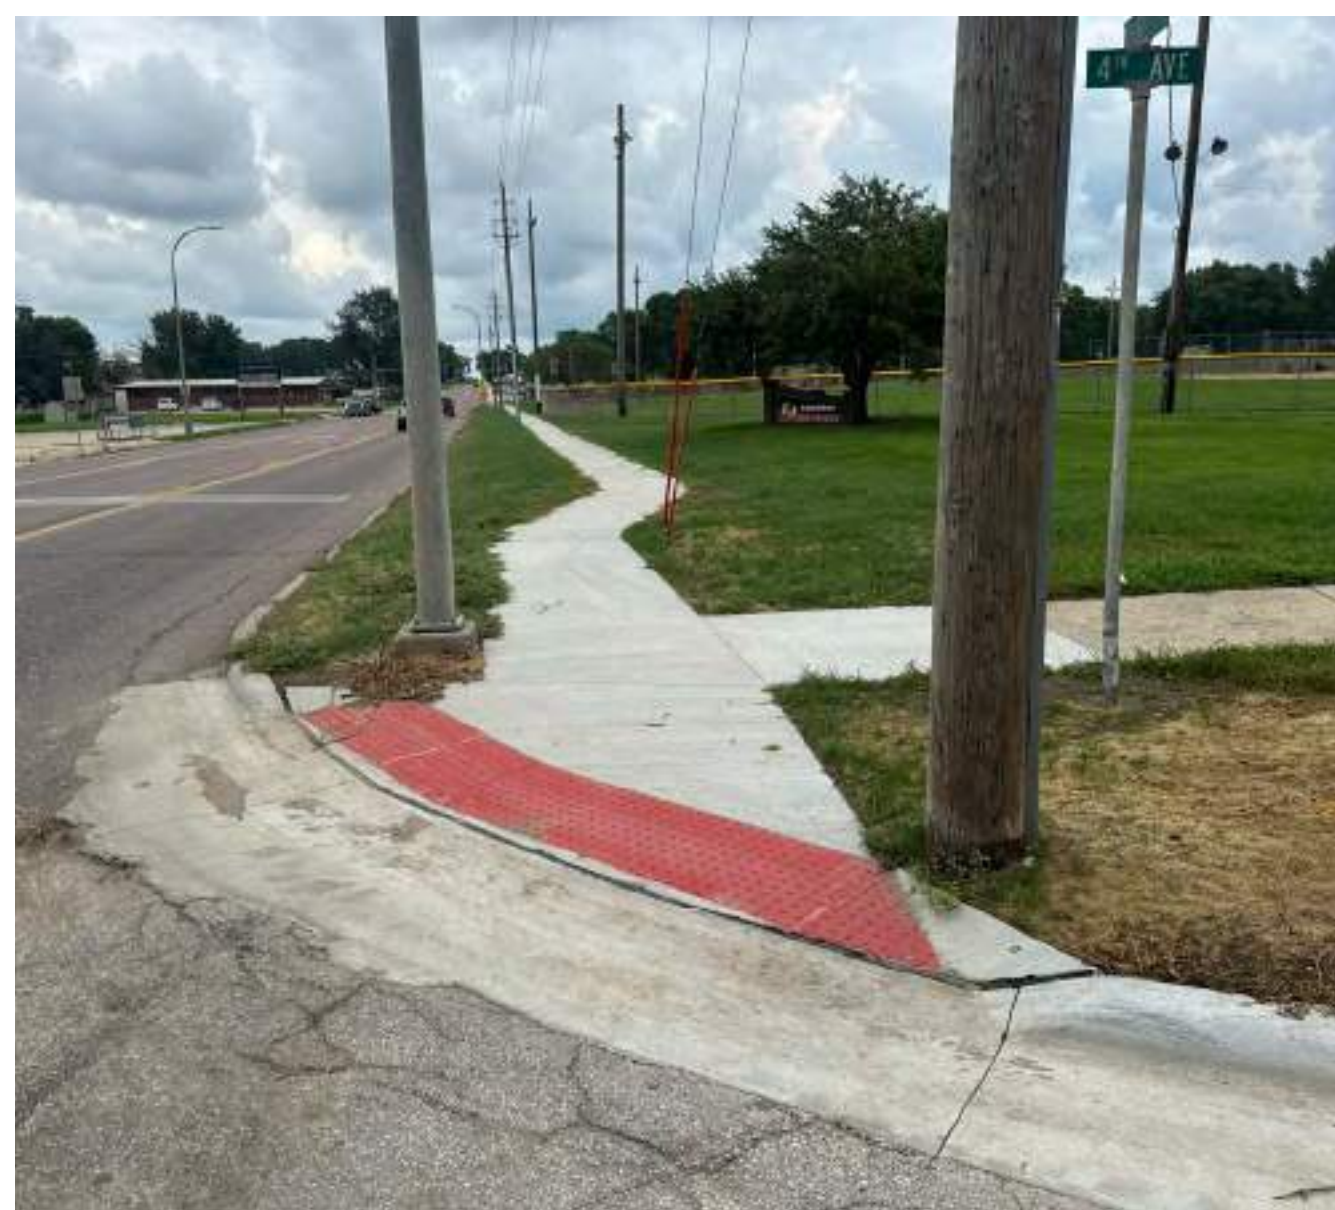
320TH STREET SIDEWALK

- Sidewalk is newly installed in excellent condition with full ADA compliance.

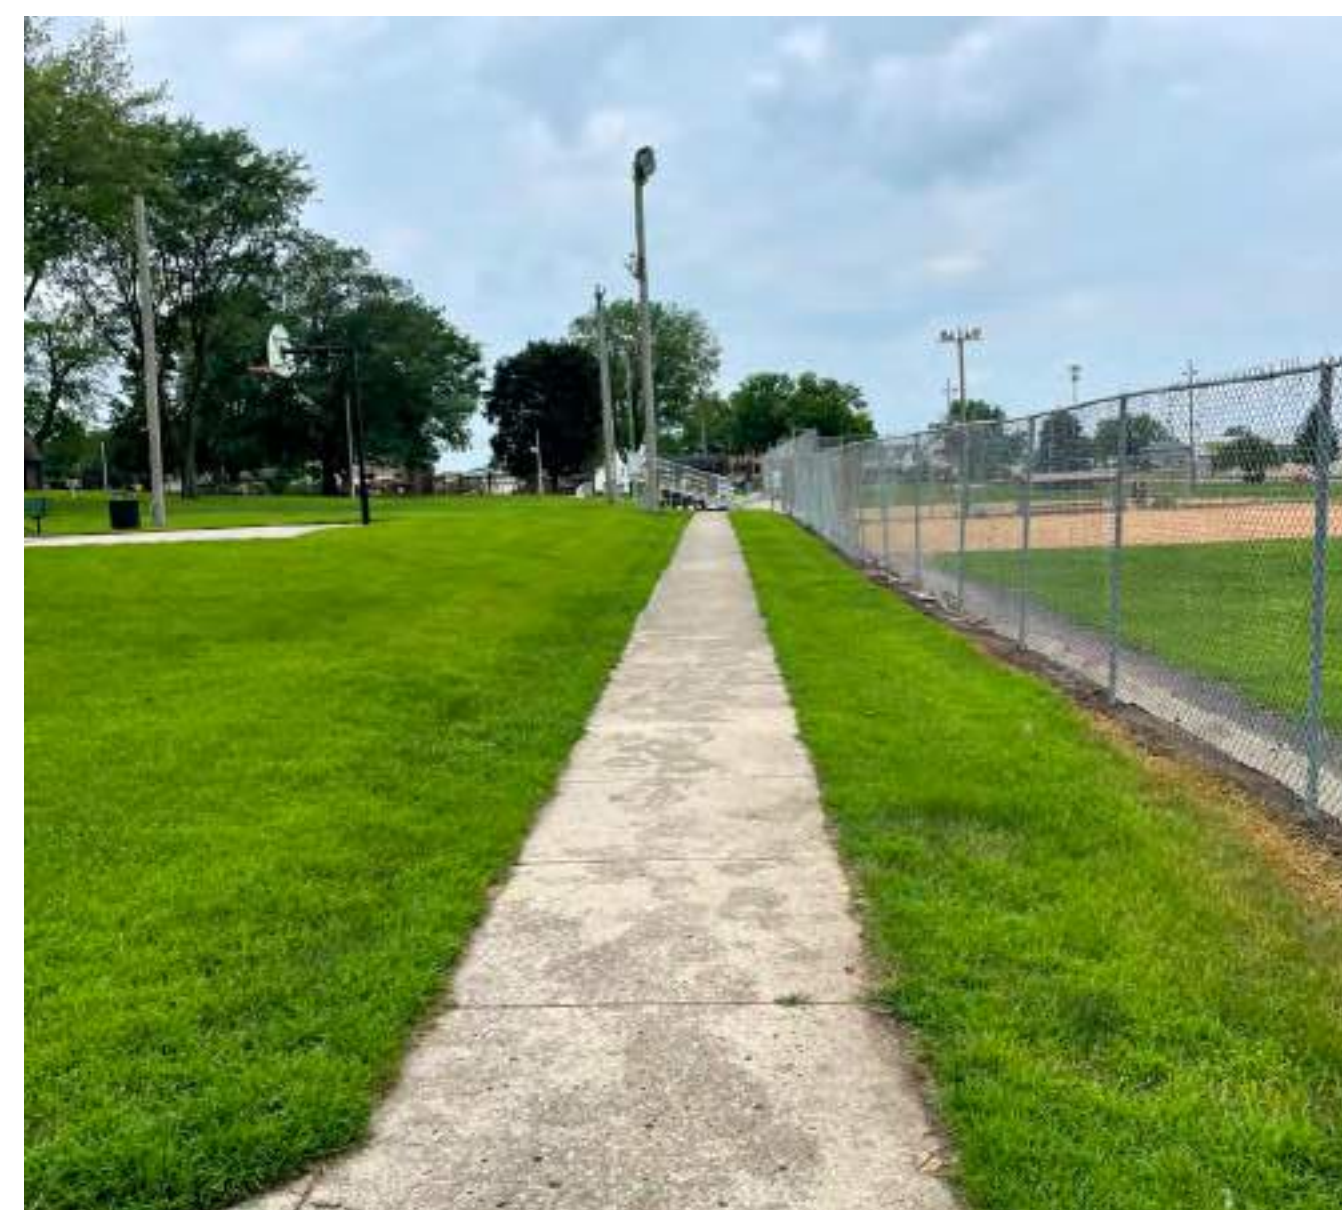
BASEBALL FIELD WALKWAY (EAST)

- 5' wide walkway is in fair condition with minimal wear.

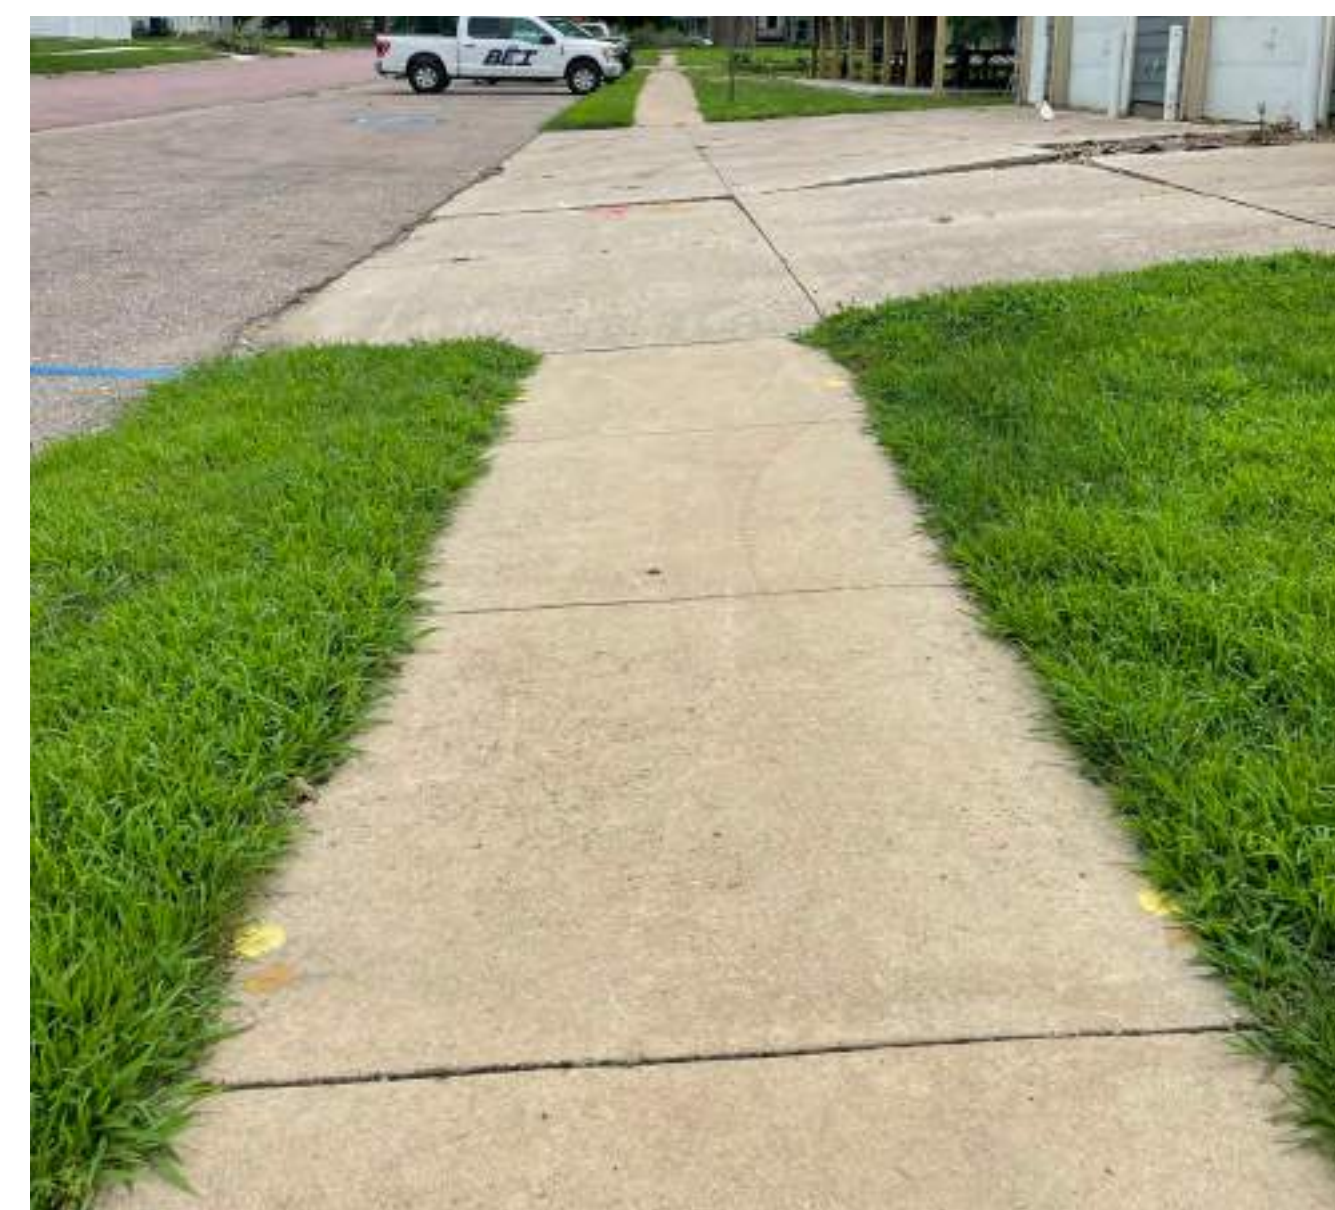
6TH AVENUE SIDEWALK

- 4' wide sidewalk is in fair condition with minimal wear. Spot areas such as ramps / approaches need to be addressed.

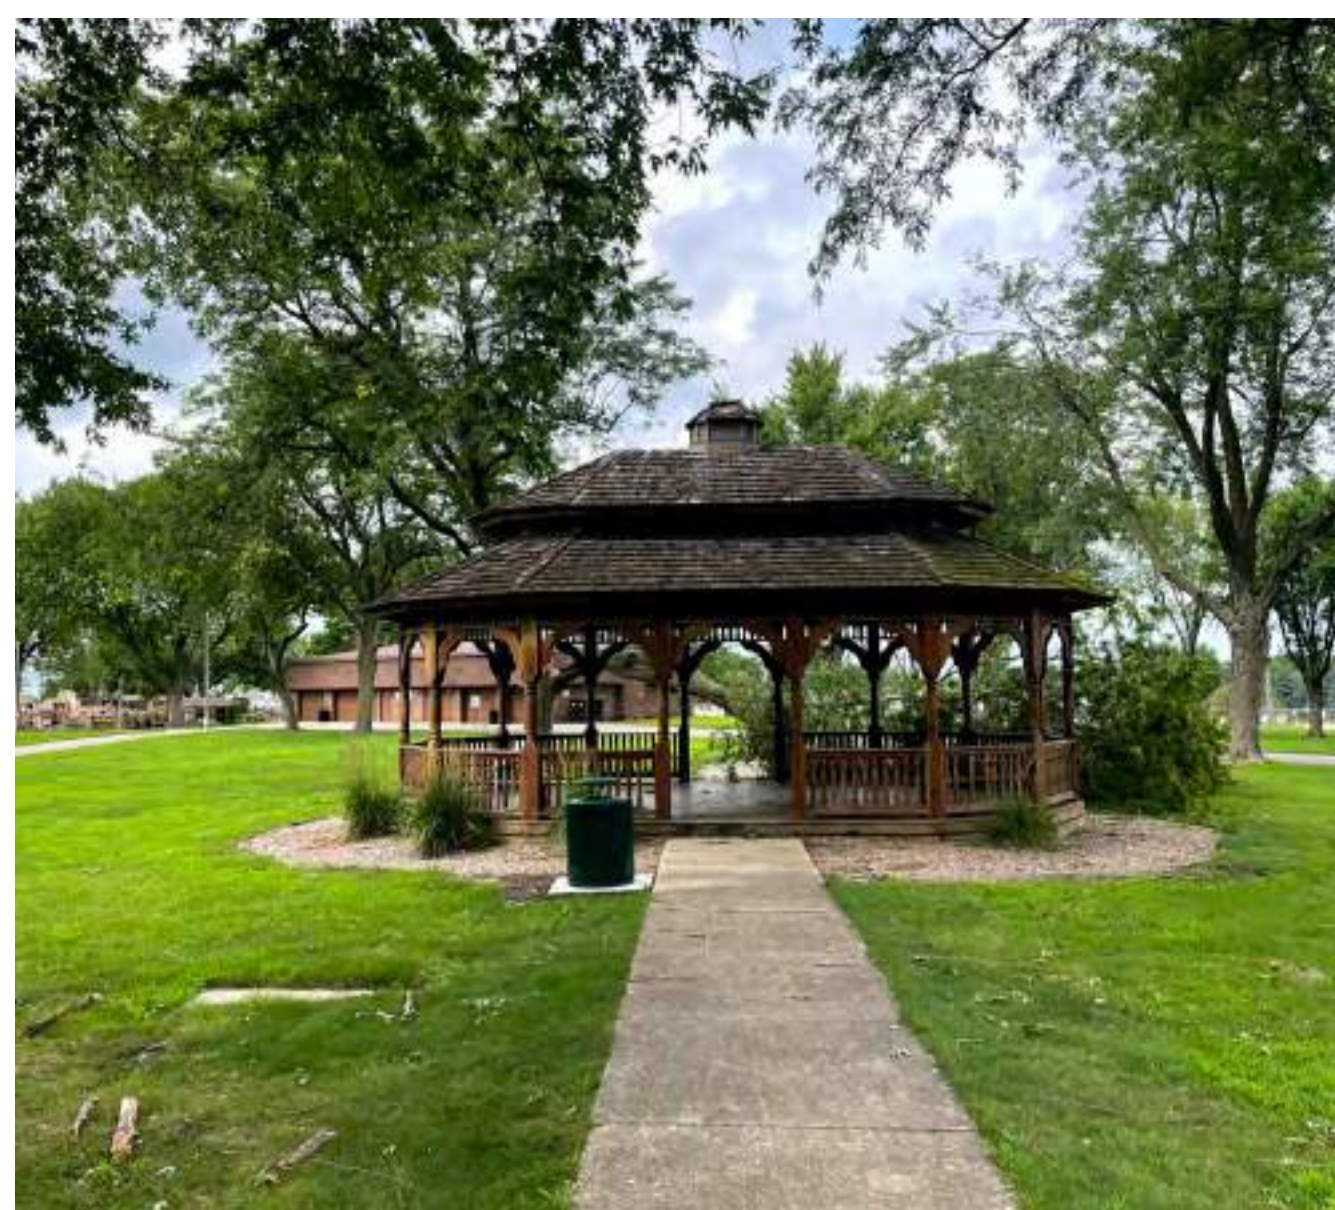
GAZEBO WALKWAY

- 5' walkway in good condition with little visible cracking or wear.

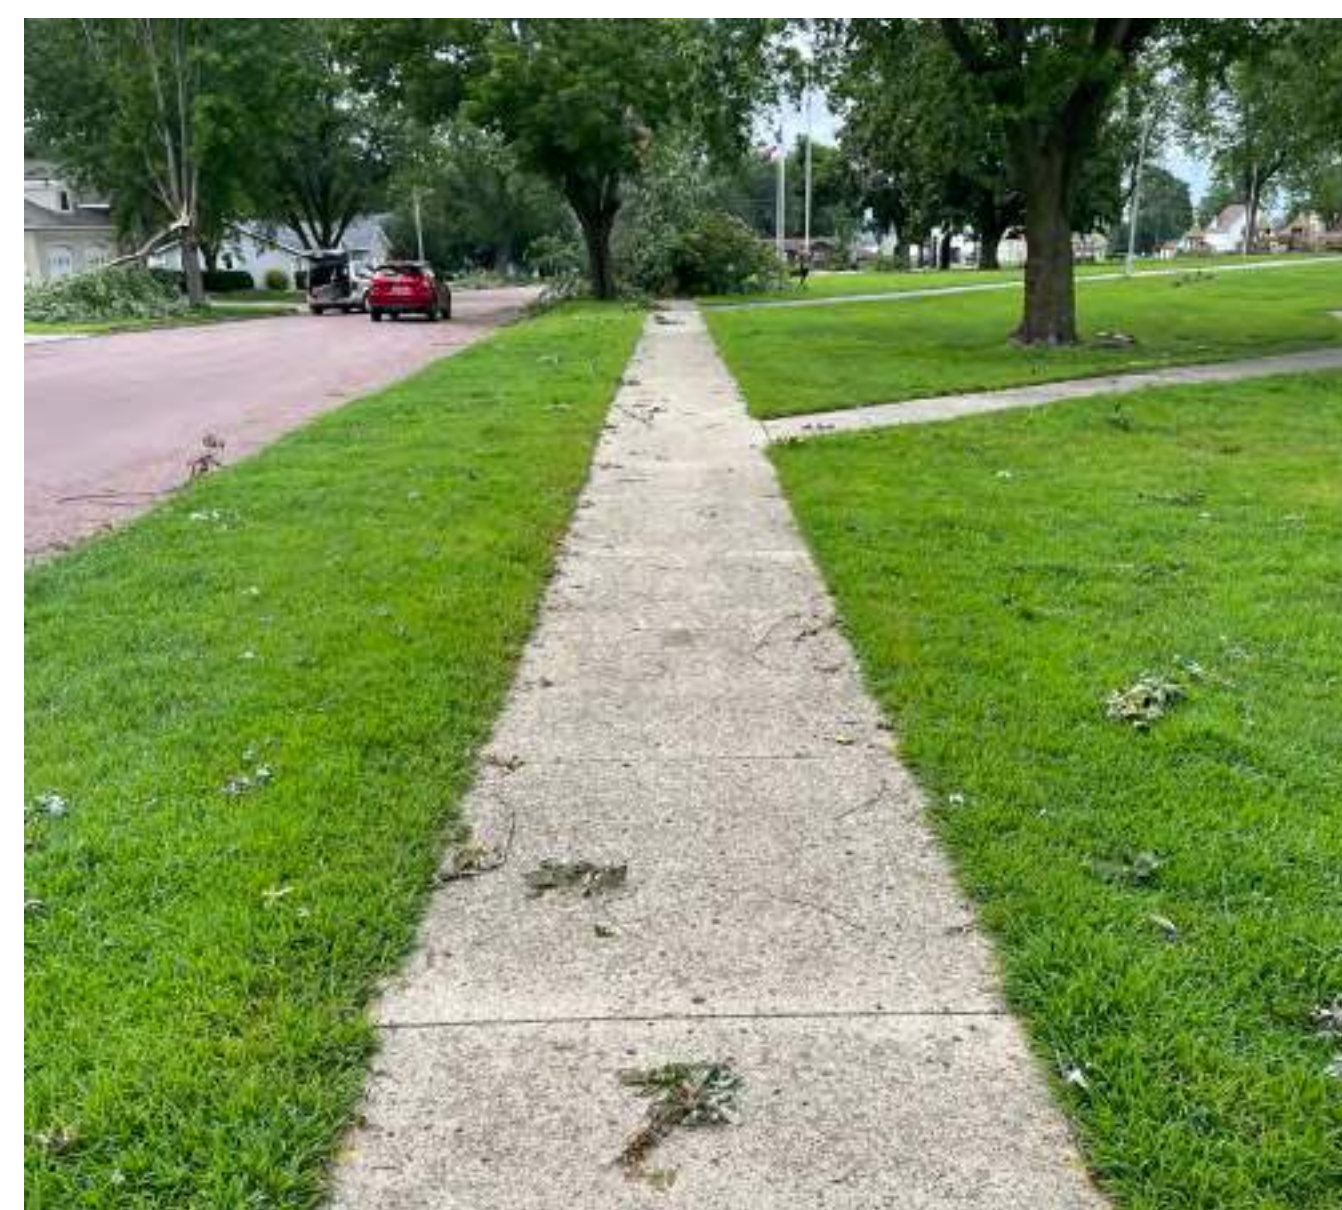
6TH STREET SIDEWALK

- 5' wide sidewalk is in fair condition with minimal wear. Spot areas such as ramps / approaches need to be addressed, along with a few damaged panels.

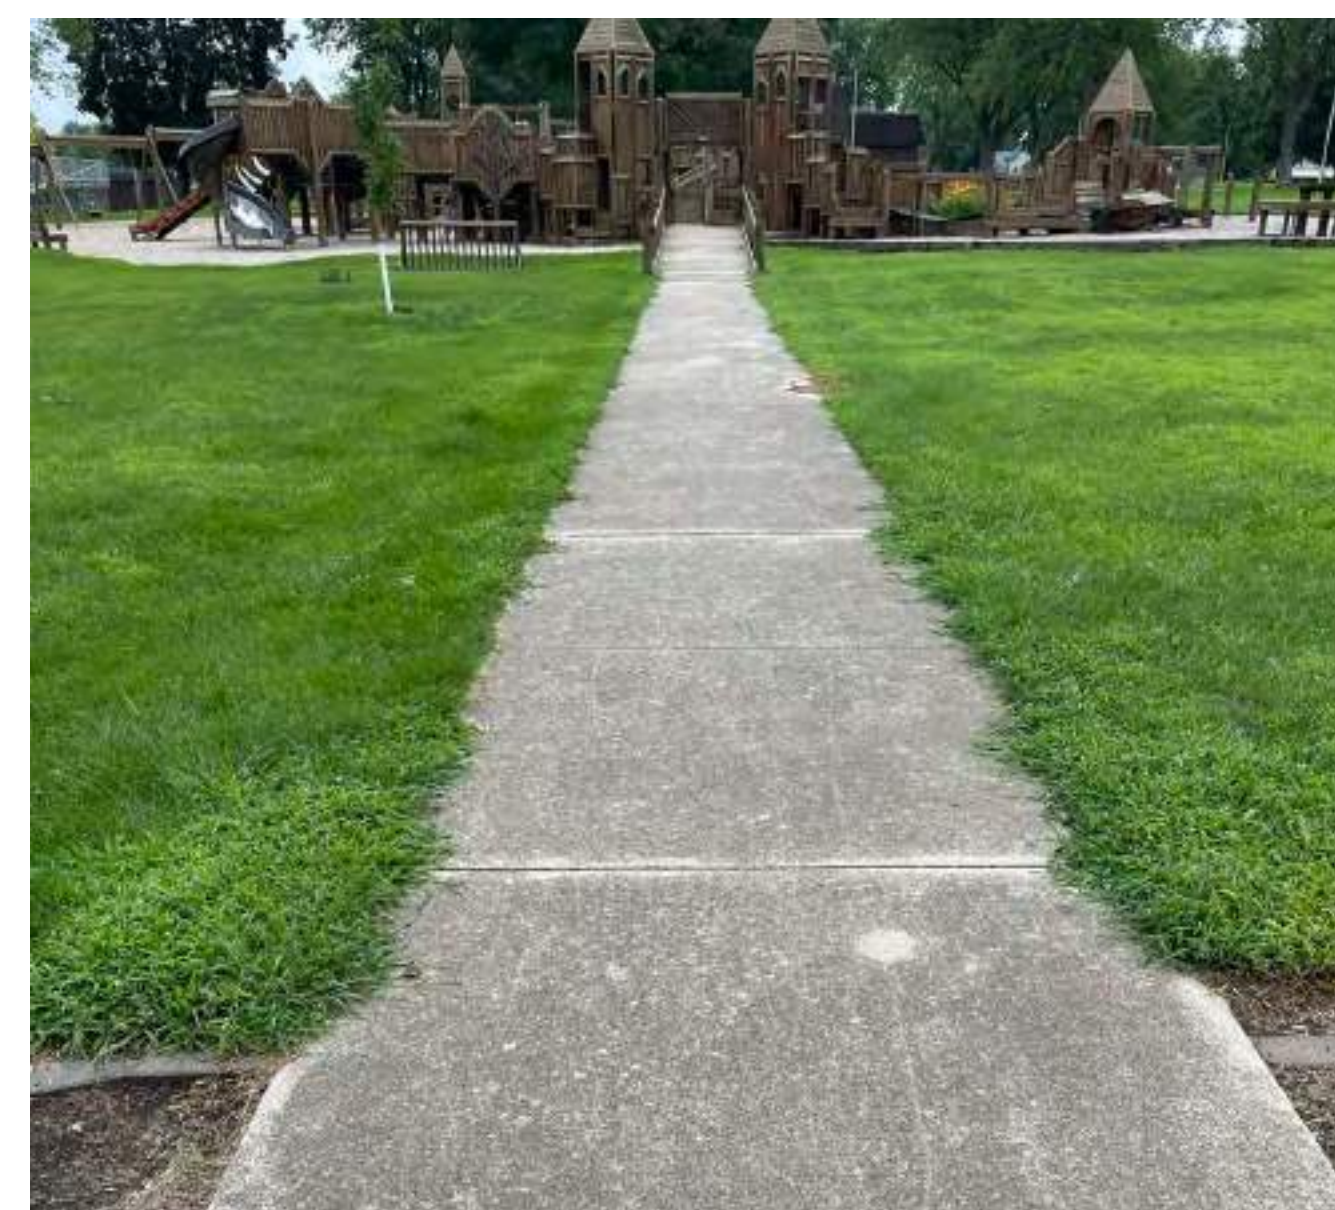
PLAYGROUND SIDEWALK (WEST)

- 6' wide sidewalk in mostly good condition with a few panels needing repair.

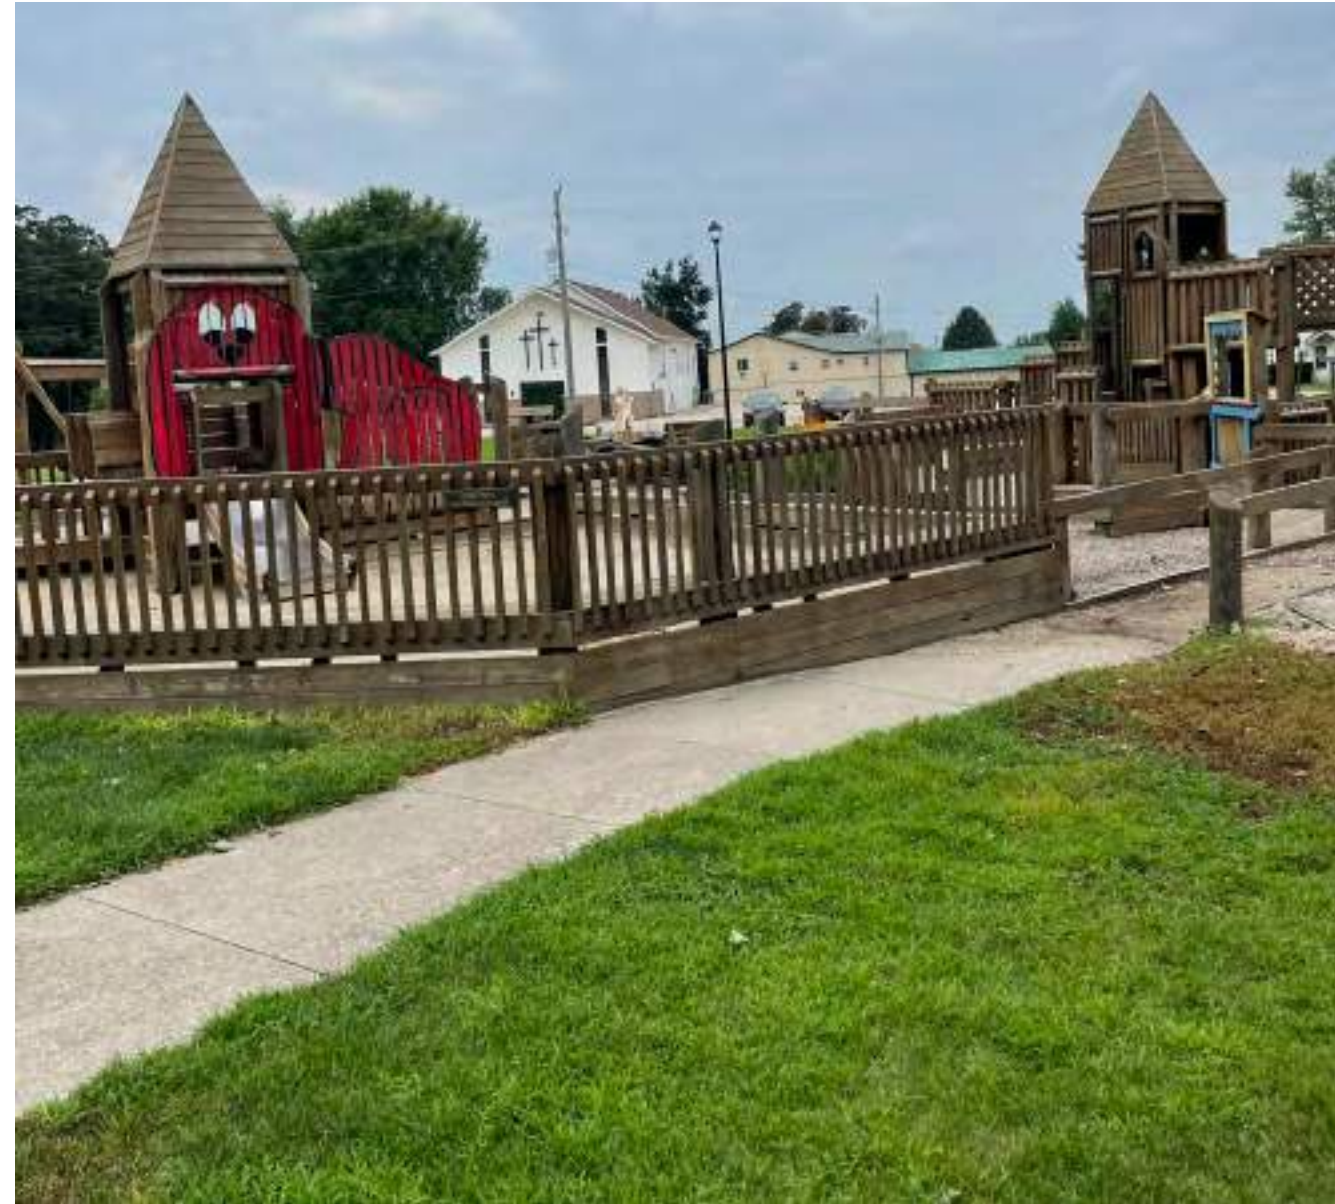
PLAYGROUND SIDEWALK (EAST)

- 6' wide sidewalk in mostly good condition.

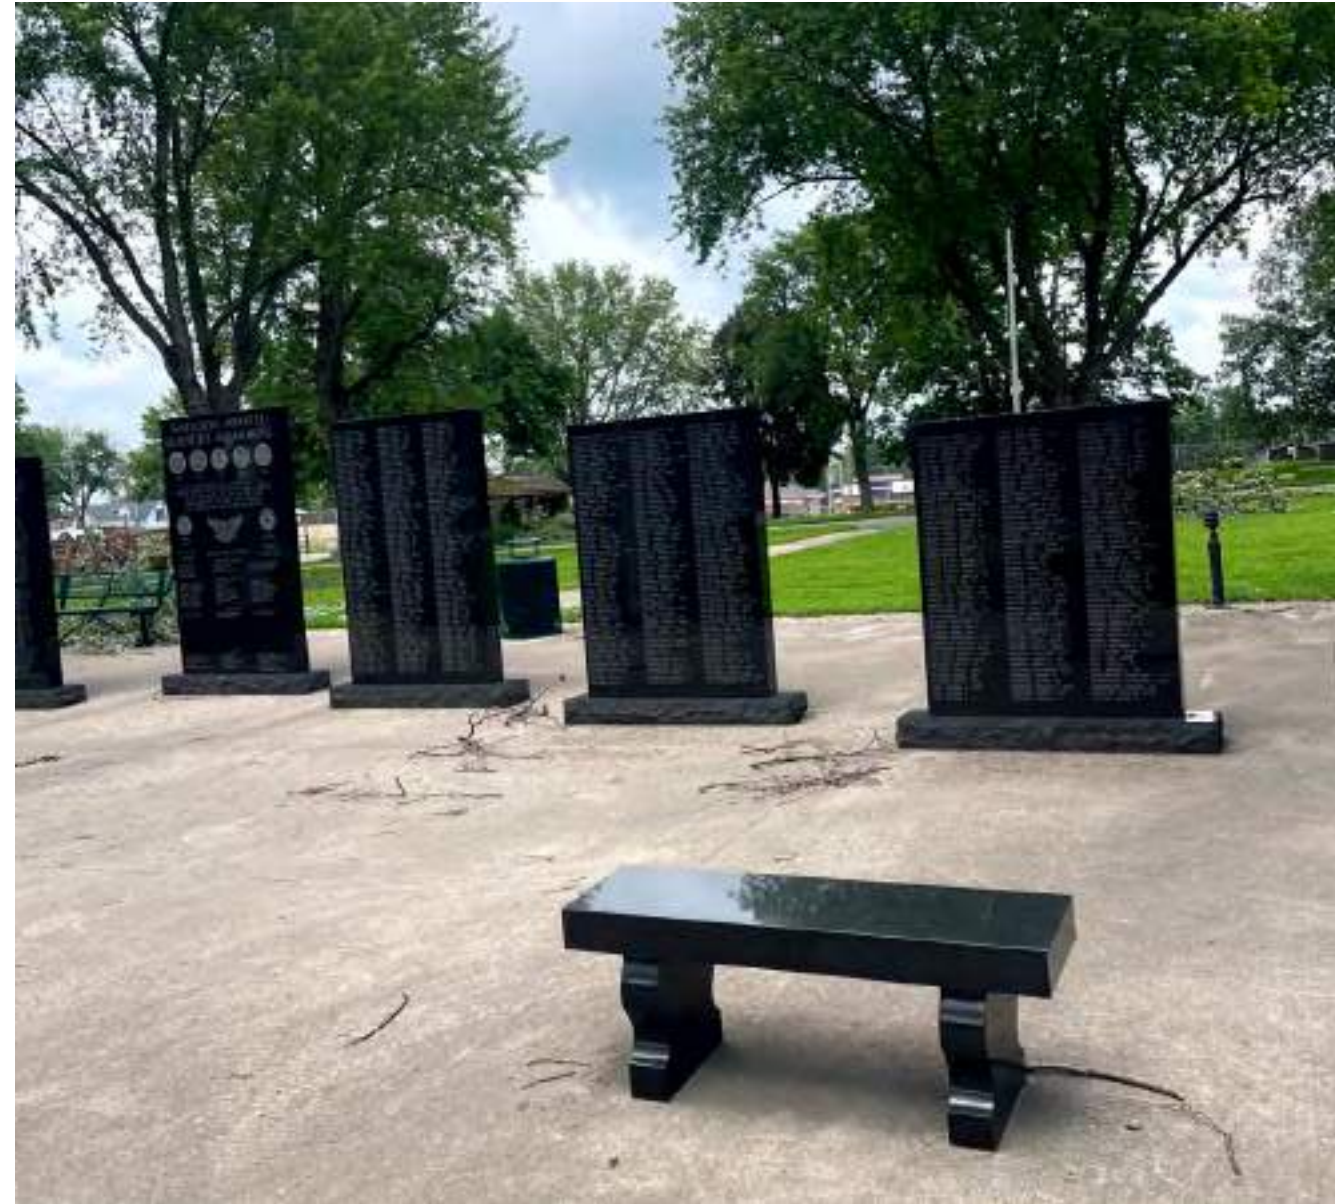
VETERANS MEMORIAL

- The memorial is in fair condition, with access issues along 6th Street (deteriorating curb and ramps). The nine black granite monuments, two granite benches, and three flagpoles are in excellent condition. Lighting appears aged, and the rock monument foundation is poor. Planting beds are mostly well maintained, and the site includes a fire pit in fair condition.

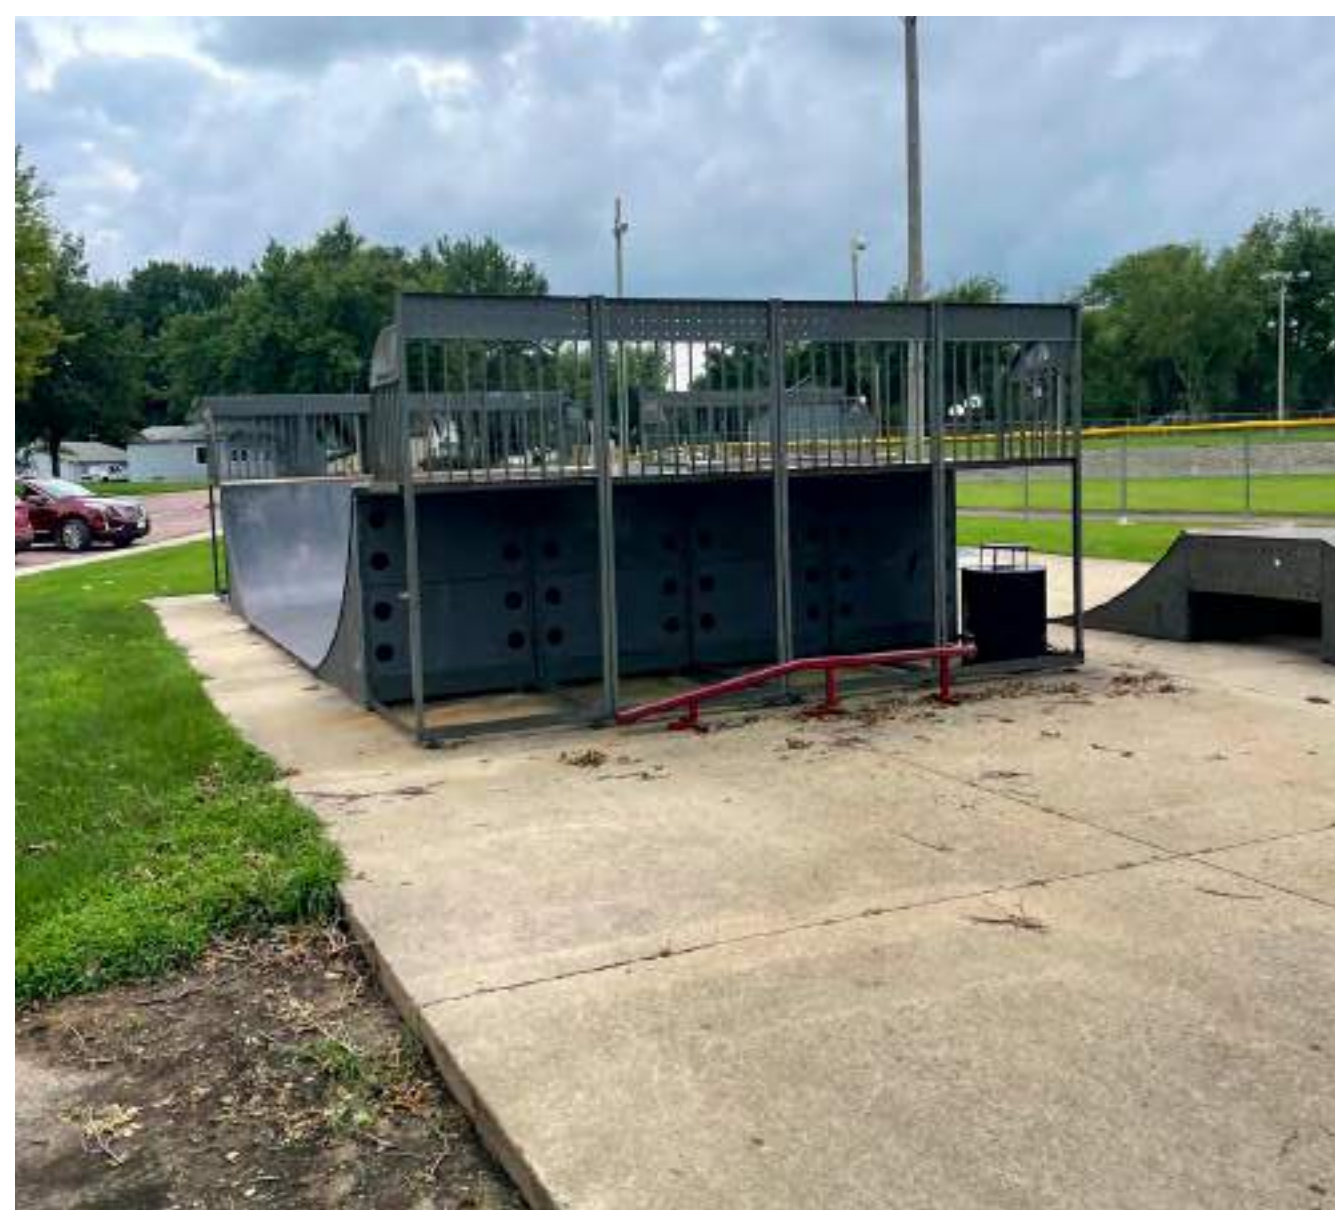
SKATE PARK

- The equipment shows significant wear and rust from age and limited use. Some concrete areas have minimal overgrowth from vegetation and contain noticeable trash and debris, while some equipment surfaces also display graffiti and paint.

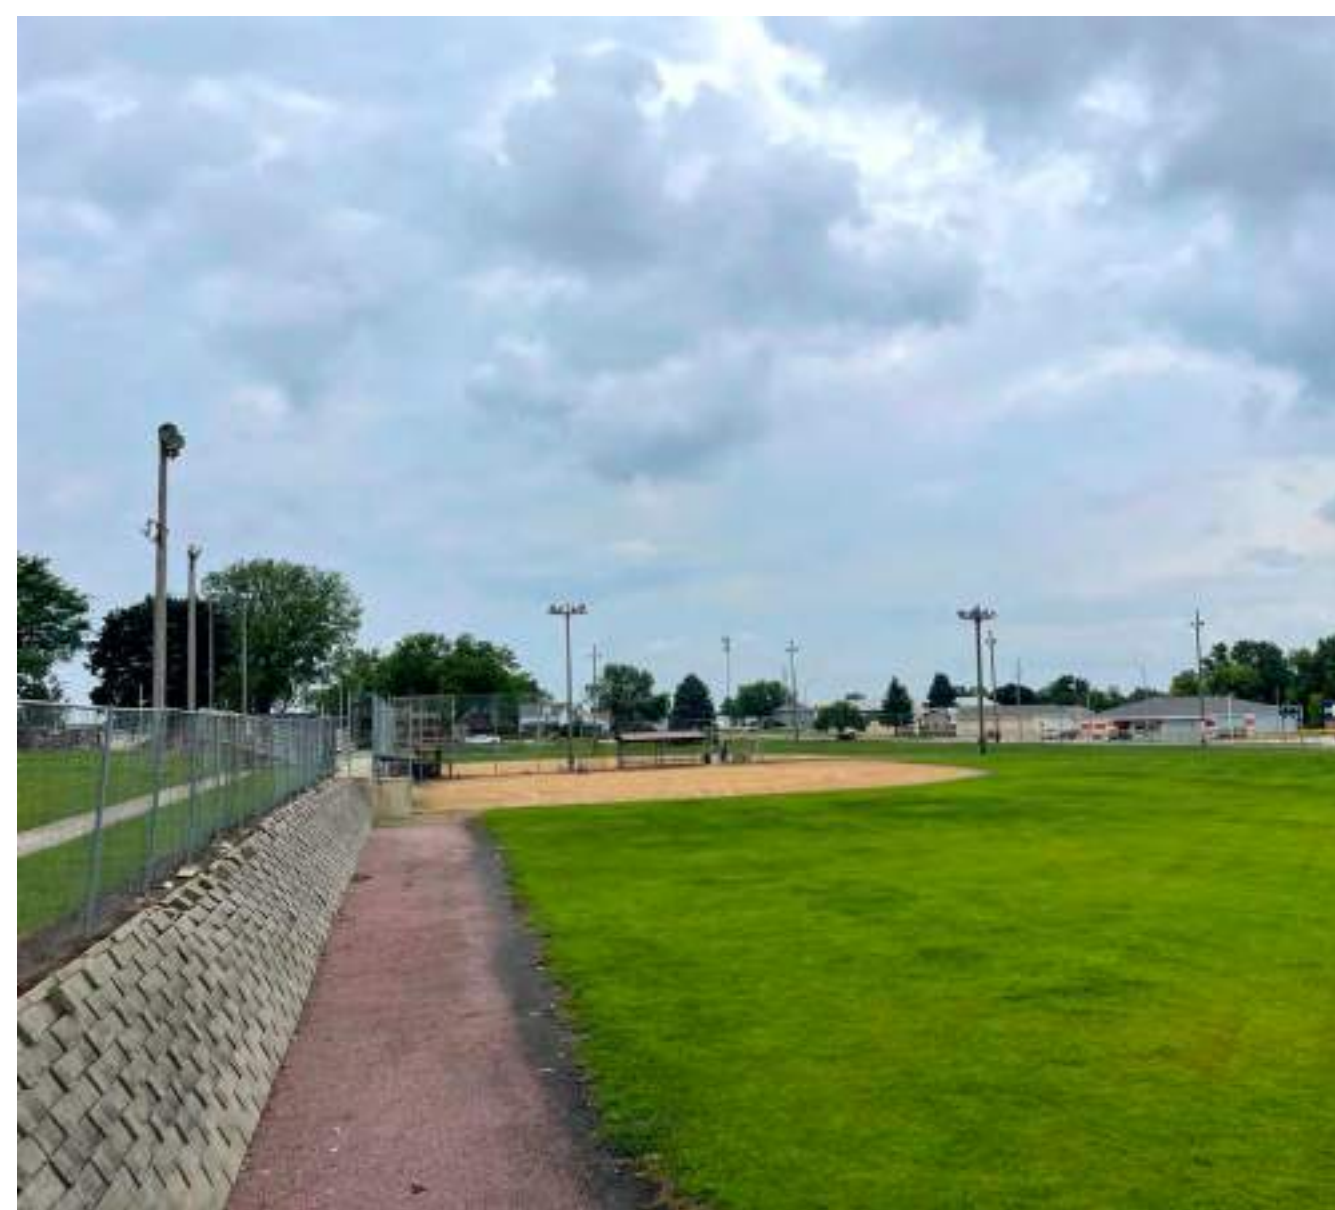
BASEBALL / SOFTBALL FIELDS

- The fields are usable but most associated amenities are in poor condition. Dugouts have cracked and warped panels, likely from poor drainage. The retaining wall and perimeter fence are deteriorating, posing potential safety concerns. Concrete and bleacher pads show cracking, heaving, and ponding water, while the bleachers themselves are in fair condition.

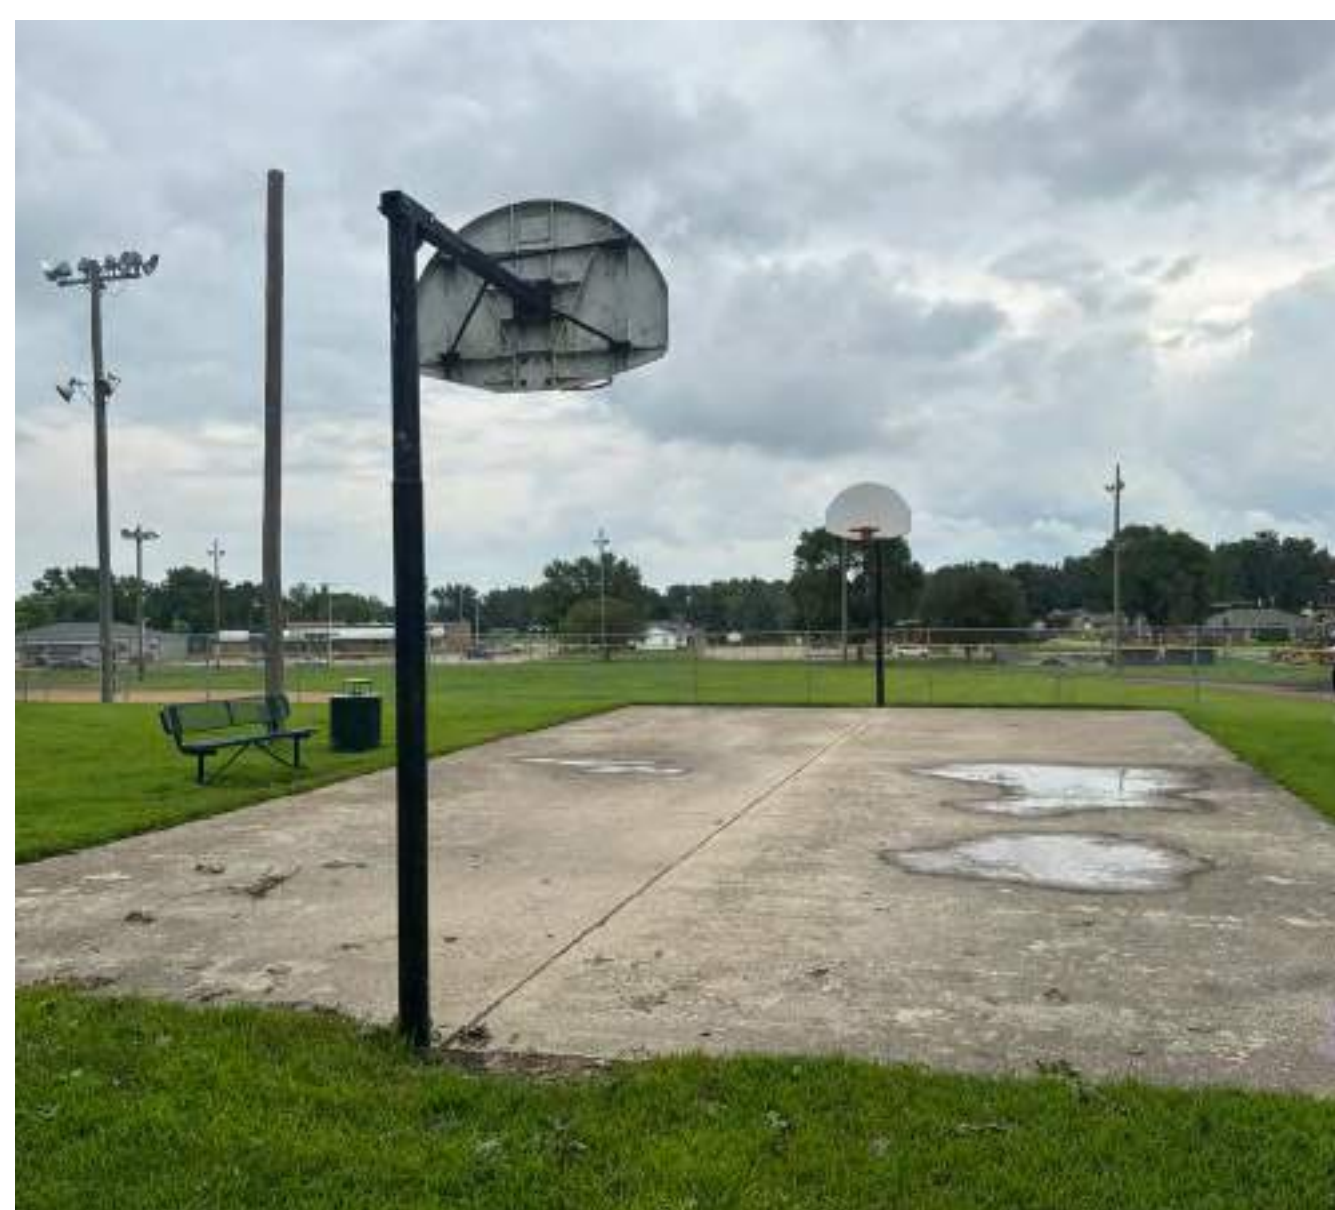
BASKETBALL COURT

- The concrete displays little cracking but appears deteriorated and weathered while also holding ponding water in several areas. Basketball hoops appear worn and outdated with no nets.
