# City Park Master Plan

CITY OF SHELDON, IOWA

CITY COUNCIL PRESENTATION - DECEMBER 3, 2025

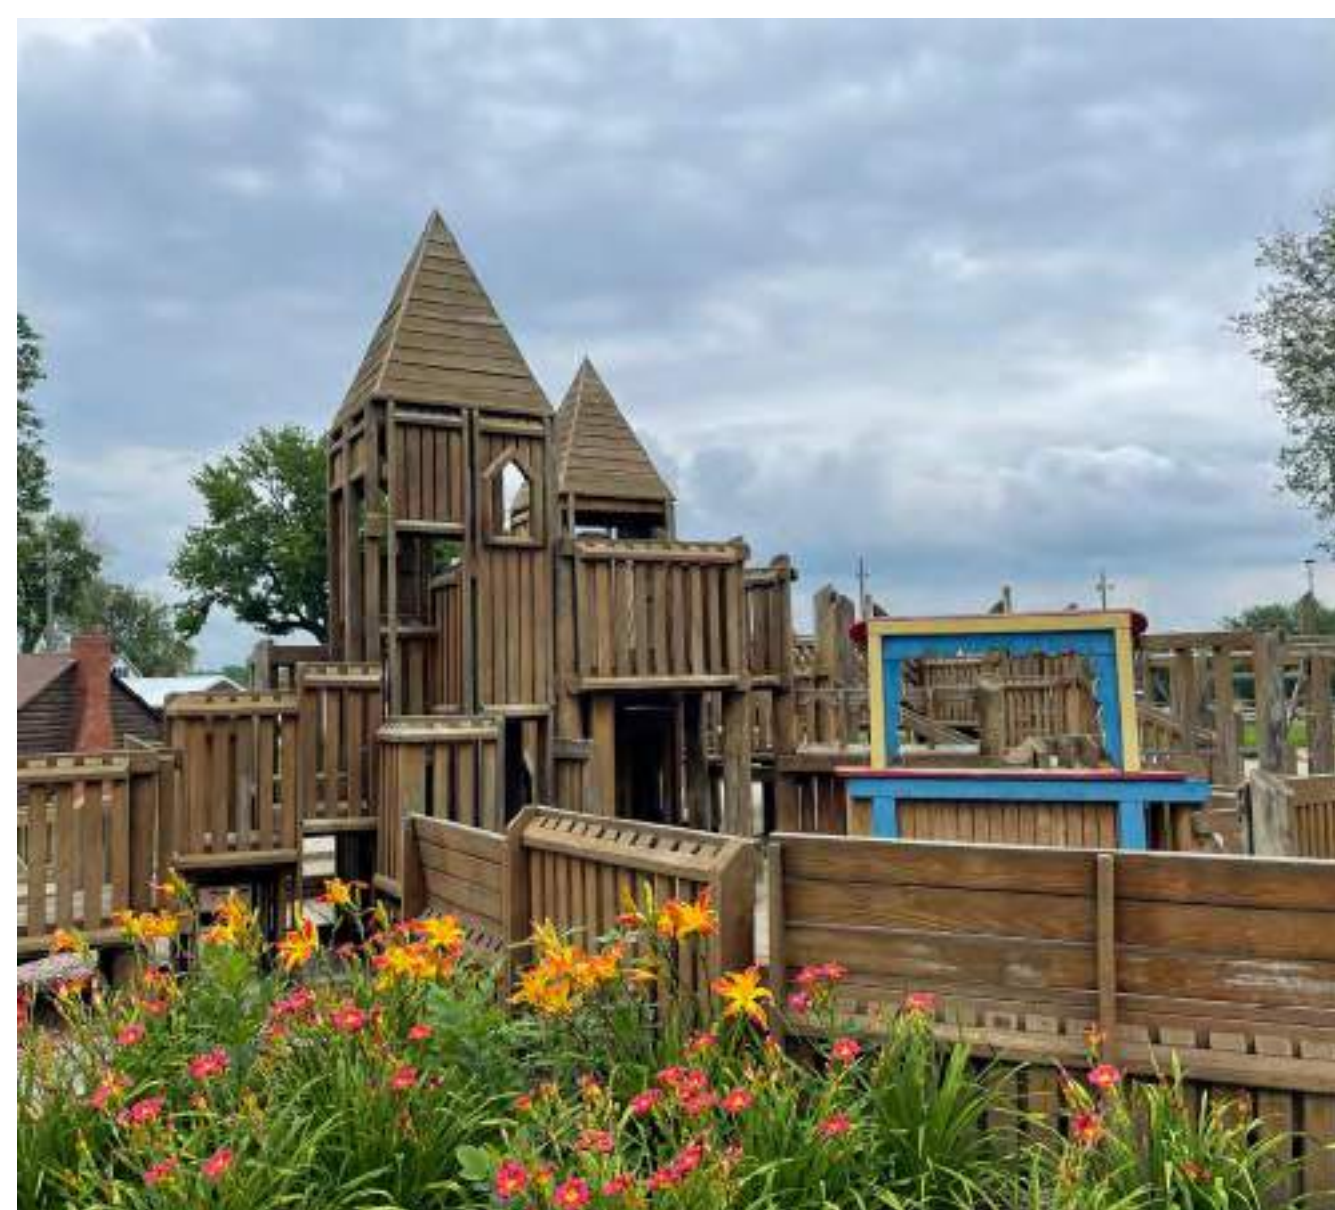
PLAYGROUND

- The playground is in fair condition and appears well used, though most equipment is outdated, consisting of wood, ropes, and tires arranged in ways that do not meet current safety standards. Play elements focus on obstacle-course and adventure / exploration-style activities, with some wood surfaces beginning to splinter. Surfacing is split between pea rock and wood mulch, both in poor condition with ponding water and vegetation overgrowth. Seating elements are functional and used while colorful animal murals add vibrancy to the space. However, wood edging around the perimeter is deteriorating, and the playground overall lacks accessibility, making it largely unusable for individuals with disabilities or mobility impairments.

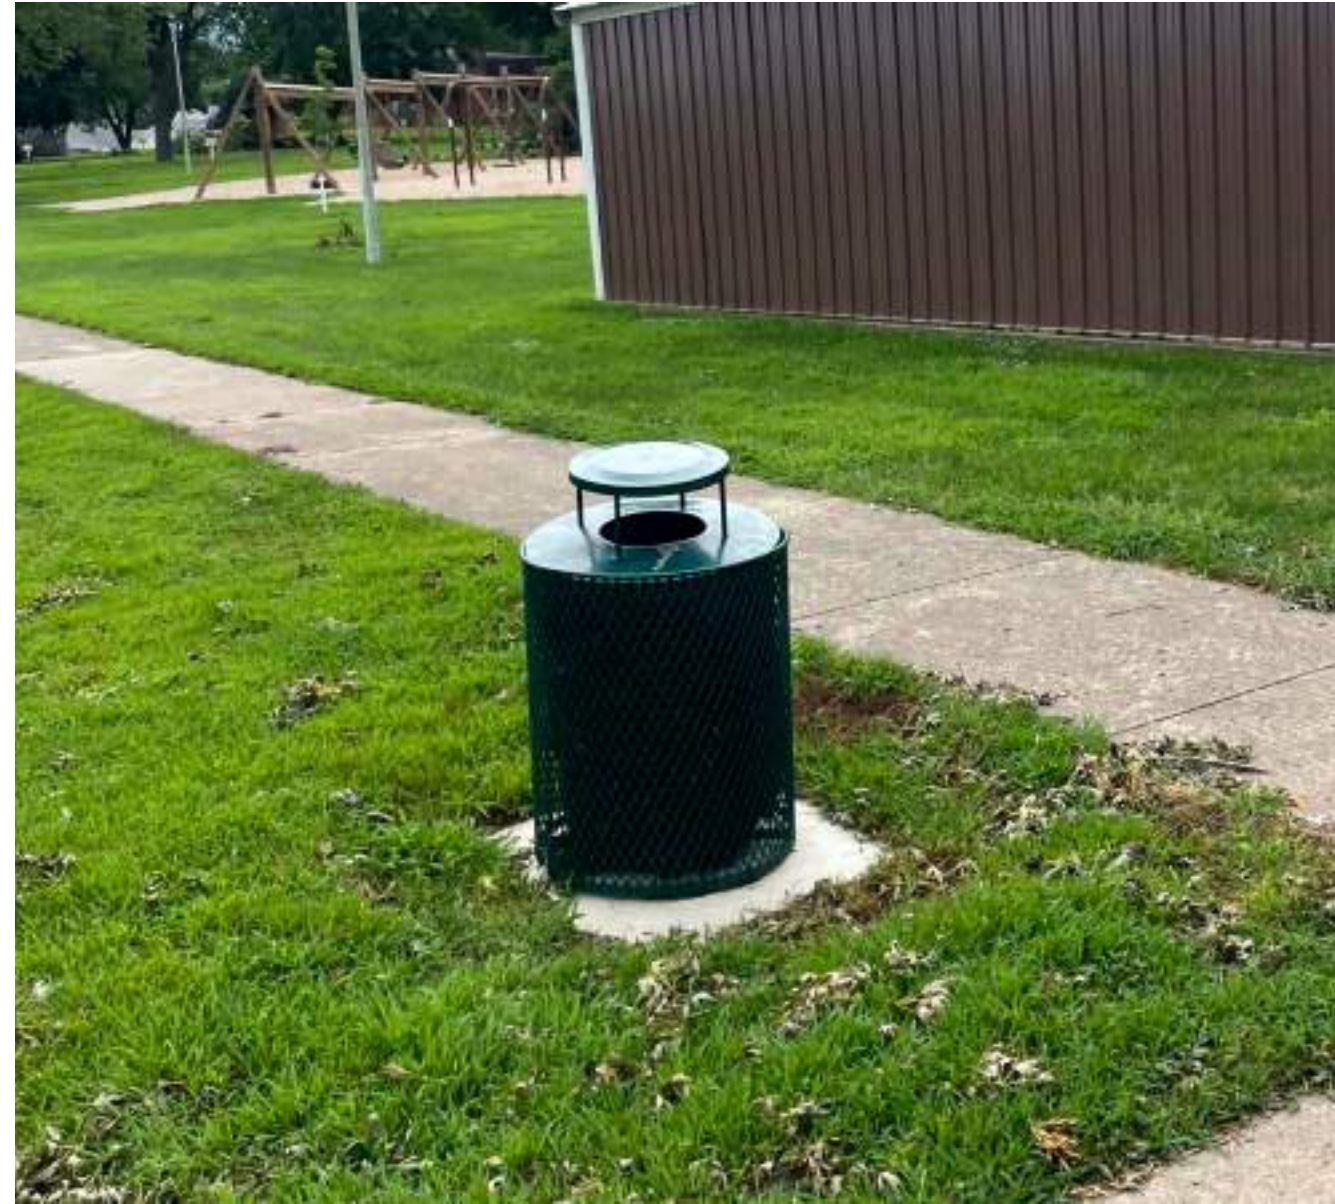
TRASH RECEPTACLE

- Multiple trash receptacles are included throughout the site in mostly good condition. Trash receptacles have an even dispersal throughout the site but could be placed more strategically in some areas.

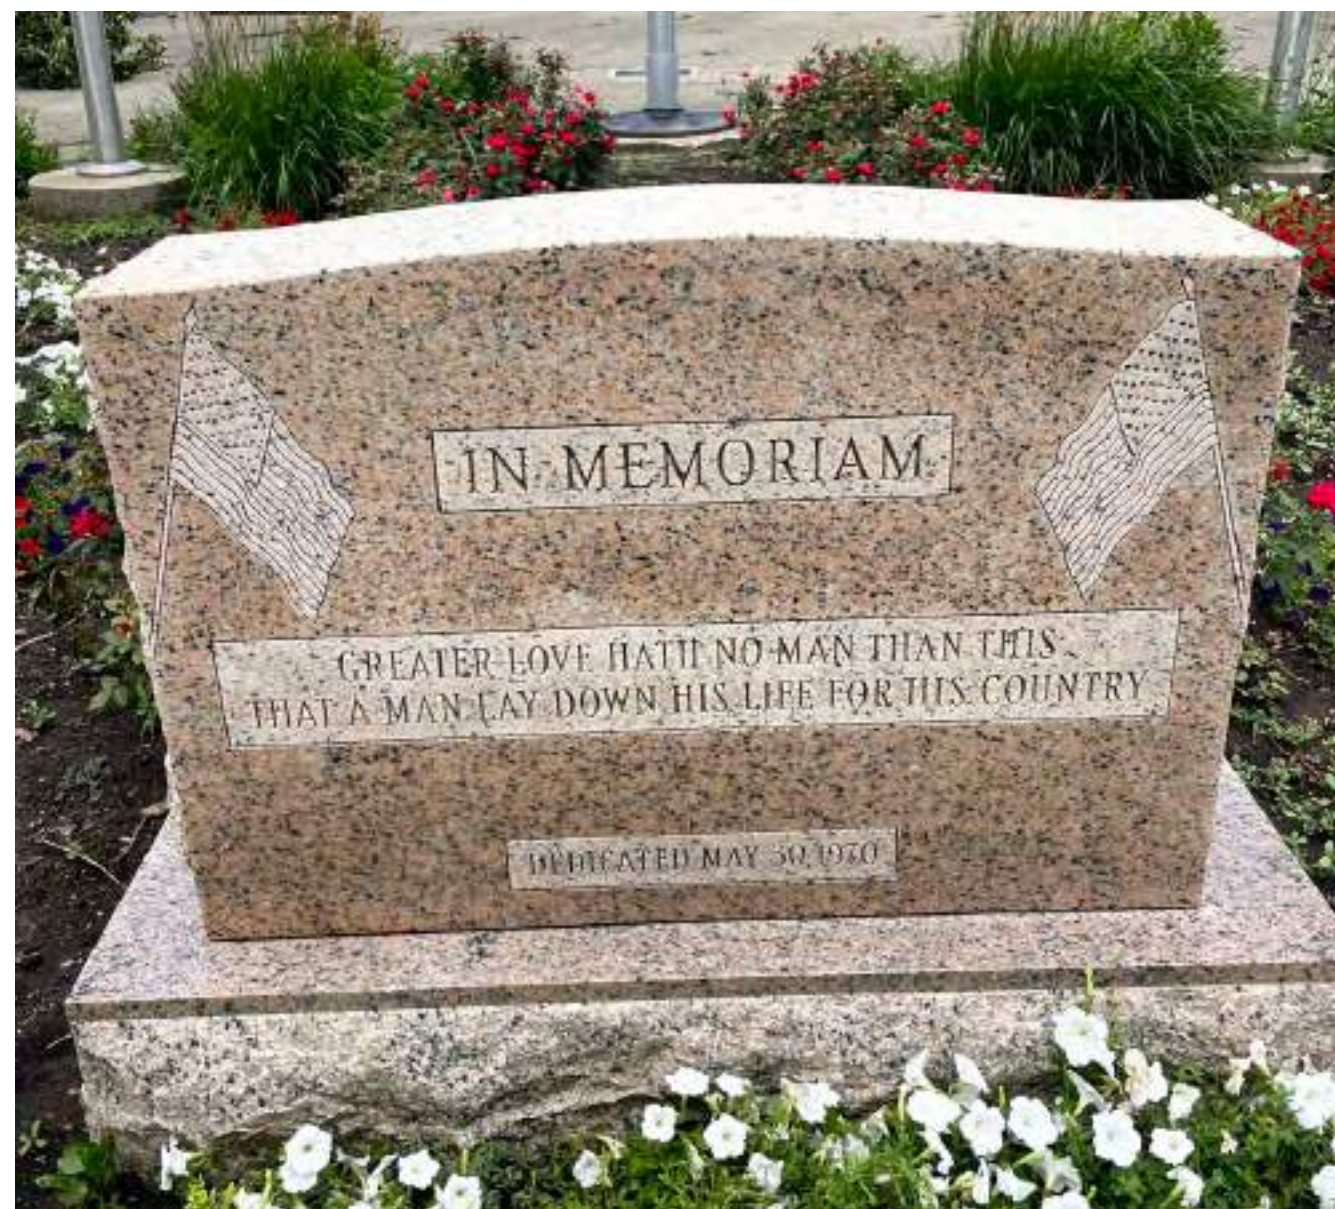
MEMORIALS / MONUMENTS

- The site includes various memorials, plaques, and monuments throughout the site aside from the veteran's memorial itself. Many of which are out of sight in planting beds or embedded into a concrete pad in the lawn. Monuments are in optimal and fair condition but most of which show noticeable signs of wear and weathering.

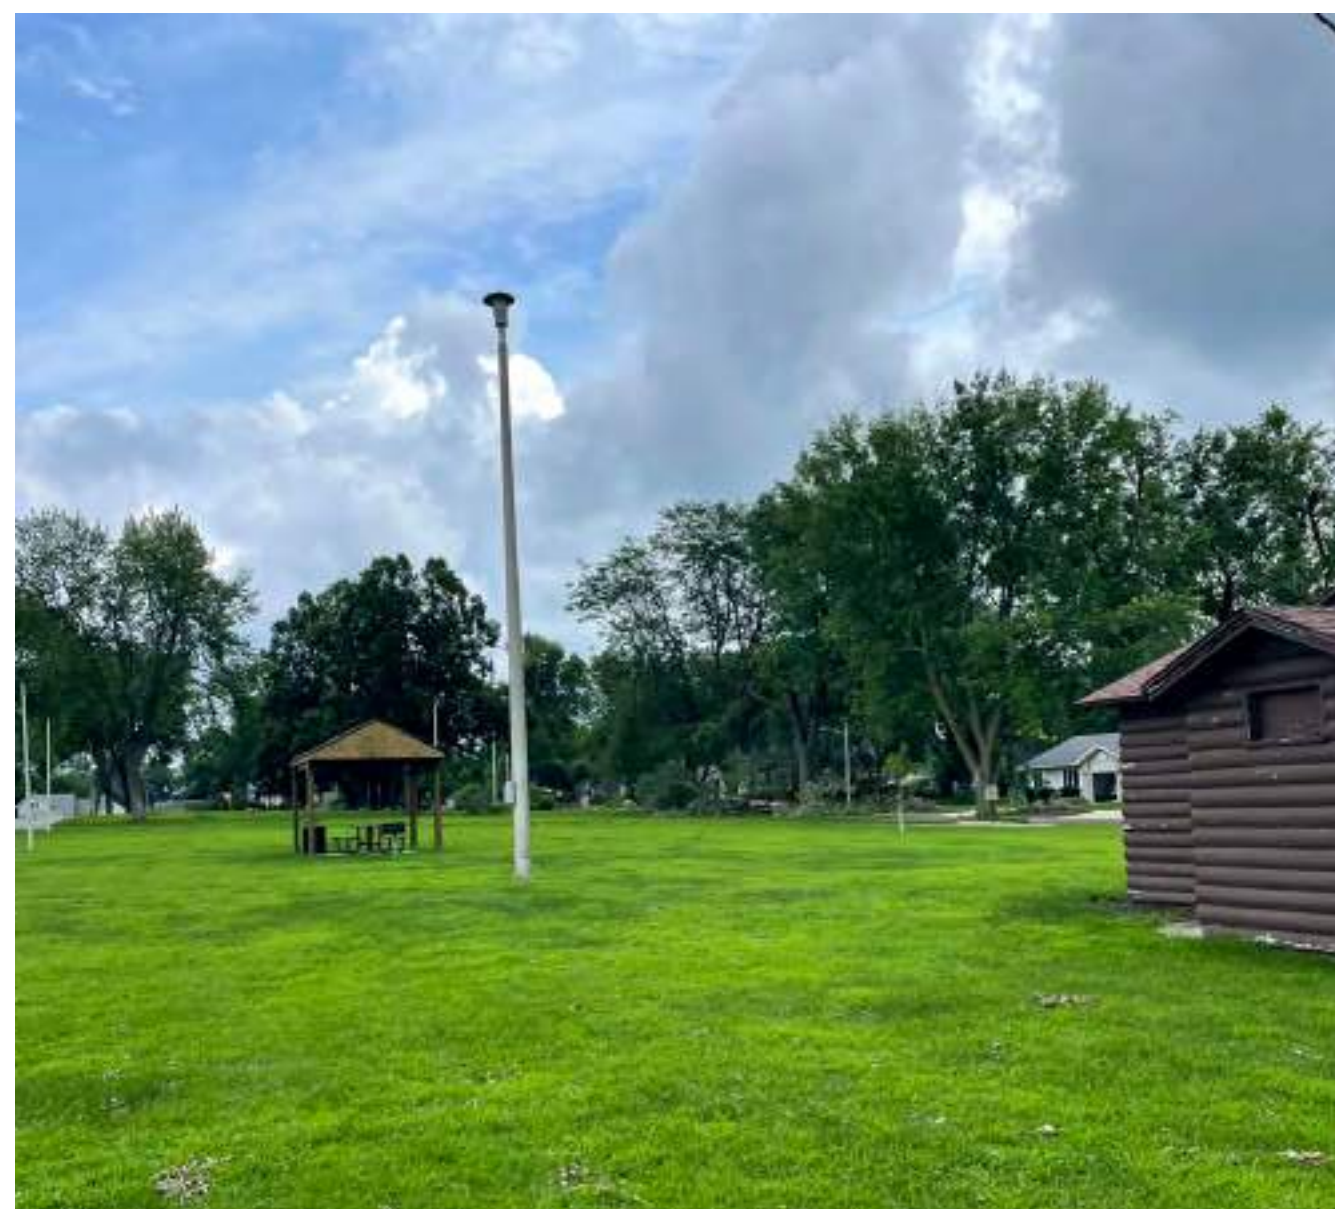
AREA LIGHTING

- The site contains 11 light poles of various mismatching types, all in mostly fair condition. Function / working condition is unknown.

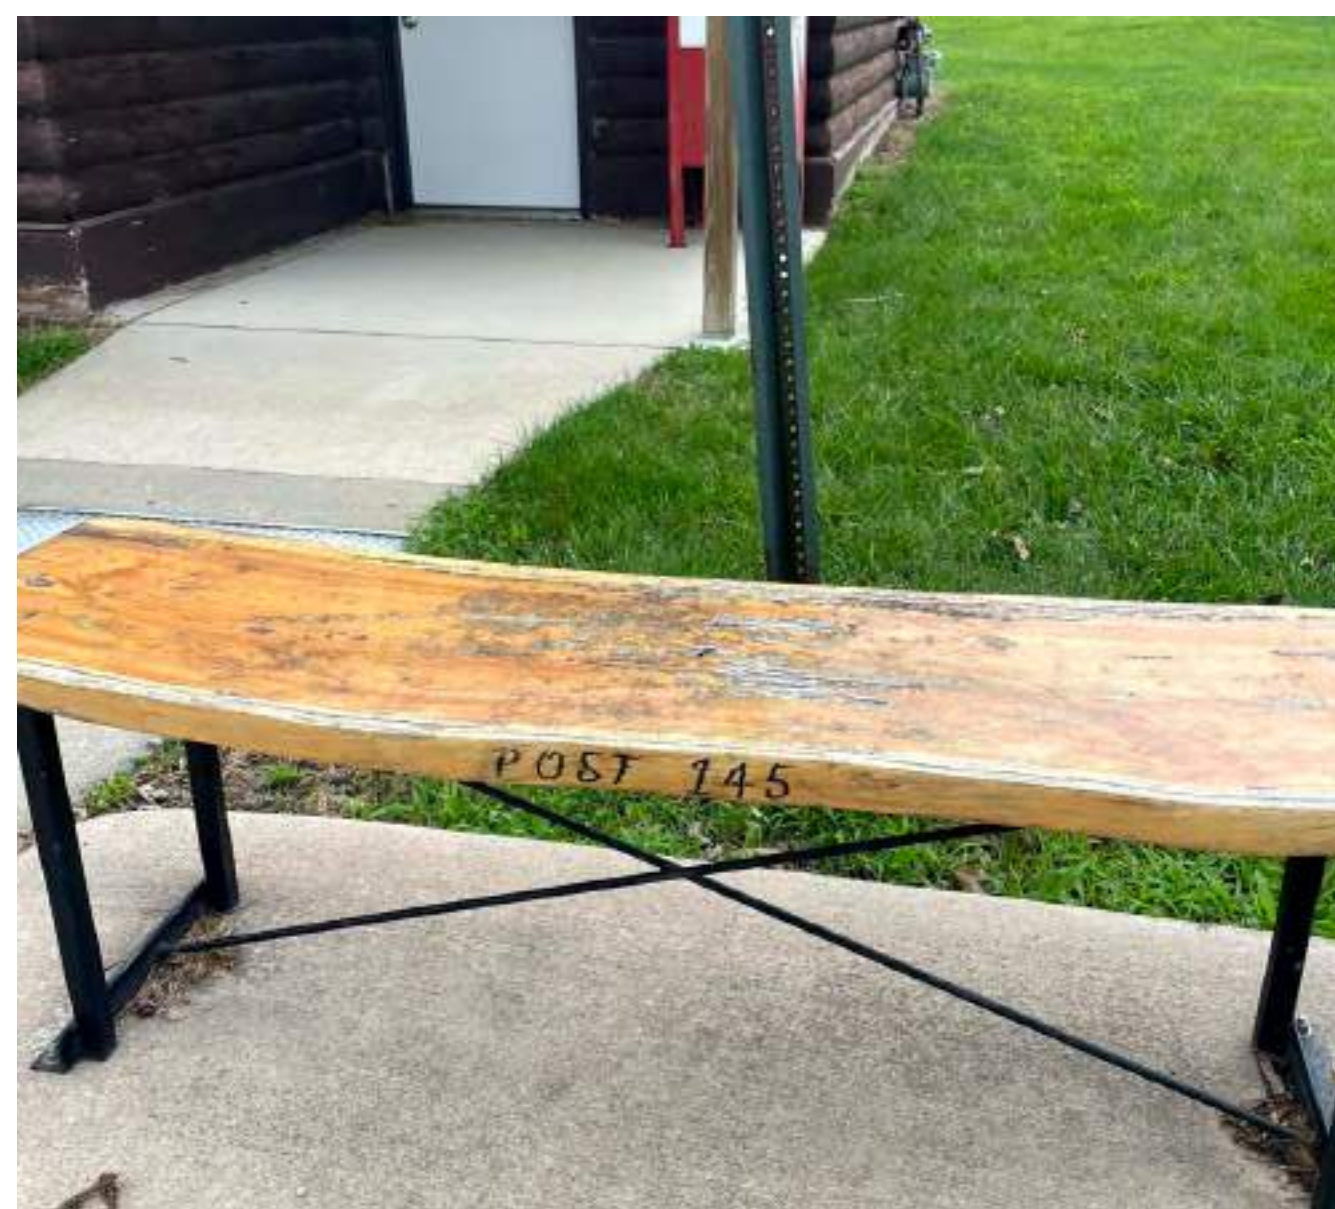
SEATING

- Seating elements (outside of major site amenity areas) appear to be in mostly good condition with some seating areas in poor condition. Seating is placed somewhat strategically throughout the site but is not ADA accessible in many areas. Seating variety is narrow, being mostly comprised of ground-mounted or moveable benches.

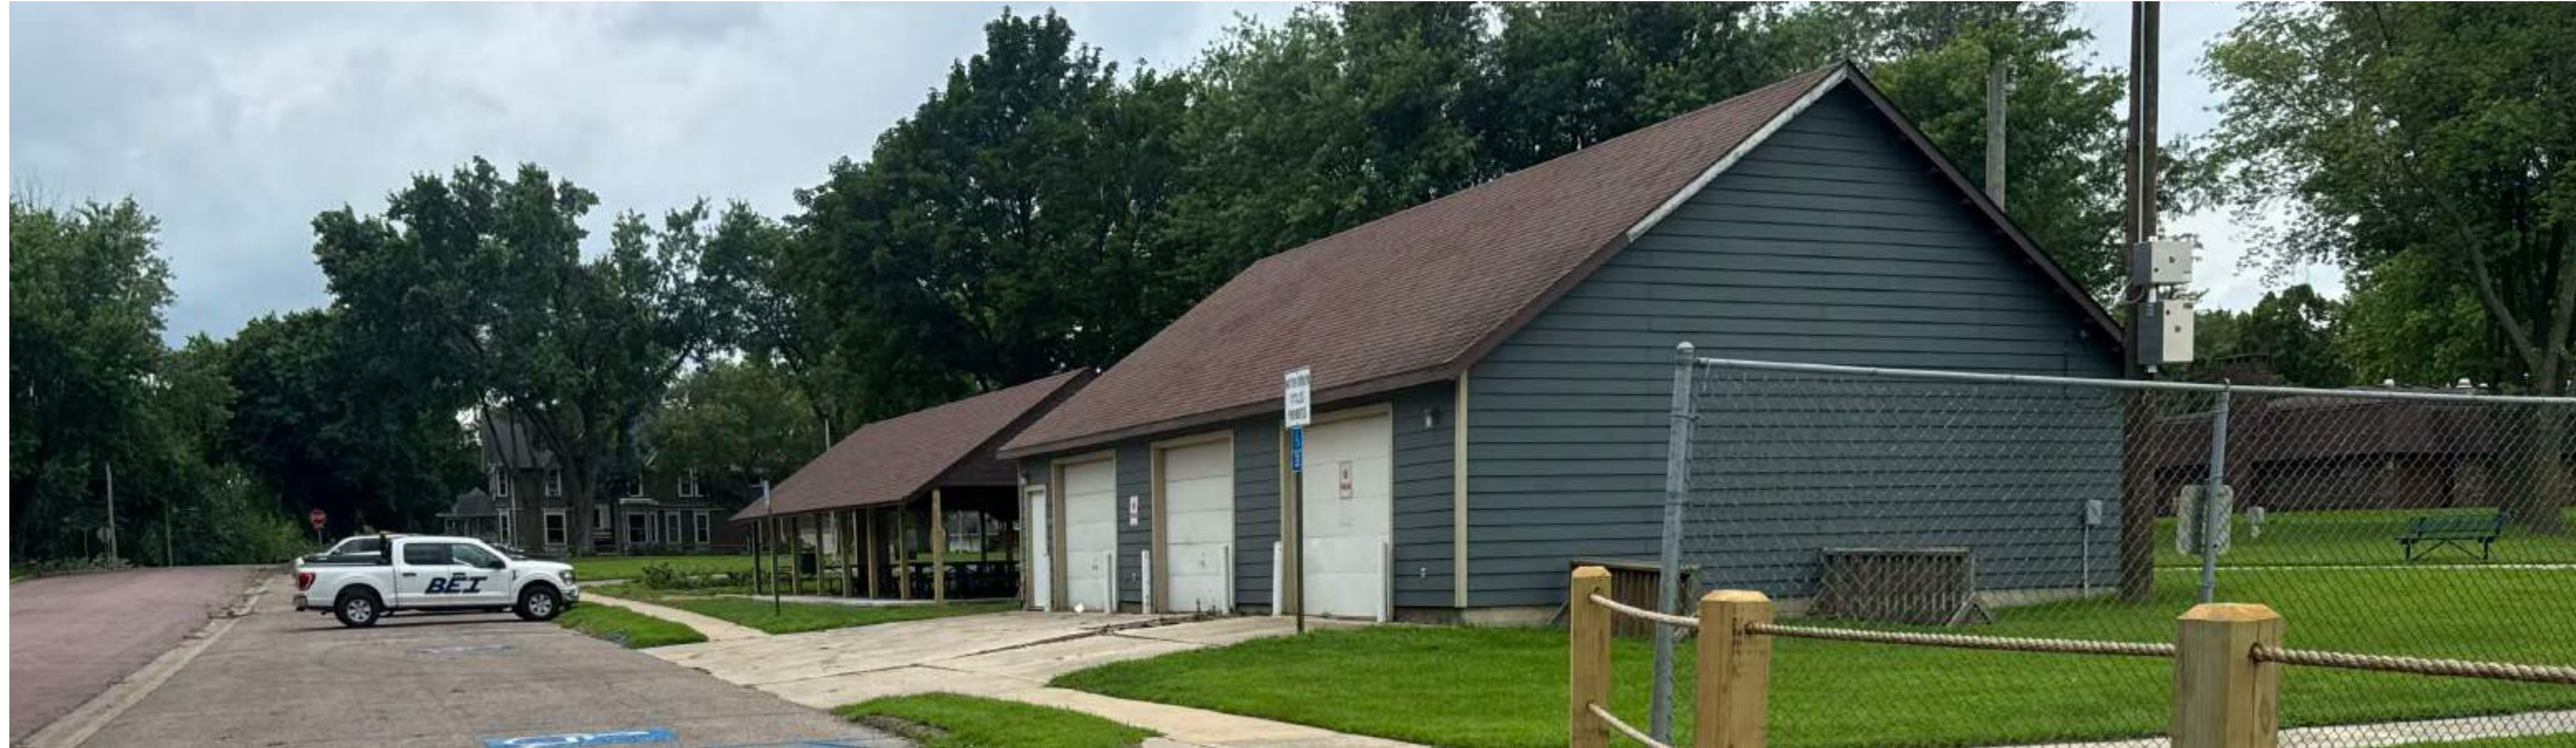
EAST GARAGE

- Several areas of the exterior trim show water damage, particularly near the ground level.
- The soffits are missing from all overhangs.
- Cracking / expansion where exterior pavement meets foundation.
- Portions of the siding are damaged, with exposed bare wood visible.
- Graffiti is present on sections of the building.
- Areas where graffiti has been painted over are discolored and inconsistent with the surrounding finish.
- Building appears to be in generally good condition for its use of storage.
- Building driveway is in poor condition.
- Interior of the building is in good condition.

- Overall, the building is functional and remains in good condition. The exterior siding shows signs of deterioration and rot, likely due to inadequate weather protection. The facility is primarily used for storing holiday and seasonal decorations, as well as various pieces of heavy equipment.

- Re-side and re-paint building.
- Add vented soffits to overhangs
- Add joint filler where exterior pavement meets foundation.
- Remove and install new fascia and metal flashing.
- Remove and install new entry door.

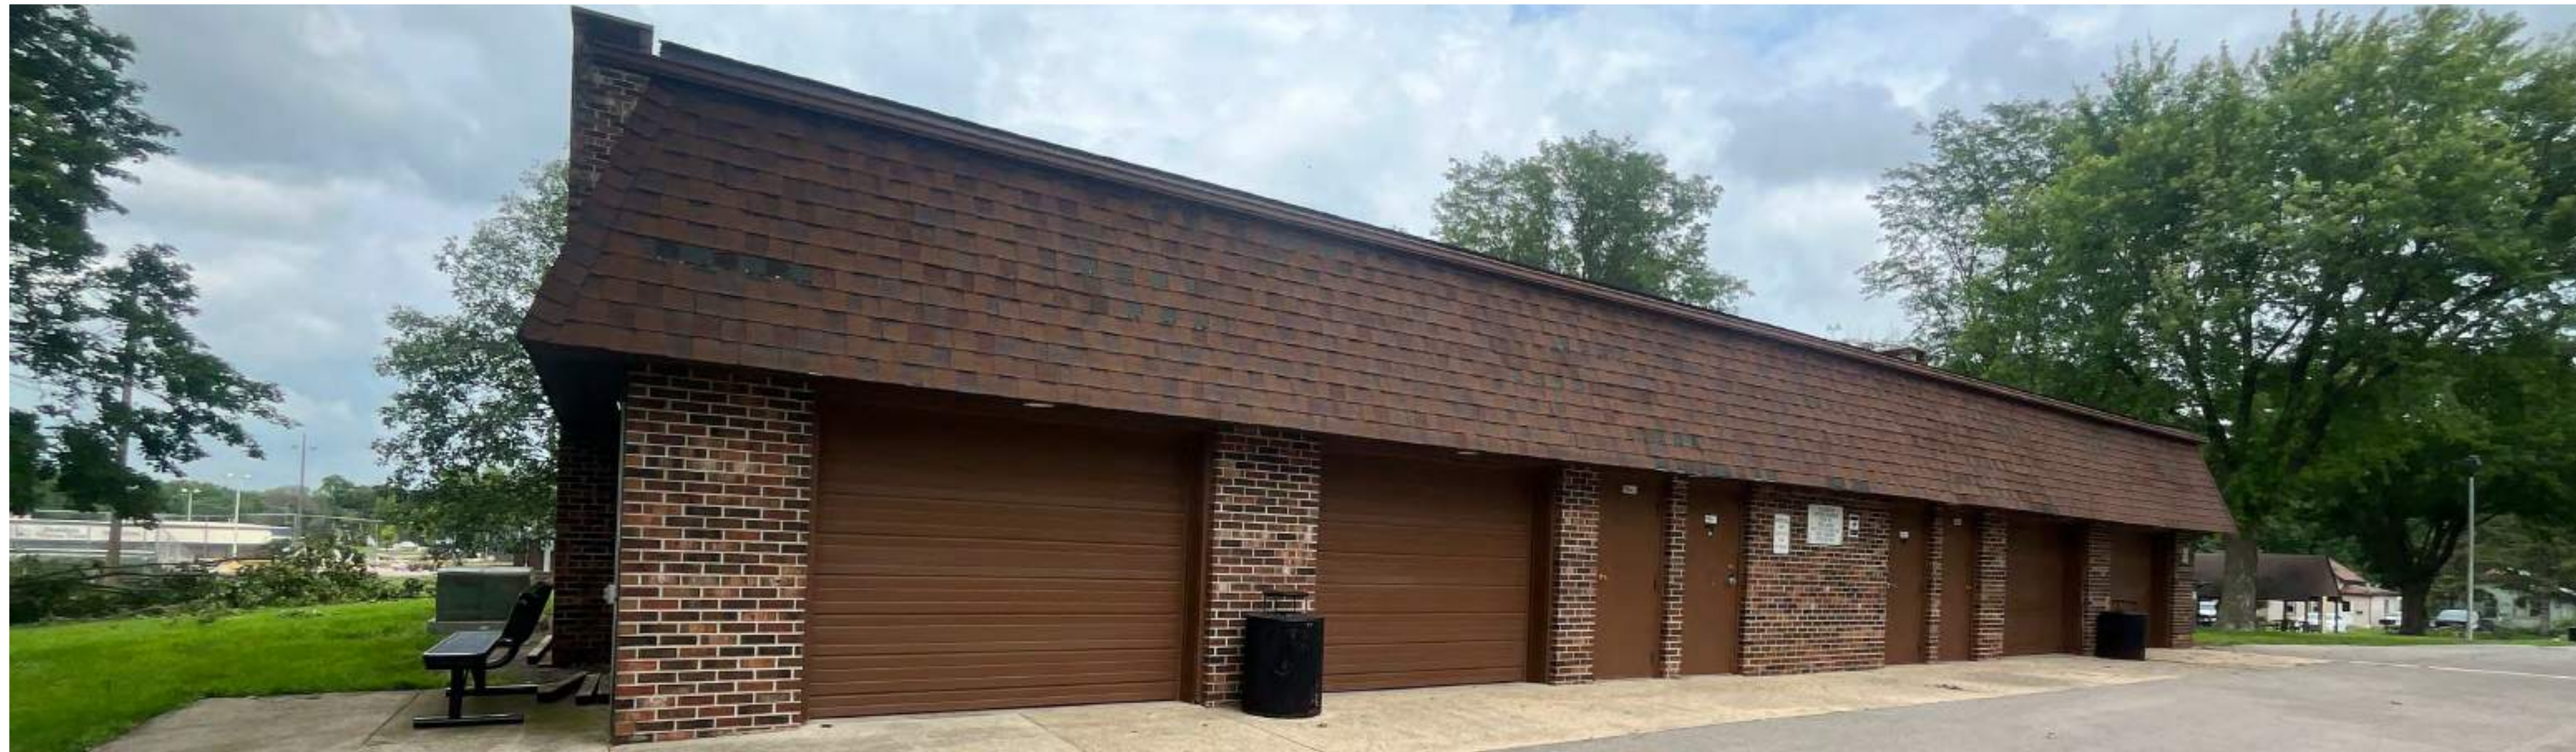
MULTI-USE SHELTER

- Shingles are missing in several areas, and some remaining shingles show noticeable discoloration.
- The chimney is missing flashing on one side.
- Gutters are incomplete, with missing downspouts and one side of the roof lacking gutters entirely.
- Standing water is present in the mechanical area and along sections of the interior walls.
- Brick surfaces show discoloration consistent with water damage.
- Lighting fixtures appear outdated.
- Door hardware is non-compliant with current accessibility standards.
- The building lacks code-compliant egress doors.
- Building contains two functional event spaces.
- Restrooms recently renovated and in excellent condition.

- Serving as a gathering space and a venue for community events, the multi-use shelter is in mostly good condition. While the restrooms have been recently renovated, the remainder of the facility has not received significant upgrades. The building materials show signs of aging; however, the overall structure appears to remain sound and in good condition.

- Remove and replace shingles and chimney flashing.
- Remove and replace gutters.
- Update light fixtures.
- Install ADA and code compliant egress doors and door hardware.
- Update overhead doors with windows in door panel.
- Replace weather stripping on bottom of overhead doors.

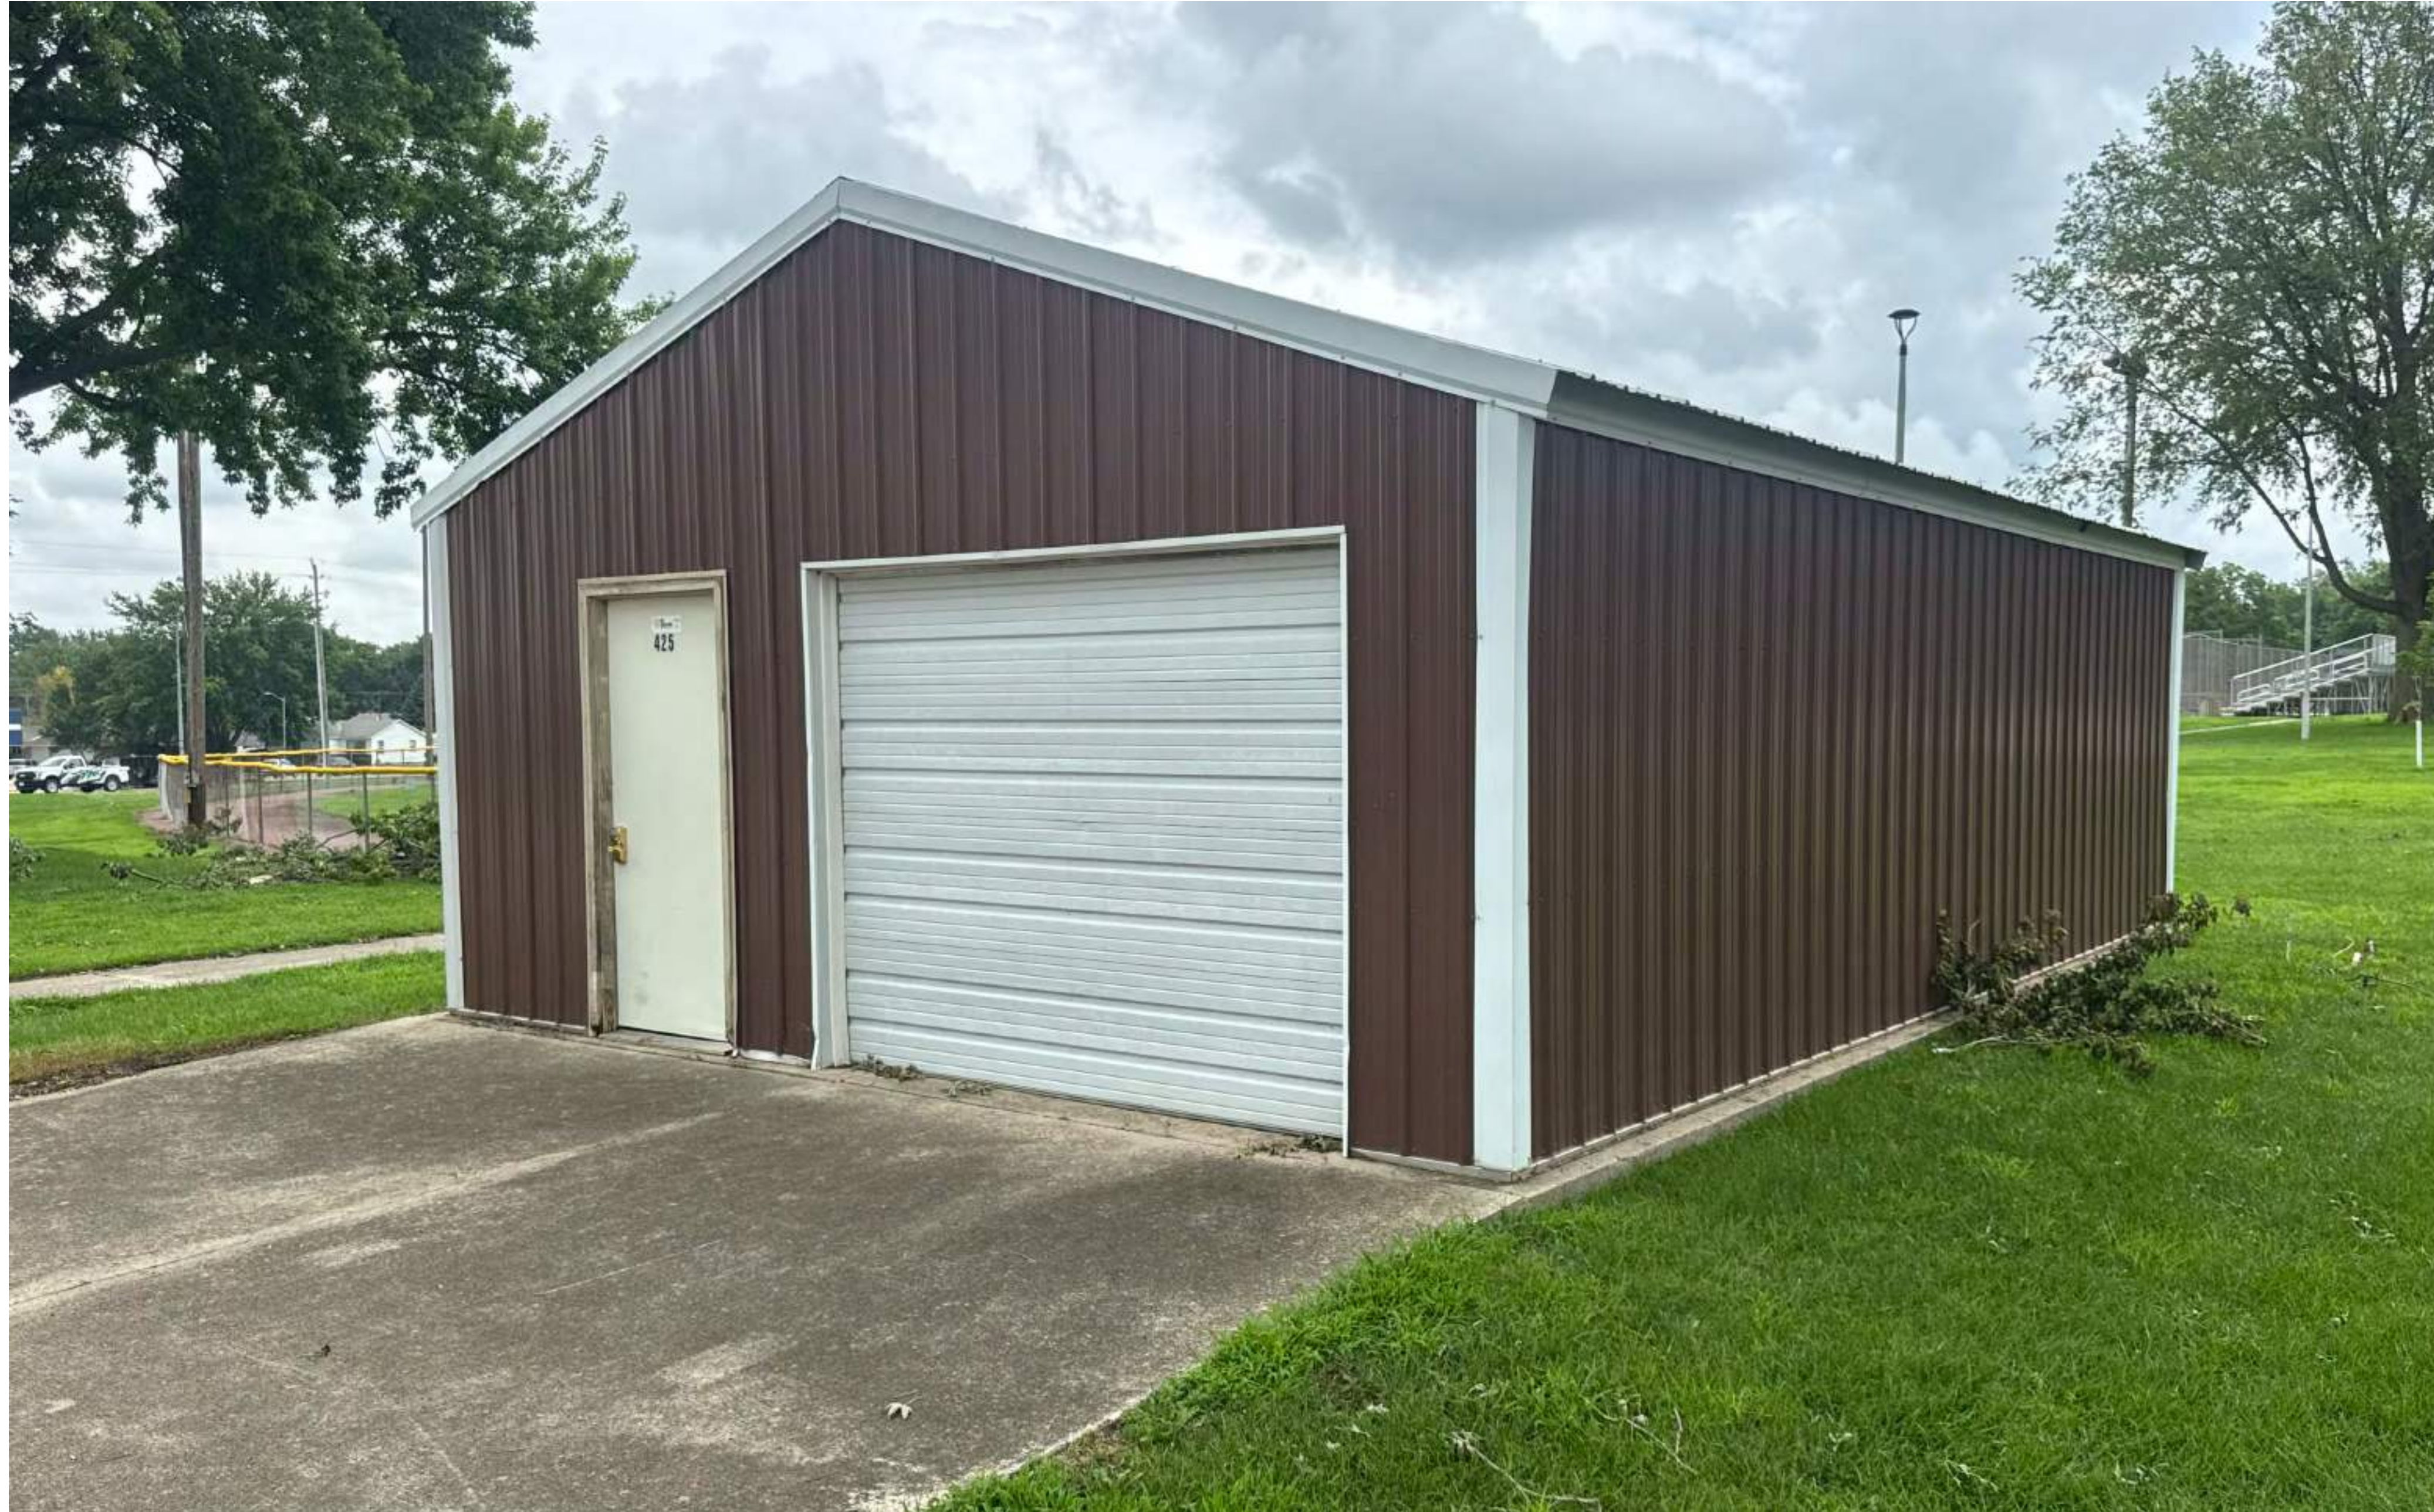
WEST GARAGE

- Aging trim along door.
- Minor damage to exterior metal panels.
- Primarily used for storage.
- Required to hop a curb at driveway entrance.
- Building interior in good condition.

- The West Garage is in good condition and is used mainly as storage for holiday and seasonal items.

- Remove and install new trim around entry door.
- Re-paint entry door.

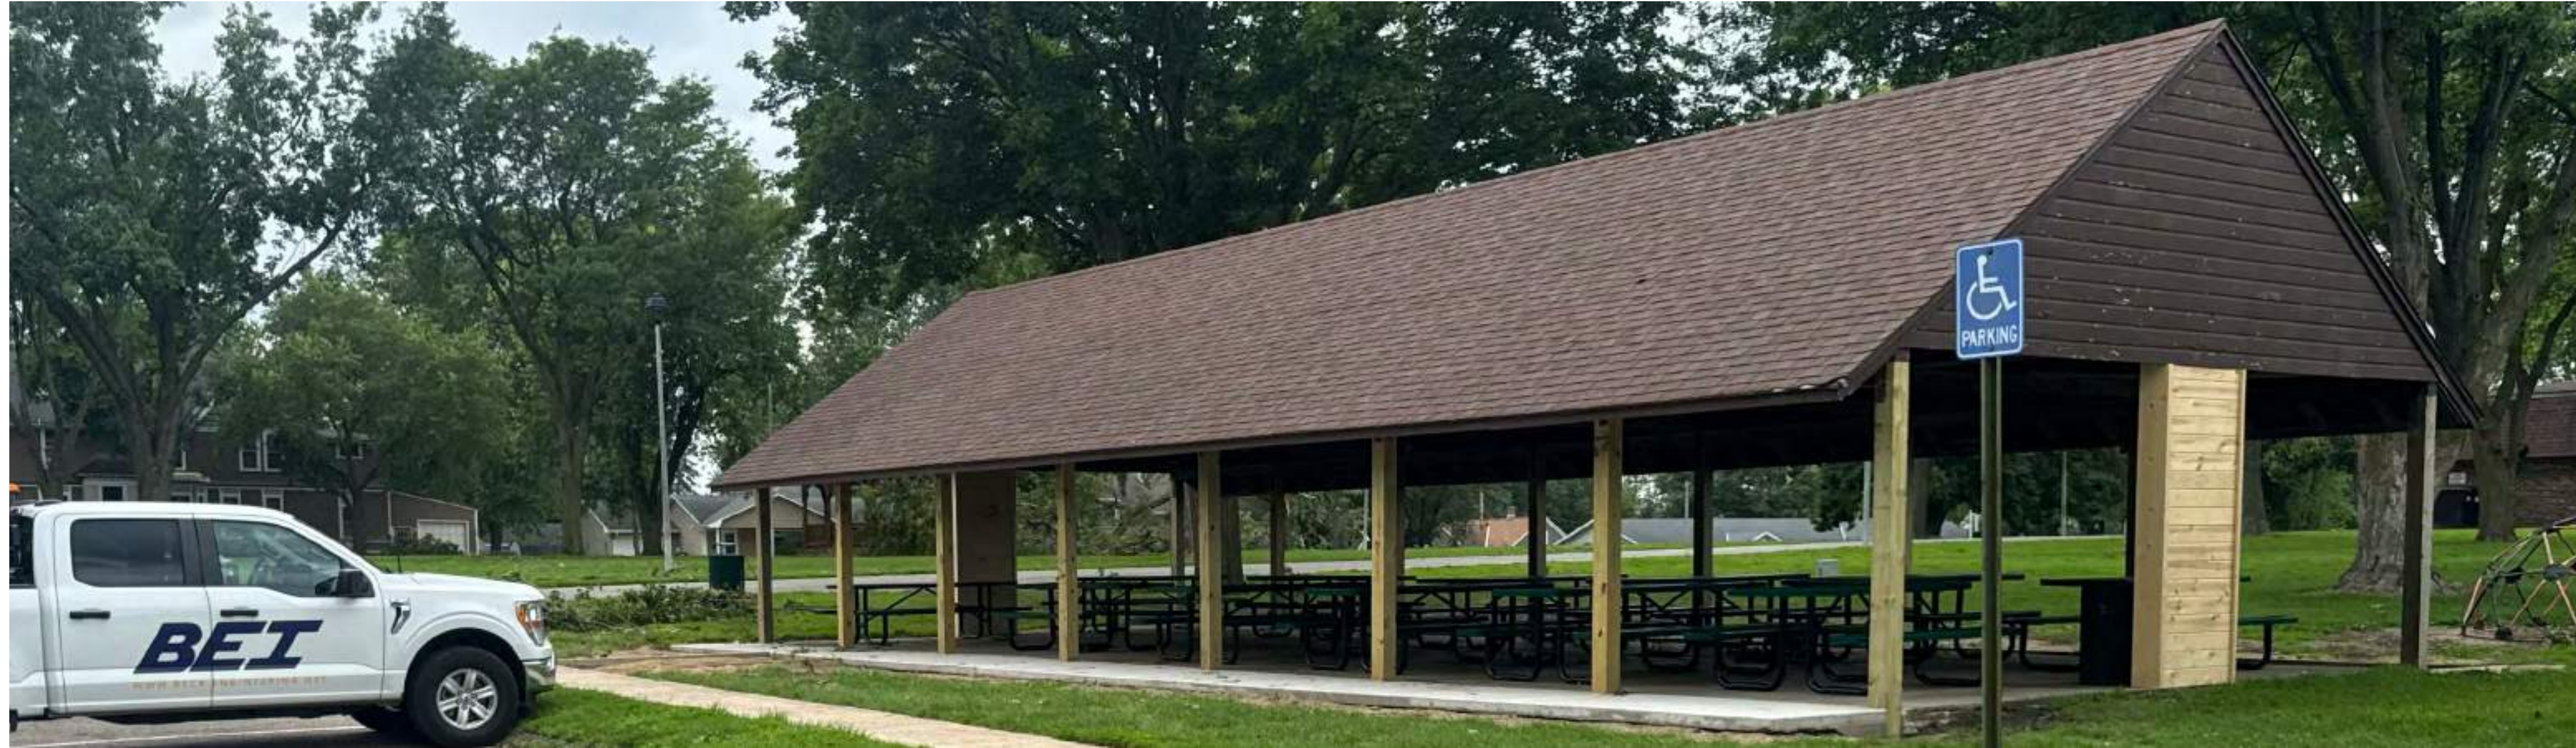
LARGE PARK SHELTER

- Exposed wire connection near lights can pose safety issues.
- Siding and framing are heavily weathered and aged.
- Added structure built from weathered wood.
- Low roof overhang (does not meet ADA head height).
- Outdated lighting throughout.
- Deteriorating wood connections.
- Kids climbing into structure using tables poses safety issues.
- Not currently accessible.
- Currently undergoing sidewalk upgrades around the perimeter.
- Currently undergoing interior upgrades in the north and south ends.
- Shelter house contains a large quantity of benches.
- Exposed nails on the bottom side of roof can pose safety issues.

- The Shelter House has been functional for a long time but is showing many signs of aging, weathering, and overall deterioration. The shelter house is still functional as it can provide a shaded seating area out of the sun and protection from rain events. However, the shelter house has many safety risks and concerns such as exposed wiring, nails, and access into the trusses due to a low roof height. The repairs underway are a step in the right direction but further repair or upgrades are needed.

- Add wall coverings to interior gable ends
- Add ceiling material
- Add ceiling / soffit lights

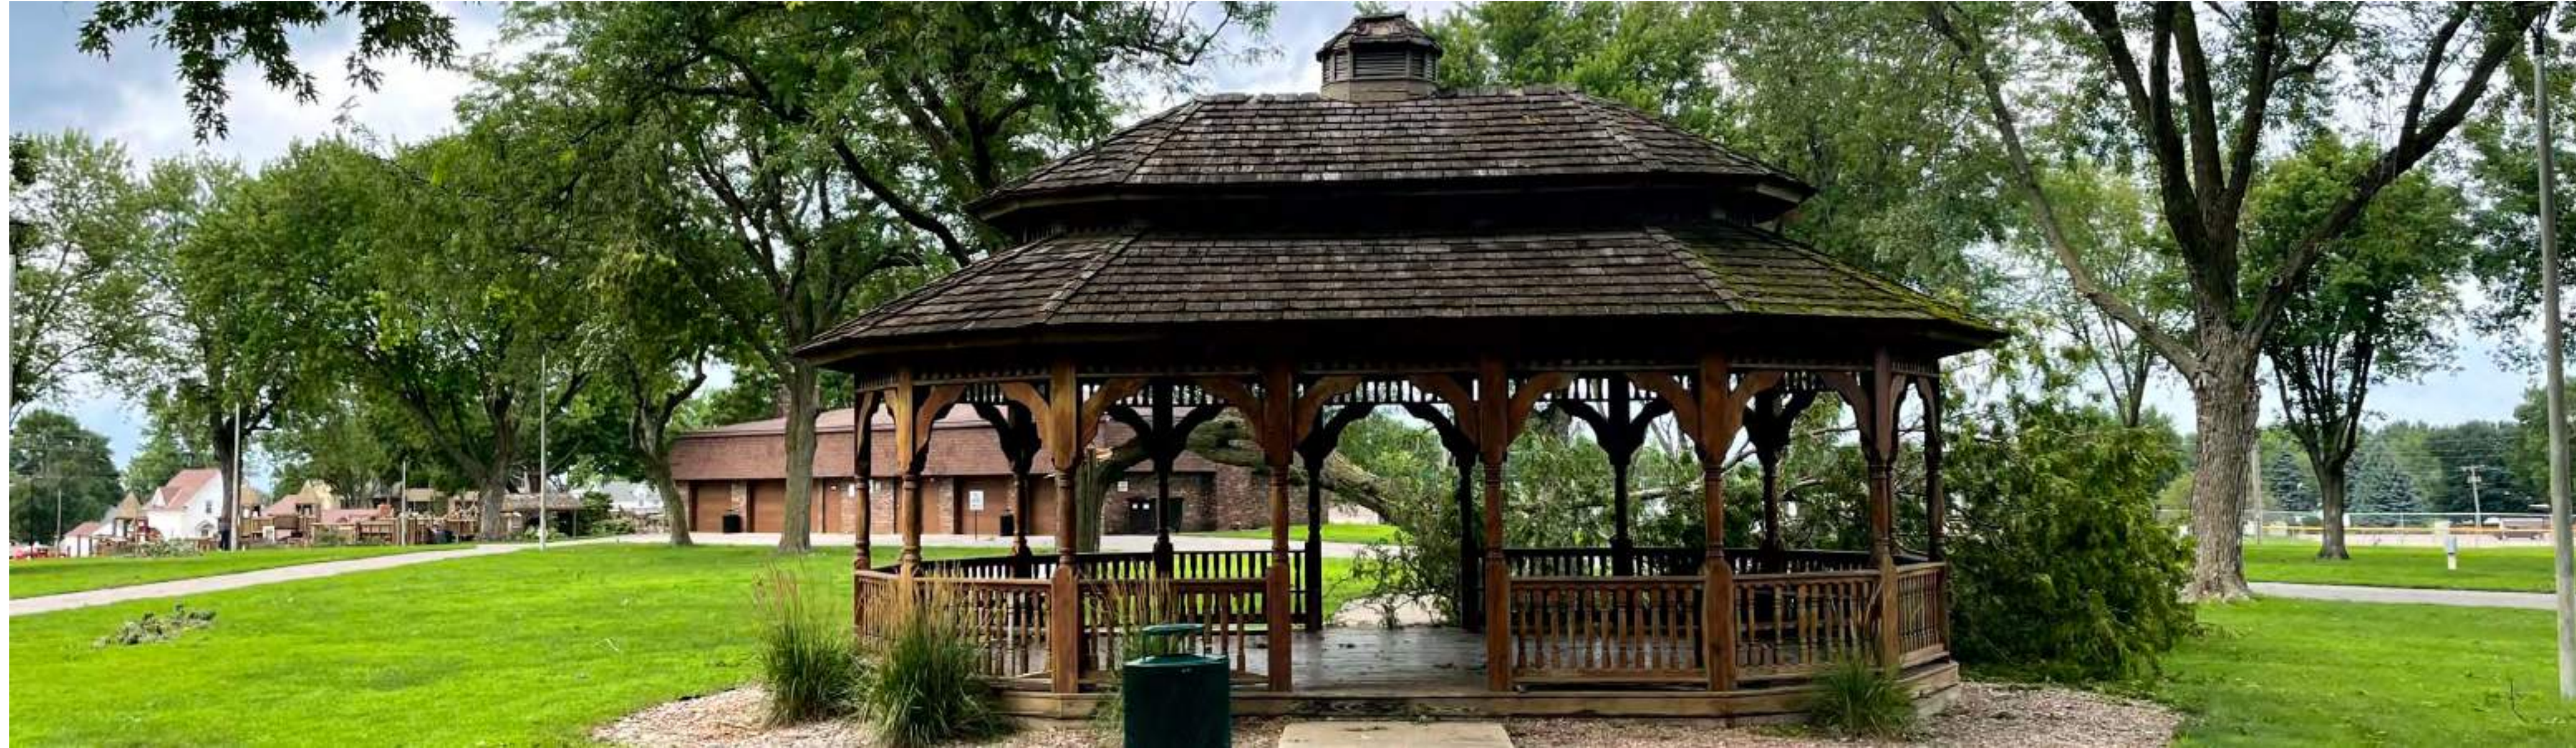
GAZEBO

- Cupola missing louvers.
- Shakes in poor condition with excessive moss buildup.
- Missing balusters along the bottom railing.
- Rotting is present around the wood at the base of the gazebo.
- Entire structure should be restrained / resealed.
- Structure is ADA accessible on one side but not on the other.
- Structure contains functionable seating on the interior.
- Wood flooring appears to be in fair condition.
- Rock mulch and plantings around the exterior add a nice accent to the gazebo.
- Cupola is in poor condition and may need replacement.

- The gazebo appears to be in fairly good condition but could benefit from upgrades. It still appears solid and functional for its use. A deeper assessment of the structure along with upgrades including staining and sealing could help the gazebo's long-term lifespan and appearance.

- Re-finish and repair cupola, posts and railings.
- Re-seal entire structure.
- Refinish floor.
- Remove and replace wood shakes on roof.

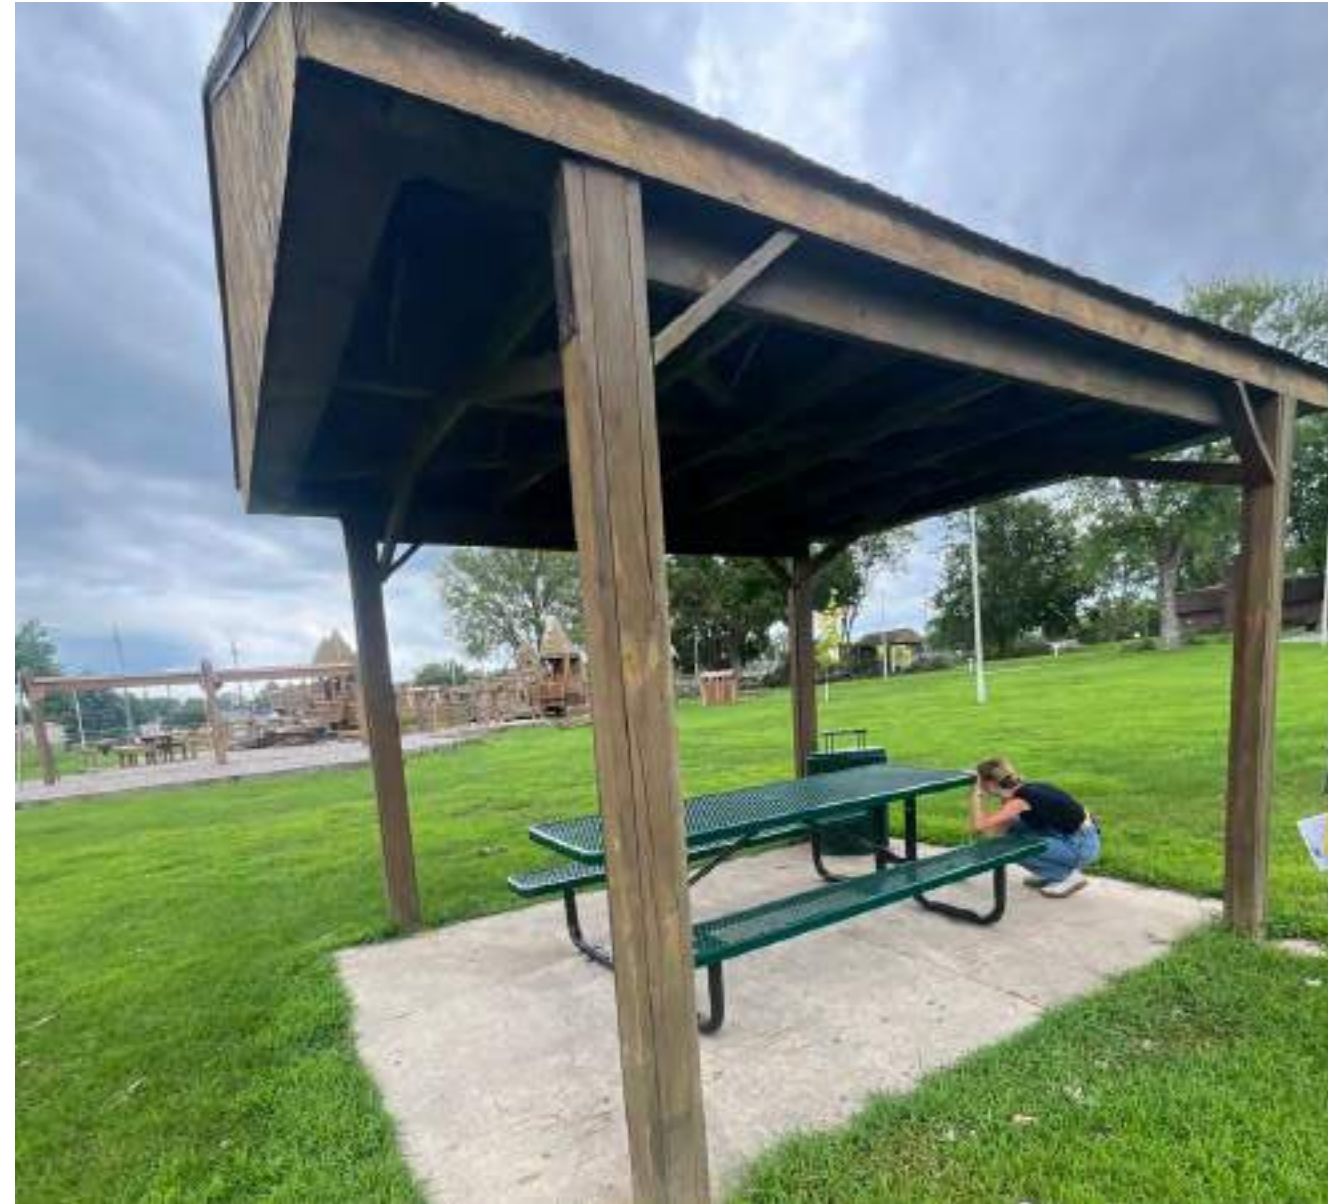
SMALL PARK SHELTER

- Exterior T1-11 sheathing in poor condition.
- Roof in poor condition.
- Wood showing age.
- Concrete pads cracking and in poor condition.
- Each shelter house contains a bench and trash receptacle.
- No accessible ADA route to shelter houses.

- Small park shelters are well used by the communities and are in fair condition overall. No accessible route is available to the park shelters.

- Replace roof shingles and touch up trim.
- Full removal and replacement of concrete pad beneath structures
- Add accessible pathway to existing concrete pad (40' length north shelter, 60' length south shelter).
