# City Park Master Plan

CITY OF SHELDON, IOWA

CITY COUNCIL PRESENTATION - DECEMBER 3, 2025

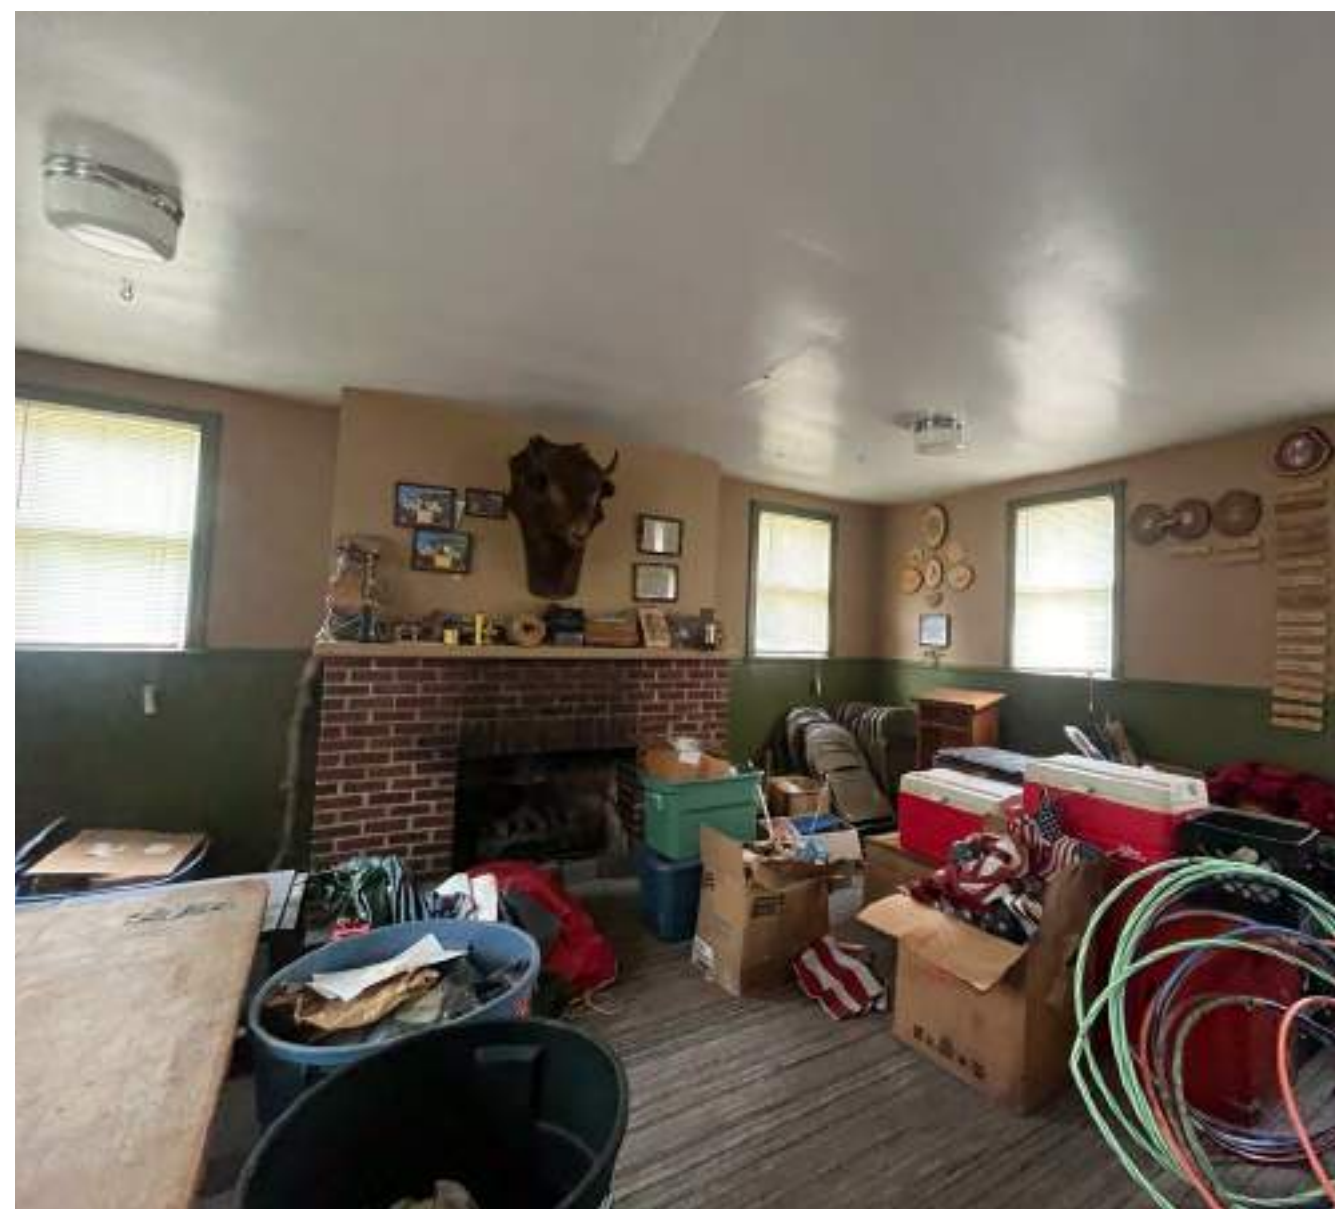
BOY SCOUT CABIN

- Interior carpet excessively worn.
- Fireplace has excessive soot buildup.
- Building is used mostly for storage but lacks adequate storage area.
- Interior door missing handle.
- Siding shows moisture issues.
- Exterior paint is peeling in many areas.
- Outdated windows.
- Chimney above the roof lacks tuckpointing.
- Exterior wooden door shows moisture infiltration/rot.
- Interior ceiling is cracking.
- Doors are not ADA-compliant.
- The interior of the building has a "pit" in the floor covered by a sign.
- No restroom within building.
- Chimney shows moisture infiltration.
- Concerns of hazardous material within the building.

• The building was previously used to hold boy scout meetings and events but has been out of use for almost a decade, now being used exclusively for storage. The building in general is in poor condition and shows signs of rot and wear in many areas including the exterior wood siding and trim, windows, roof, chimney, interior floor, and interior ceiling.

- Remove existing flooring, replace with new flooring.
- Clean and re-tuckpoint interior and exterior of brick chimney and fireplace.
- Re-side building exterior.
- Remove and re-install new windows.
- Add restroom.
- Replace exterior doors.
- Repair cracking ceiling.
- Removal of hazardous material.

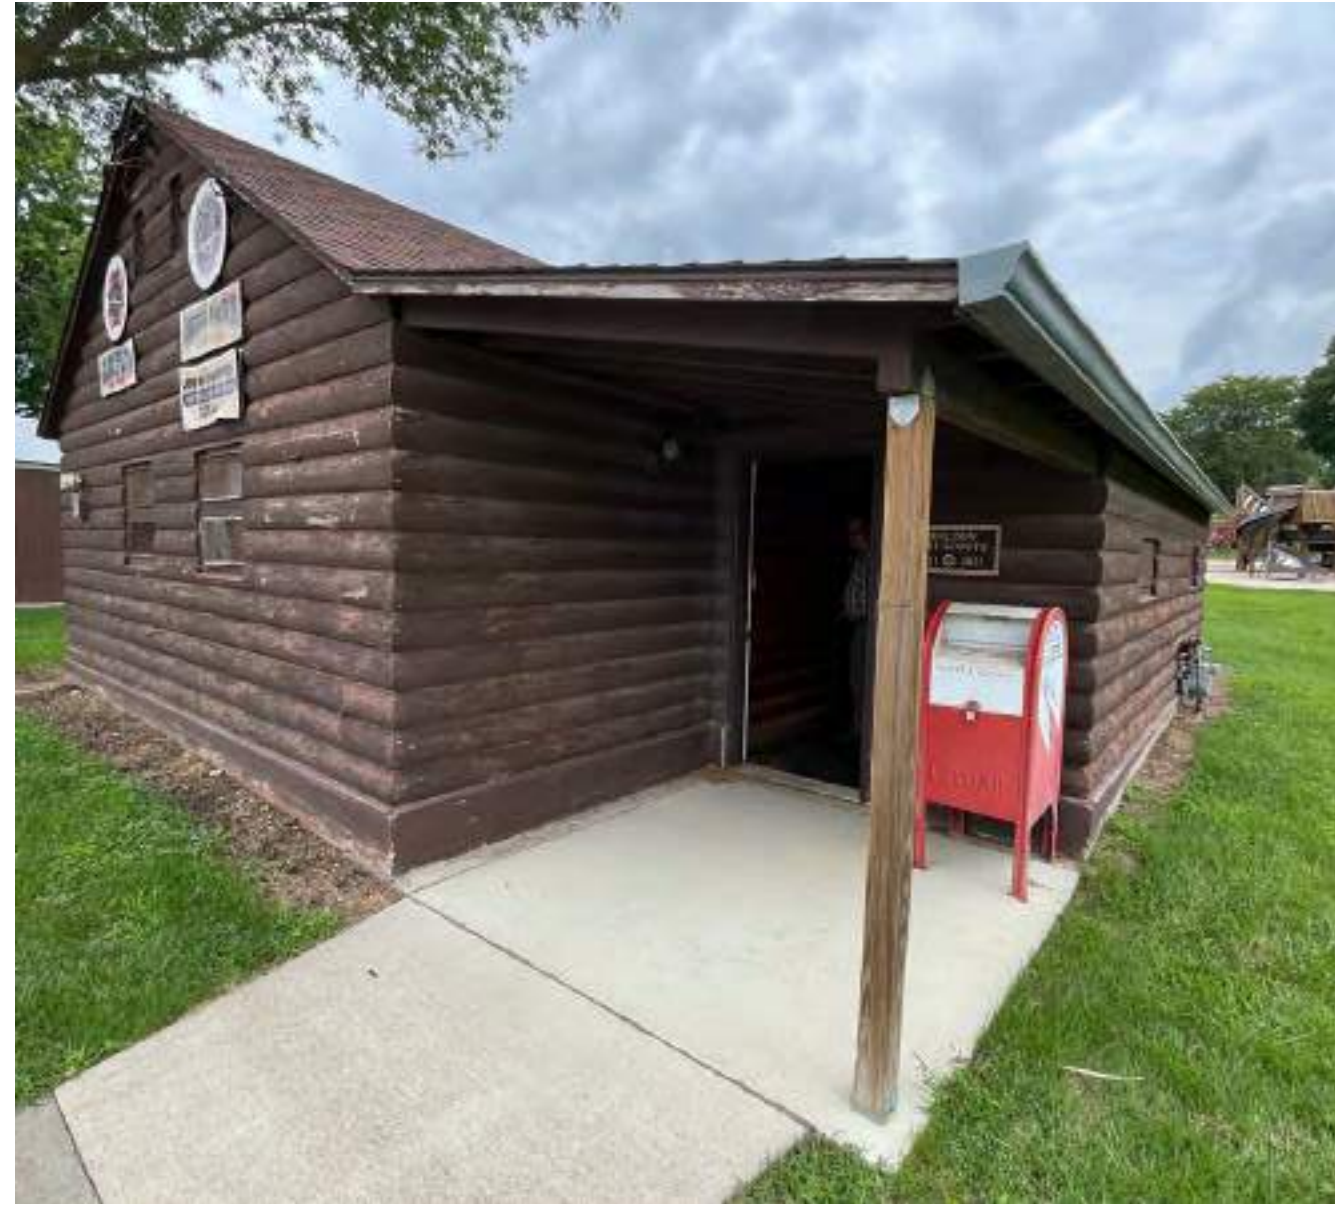
GIRL SCOUT CABIN / VFW

- Concerns of hazardous material within the building.
- Bathroom not ADA-compliant.
- Siding in poor condition and shows moisture issues.
- Exterior paint is peeling in many areas.
- Windows are outdated and in poor condition.
- Roof in poor condition.
- Hole in siding on south side of chimney.
- Chimney shows moisture infiltration.
- Doors do not have ADA-compliant door handles.
- No clearly labeled fire egress.
- Electric code concerns.
- Stove top has no hood.
- Building used for storage though lacks in adequate storage area.
- Building still used for VFW meetings.
- ADA parking outside of building is non-compliant.

- The Girl Scout Cabin / VFW has been around for a long time and is still being used by the girl scouts and VFW as a meeting place. The building in general is in poor condition and shows signs of rot and wear in many areas including the exterior wood siding and trim, windows, roof, chimney, interior materials, and flooring.

- Remove existing flooring, replace with new flooring.
- Re-side building.
- Remove and re-install new windows.
- Remove and install new fascia boards and metal flashing.
- Remove and re-install shingles on roof.
- Clean and re-tuckpoint exterior of brick chimney.
- Install new gutters and downspouts.
- Install ADA compliant door handles.
- Incorporate emergency exit / fire egress plan.
- Install new kitchen counter tops and casework.
- Removal of hazardous materials.

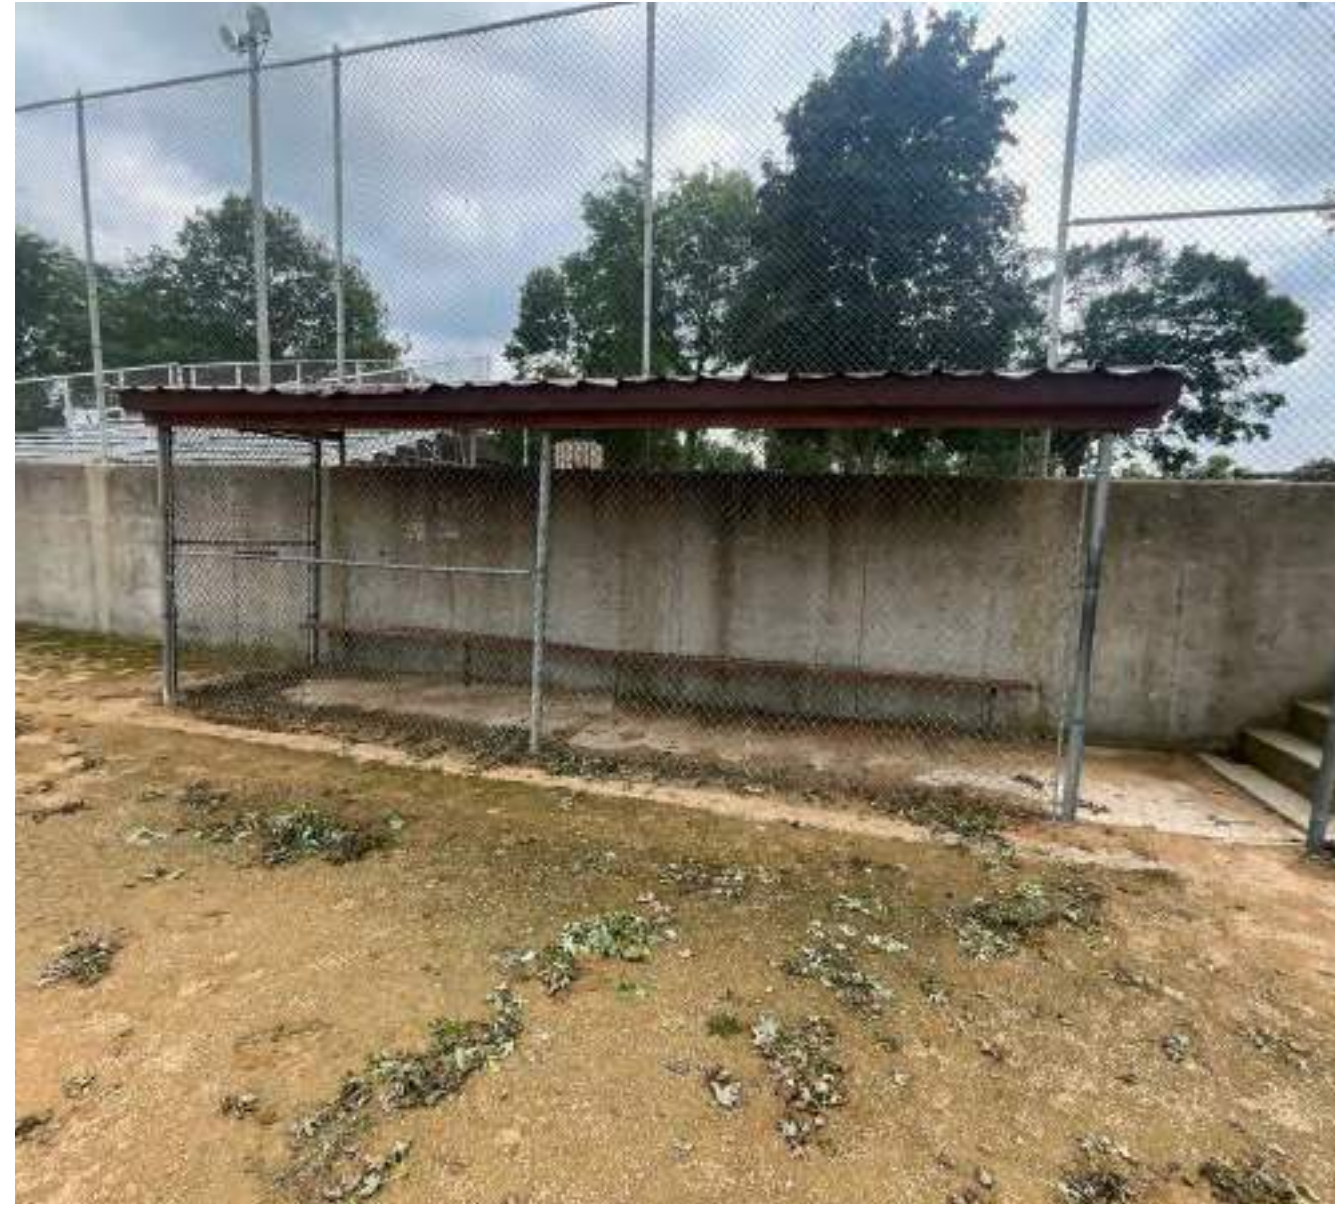
BASEBALL DUGOUTS

- Roofs are in bad condition.
- Chain link fence in poor condition.
- Bench seats are in poor condition and rotting in some places.
- Wood at the announcer stand in rotting and deteriorating.
- Powerbox requires inspection.
- Drinking fountain in poor condition.
- Concrete underneath dugouts in poor condition and slopes towards wall creating standing water and drainage issues.
- Retaining wall behind dugouts in poor condition.
- No ADA access to dugouts.

- The baseball dugouts are in very poor condition and have no ADA access. Dugouts are useable but require further update as they are nearly in disrepair with most amenities requiring updates and repair.

DEMOLISH

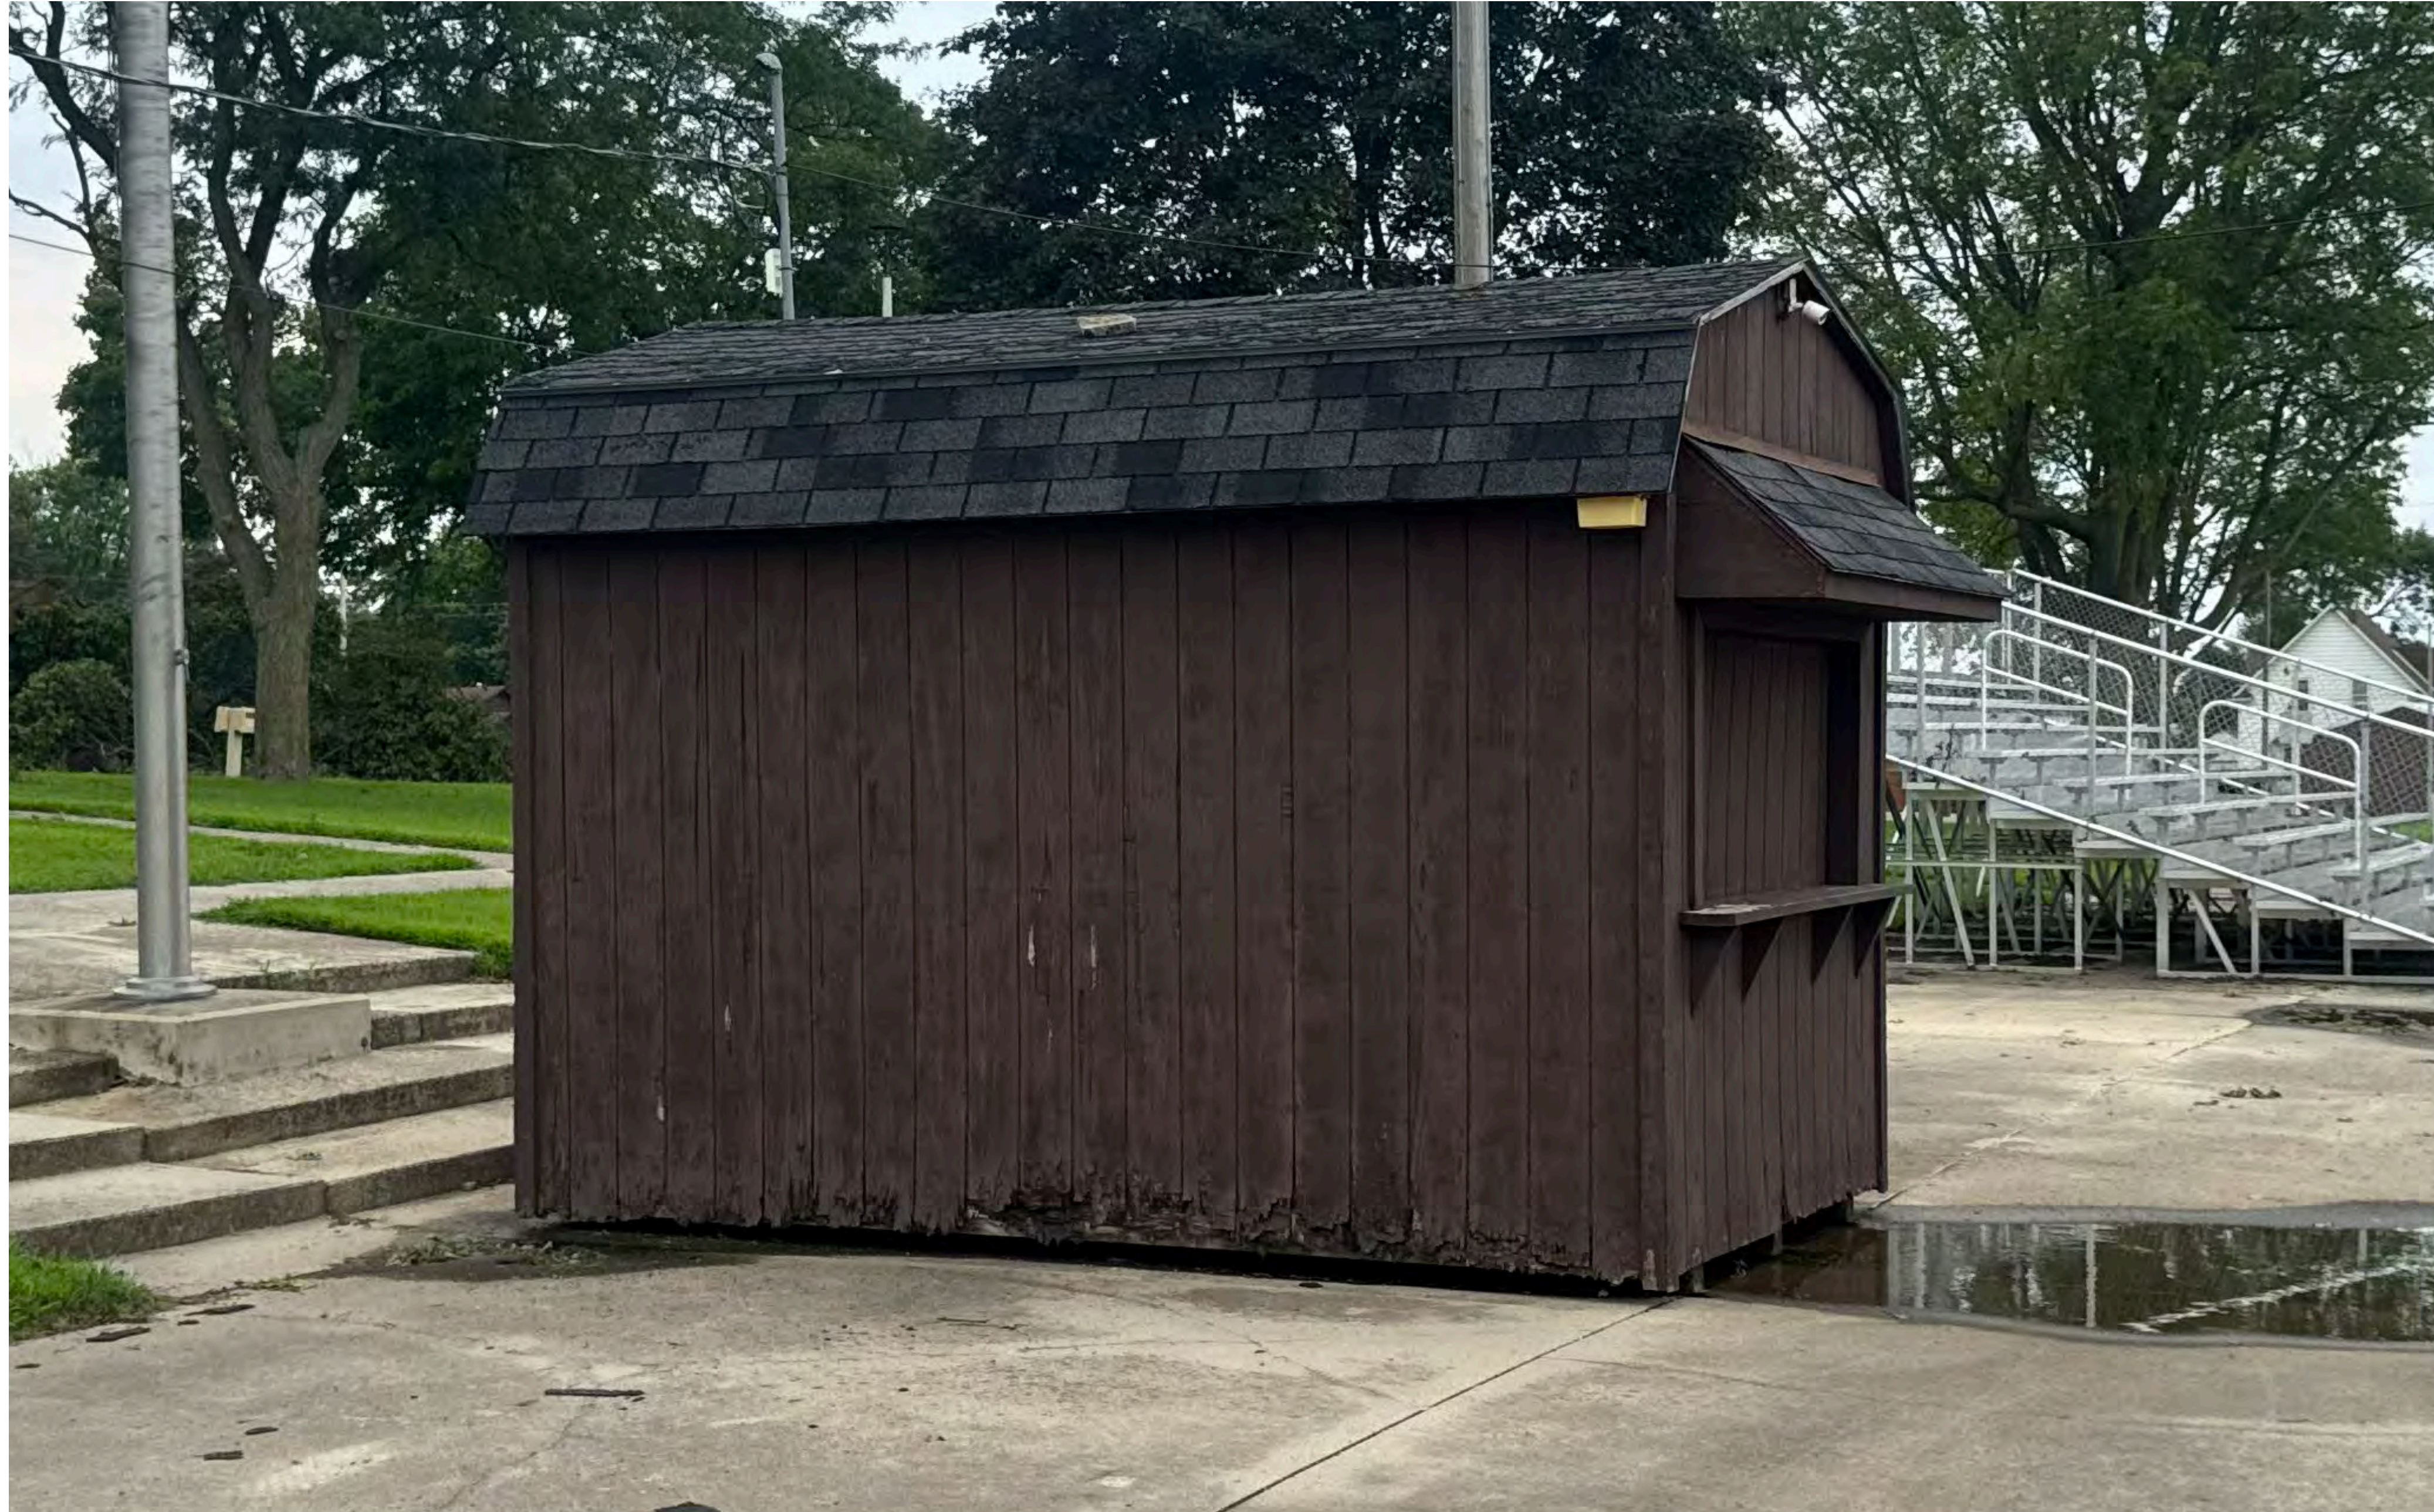
CONCESSION STAND

- Exterior T1-11 sheathing needs replacement.
- Skids at bottom of building show moisture issues.
- Shingles are in poor condition with leaking issues likely present.
- Shingles warped in areas.
- Moisture issues along building base with excessive rotting.
- No accessible route.
- Damaged door at bottom.

DEMOLISH
