# City Park Master Plan

CITY OF SHELDON, IOWA

CITY COUNCIL PRESENTATION - DECEMBER 3, 2025

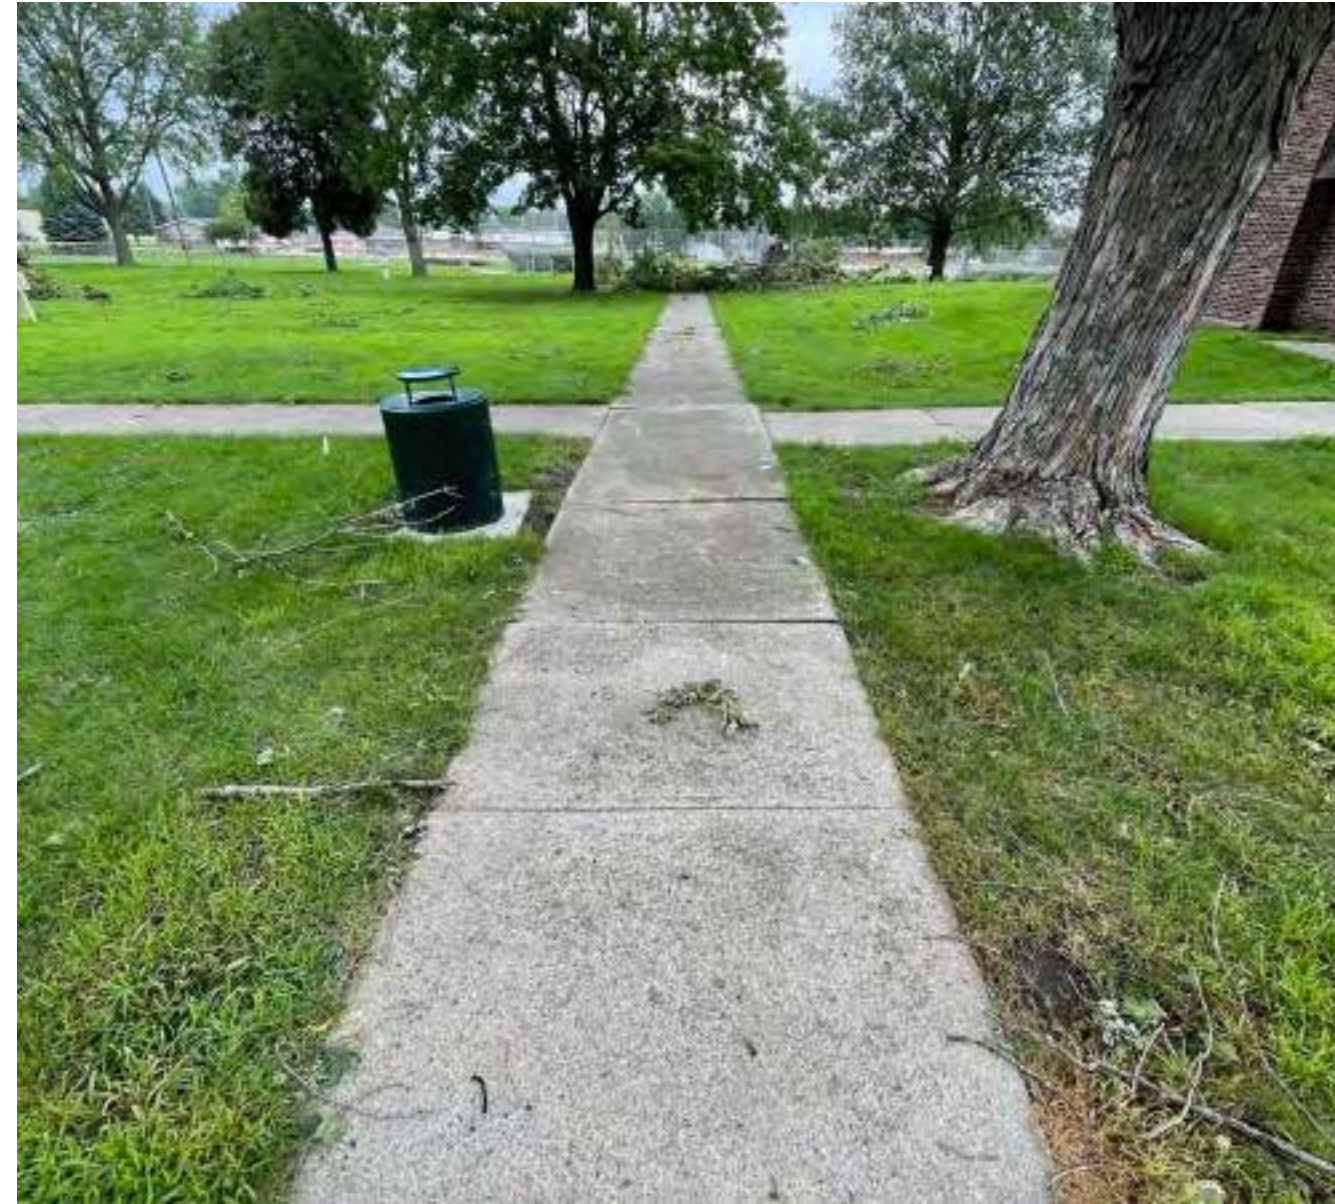
BASEBALL FIELD WALKWAY (CENTER)

- 5' wide sidewalk in mostly good condition with minimal wear.

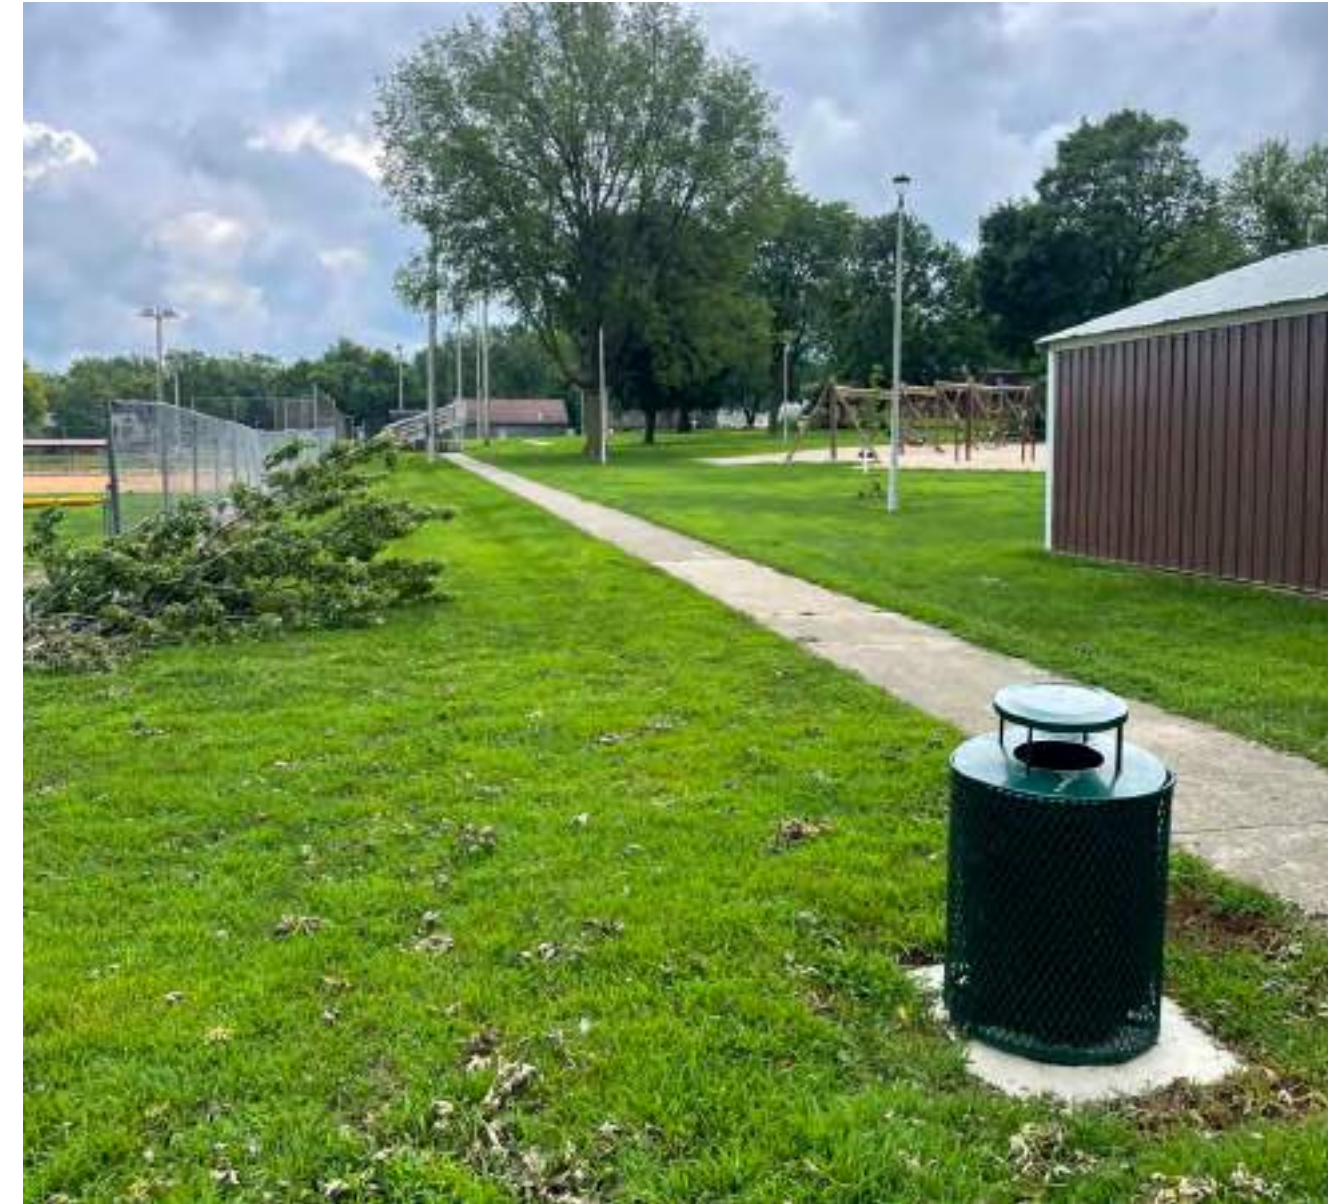
BASEBALL FIELD WALKWAY (WEST)

- 5' wide sidewalk in mostly good condition with minimal wear.

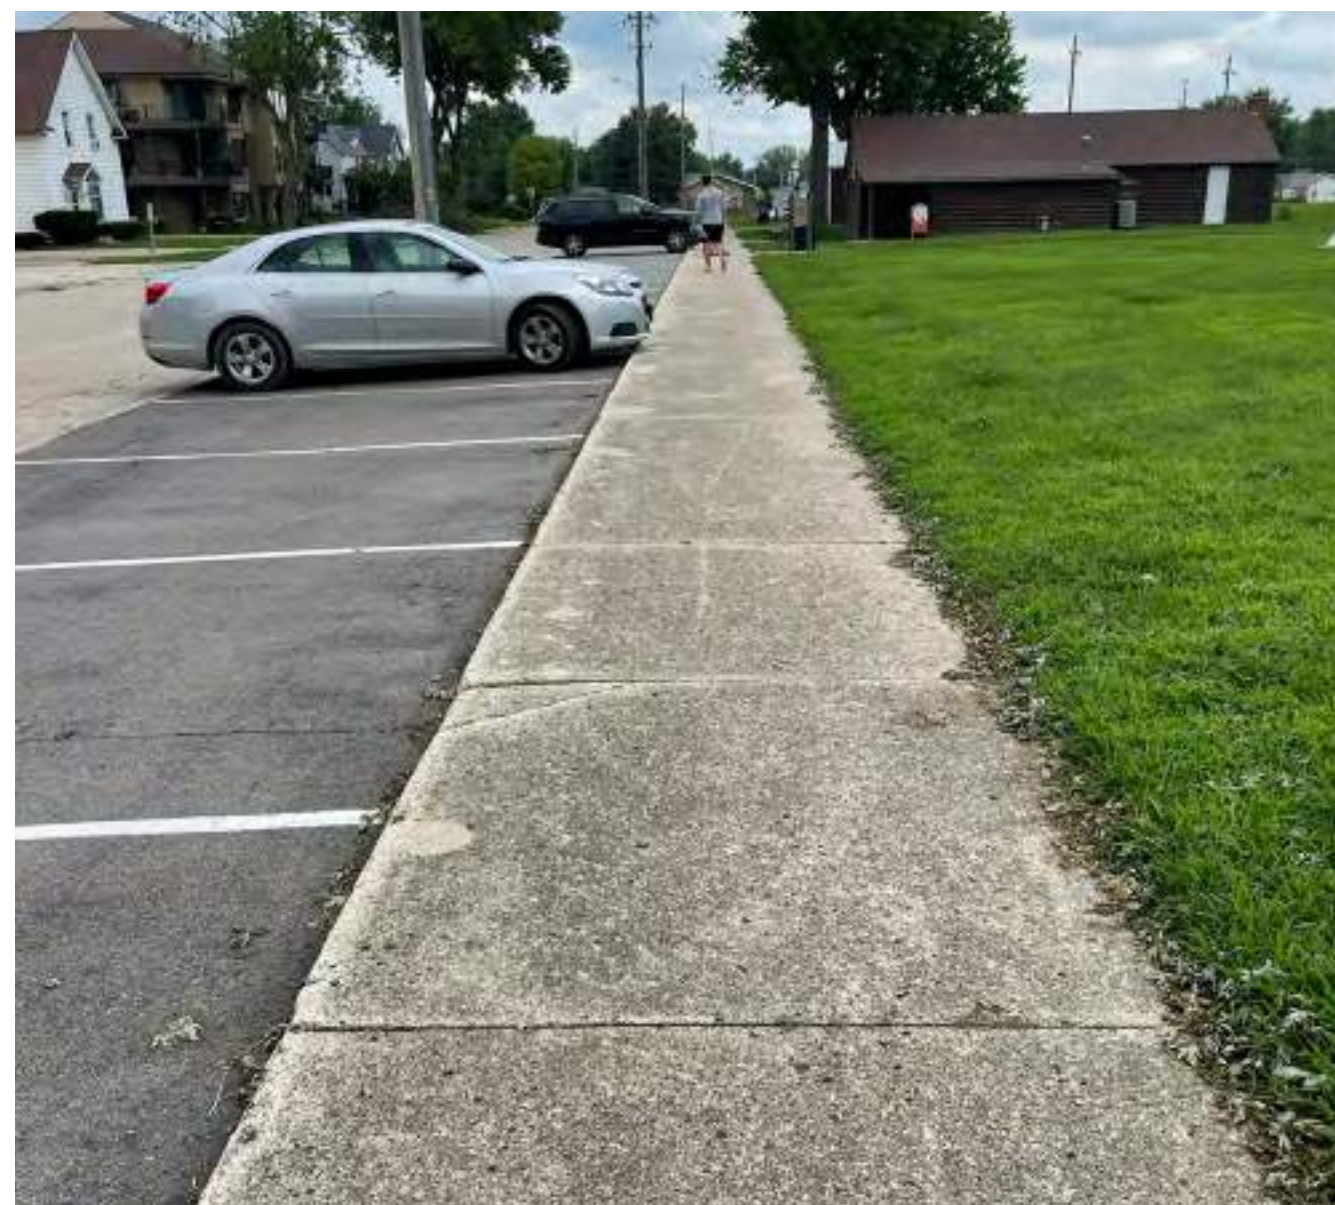
4TH AVENUE SIDEWALK

- 6' wide sidewalk in mostly good condition with minimal wear and cracking.

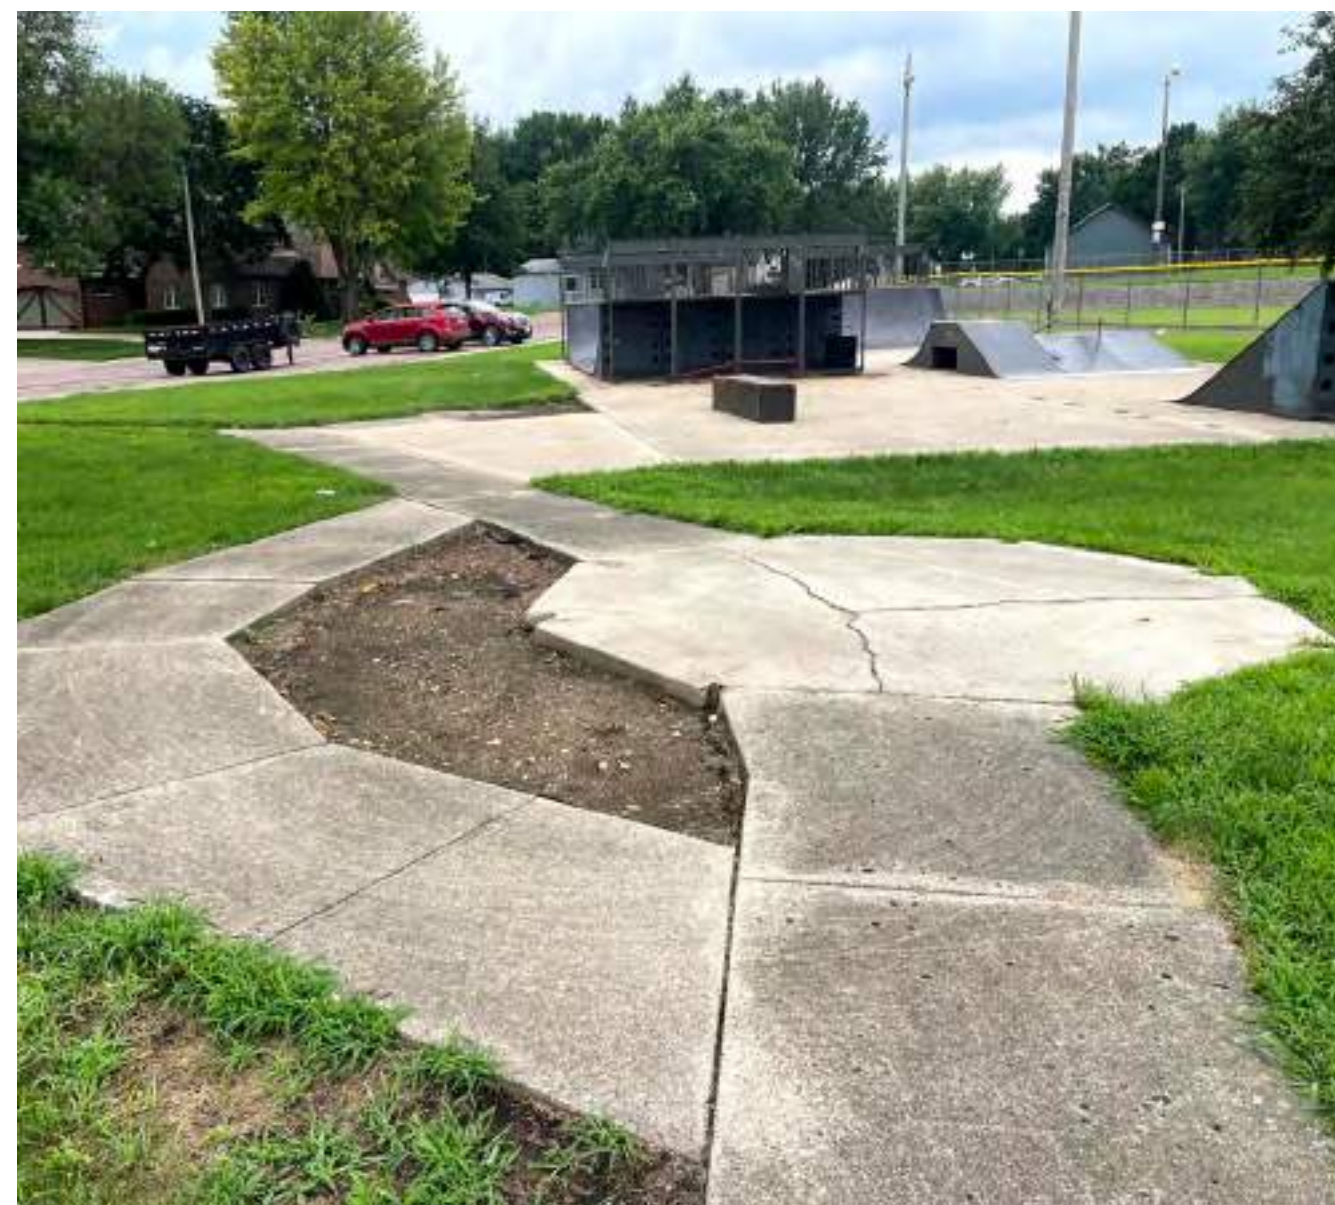
SKATE PARK SIDEWALK

- 4' wide sidewalk contains cracks, prolonged wear, and tripping hazards at former gazebo pad.

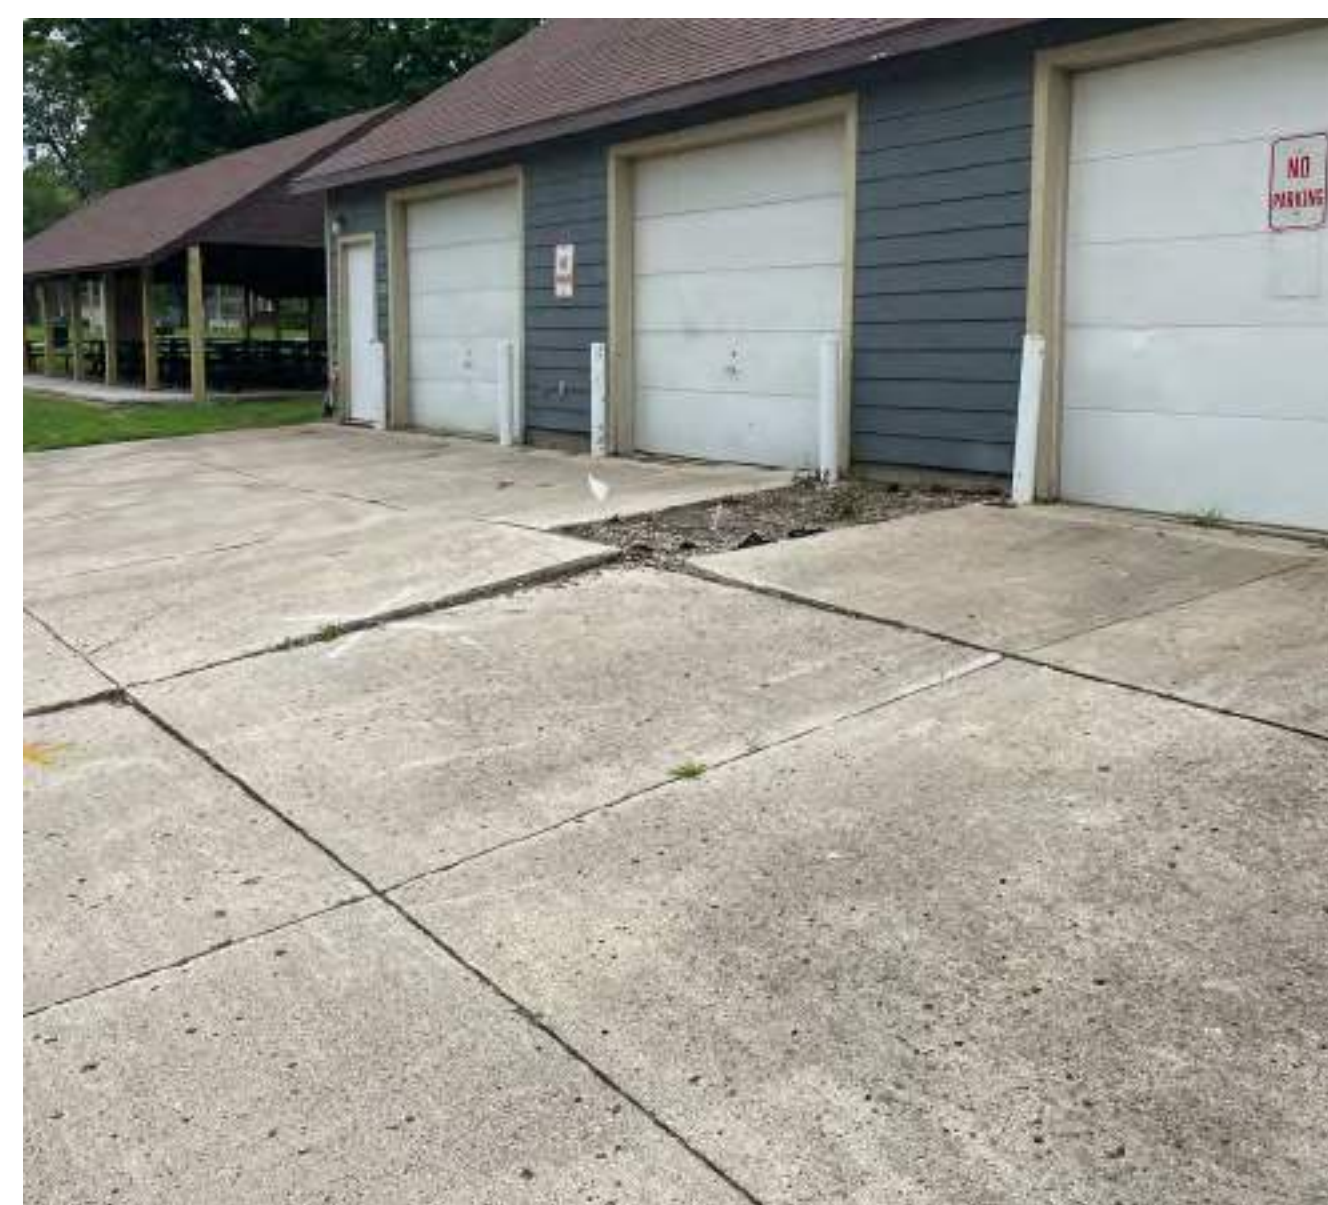
EAST GARAGE DRIVEWAY

- Driveway contains fairly poor pavement and lacks an ADA-compliant sidewalk crossing due to excessive cross slope.

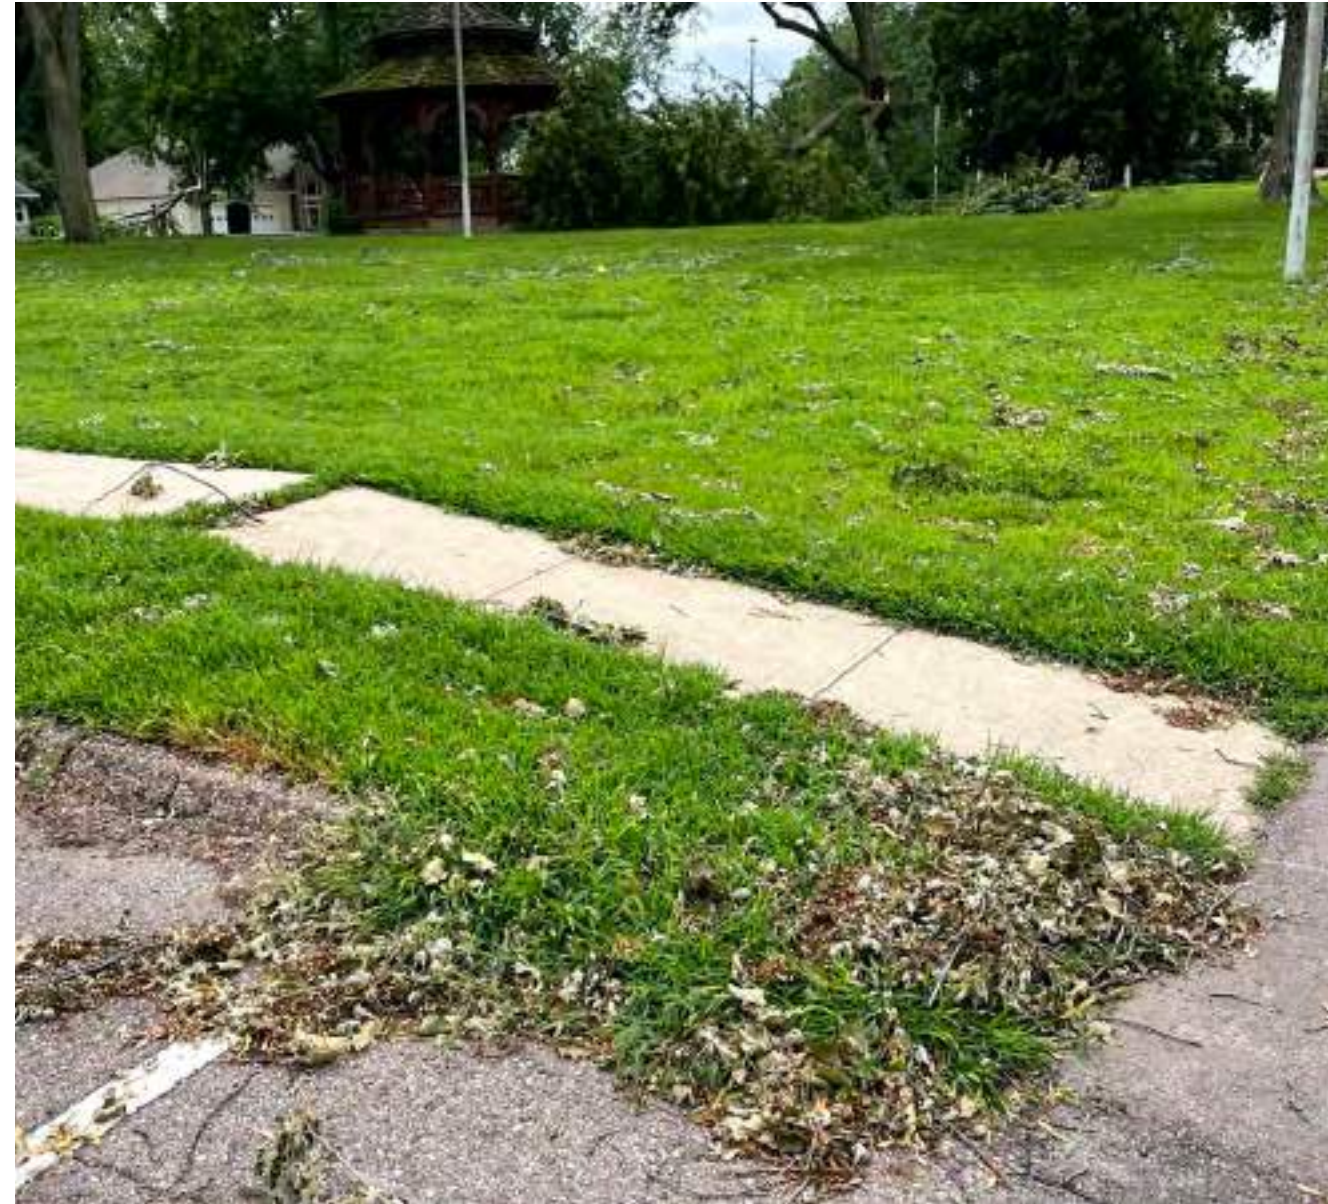
ASPHALT DRIVE SIDEWALK APPROACHES

- Ramps are in good condition and newly installed but too steep and not ADA compliant.

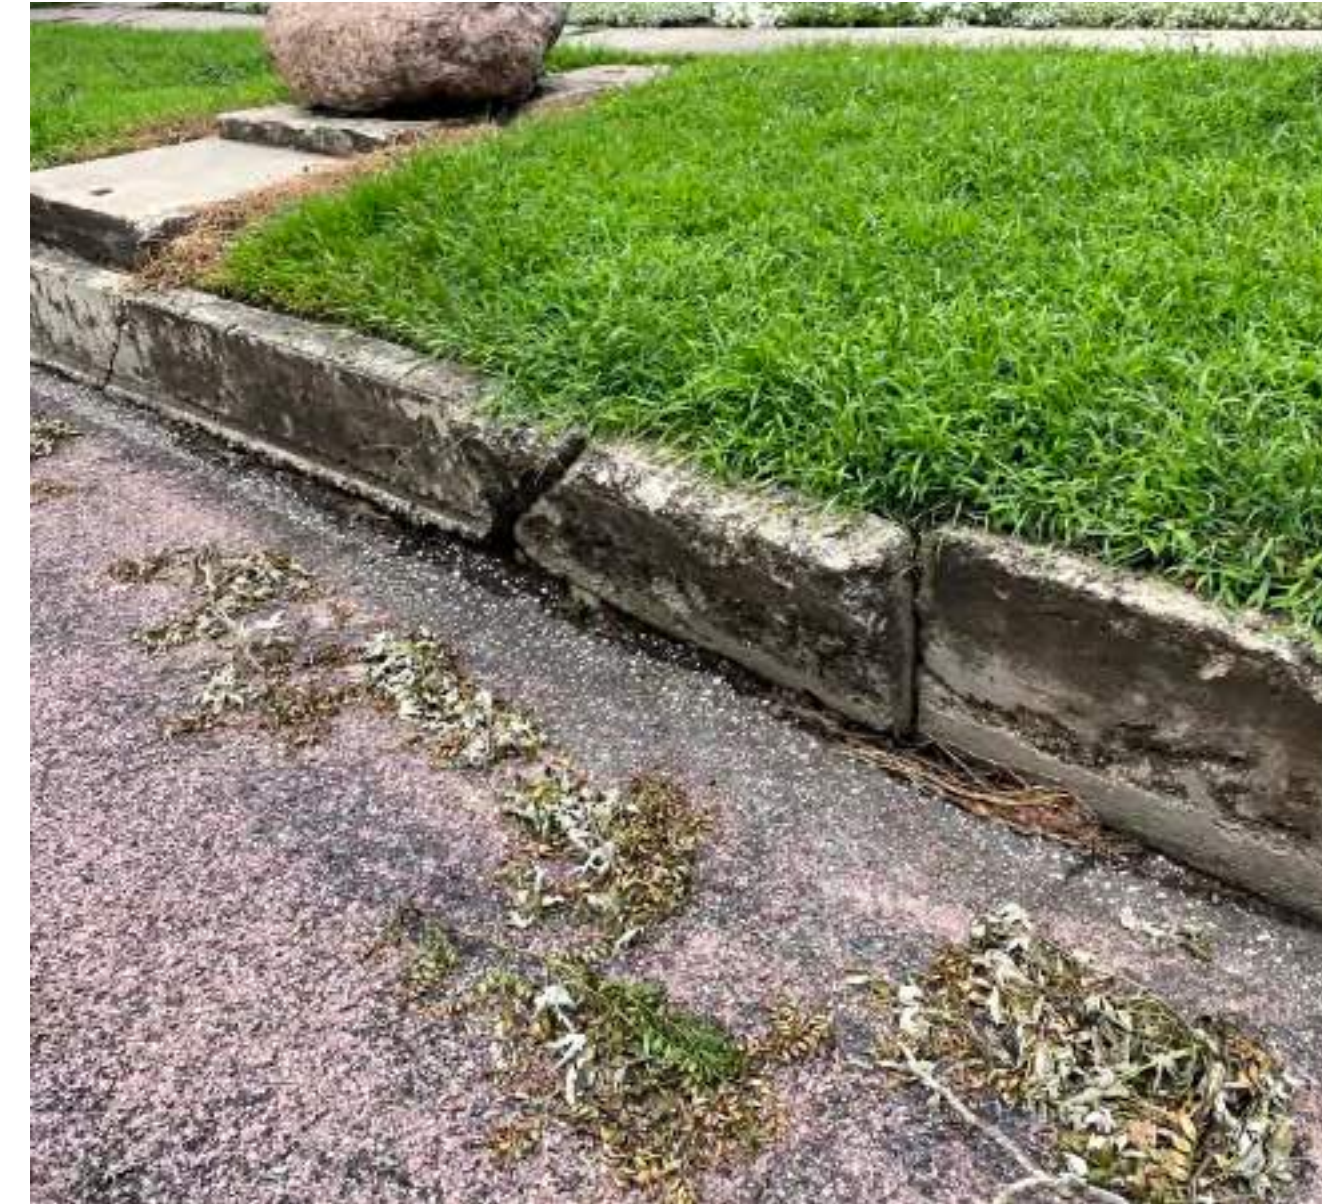
6TH STREET CURB

- Tall vertical curb is in disrepair and needs replacement.

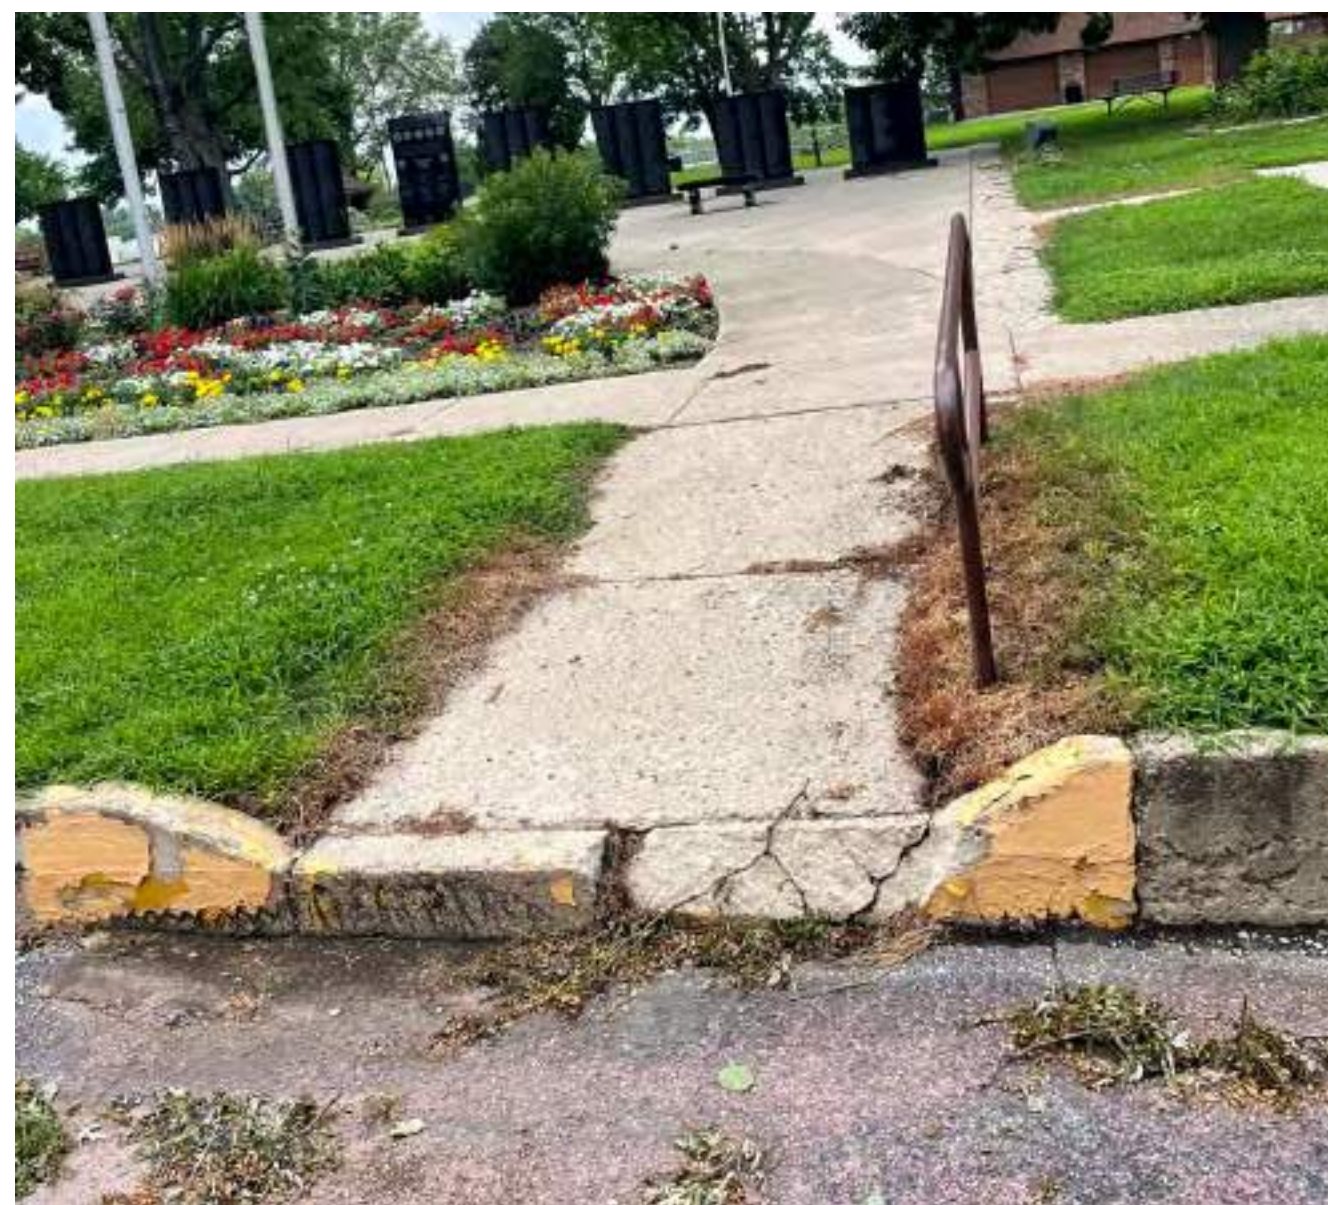
MEMORIAL RAMPS

- Ramps to access veteran's memorial are in disrepair with excessive cracking and not ADA compliant.

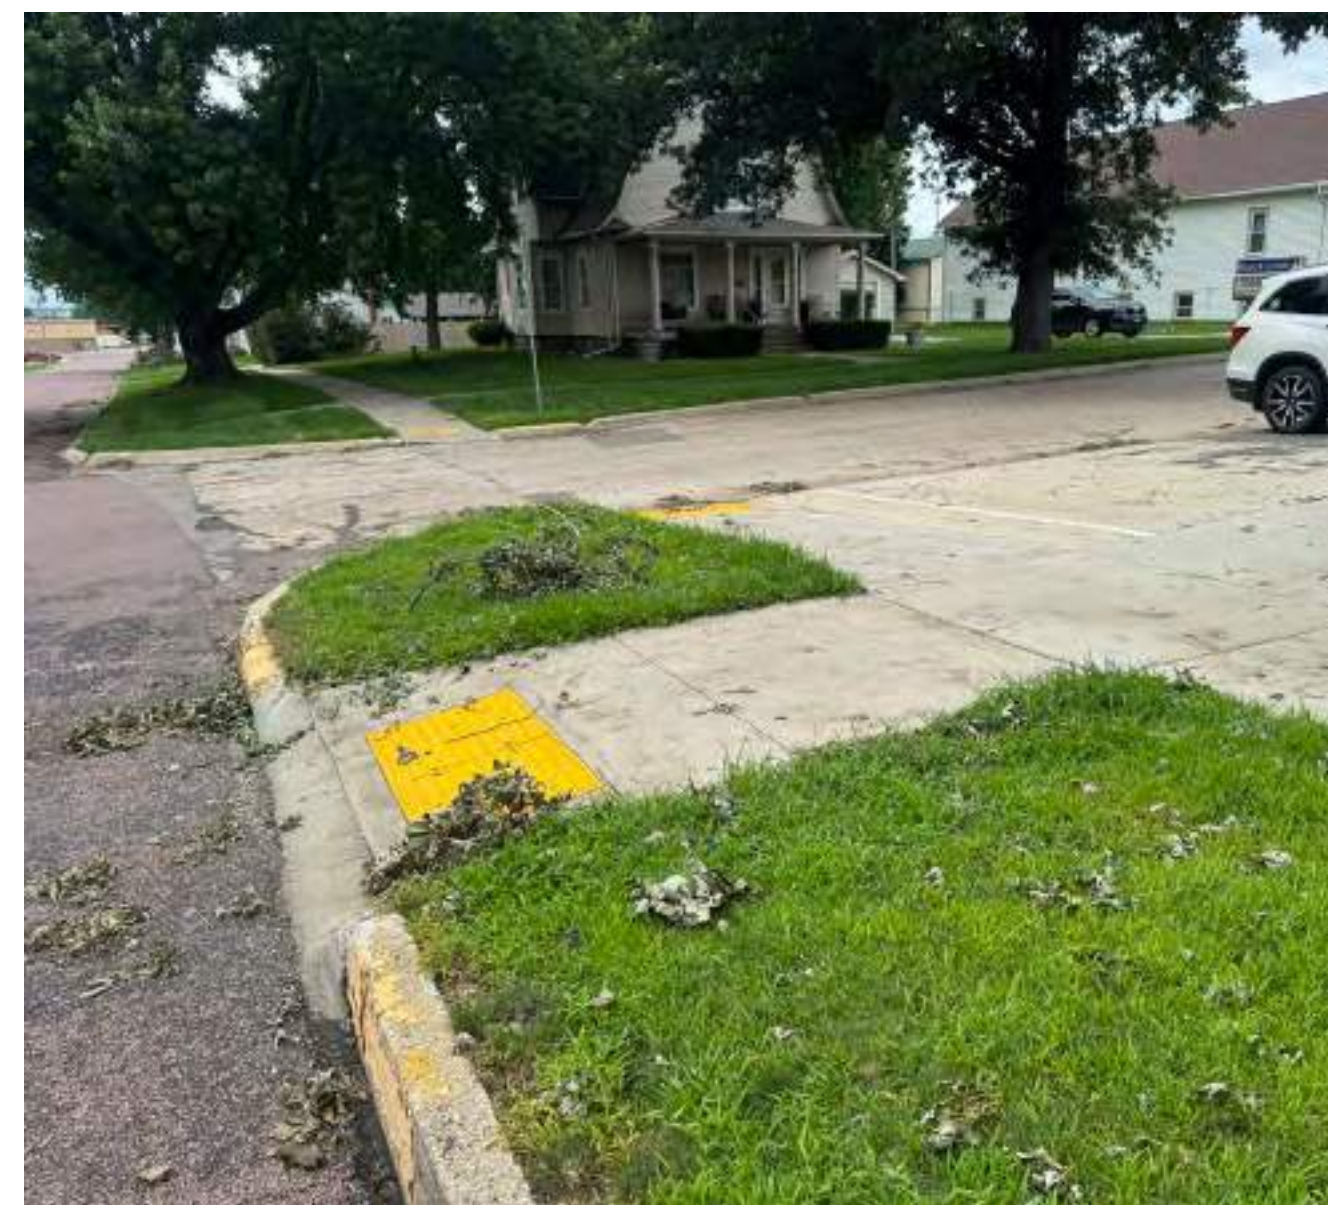
4TH AVENUE / 6TH STREET SIDEWALK APPROACHES

- Ramps are in good condition and newly installed but too steep and not ADA compliant.

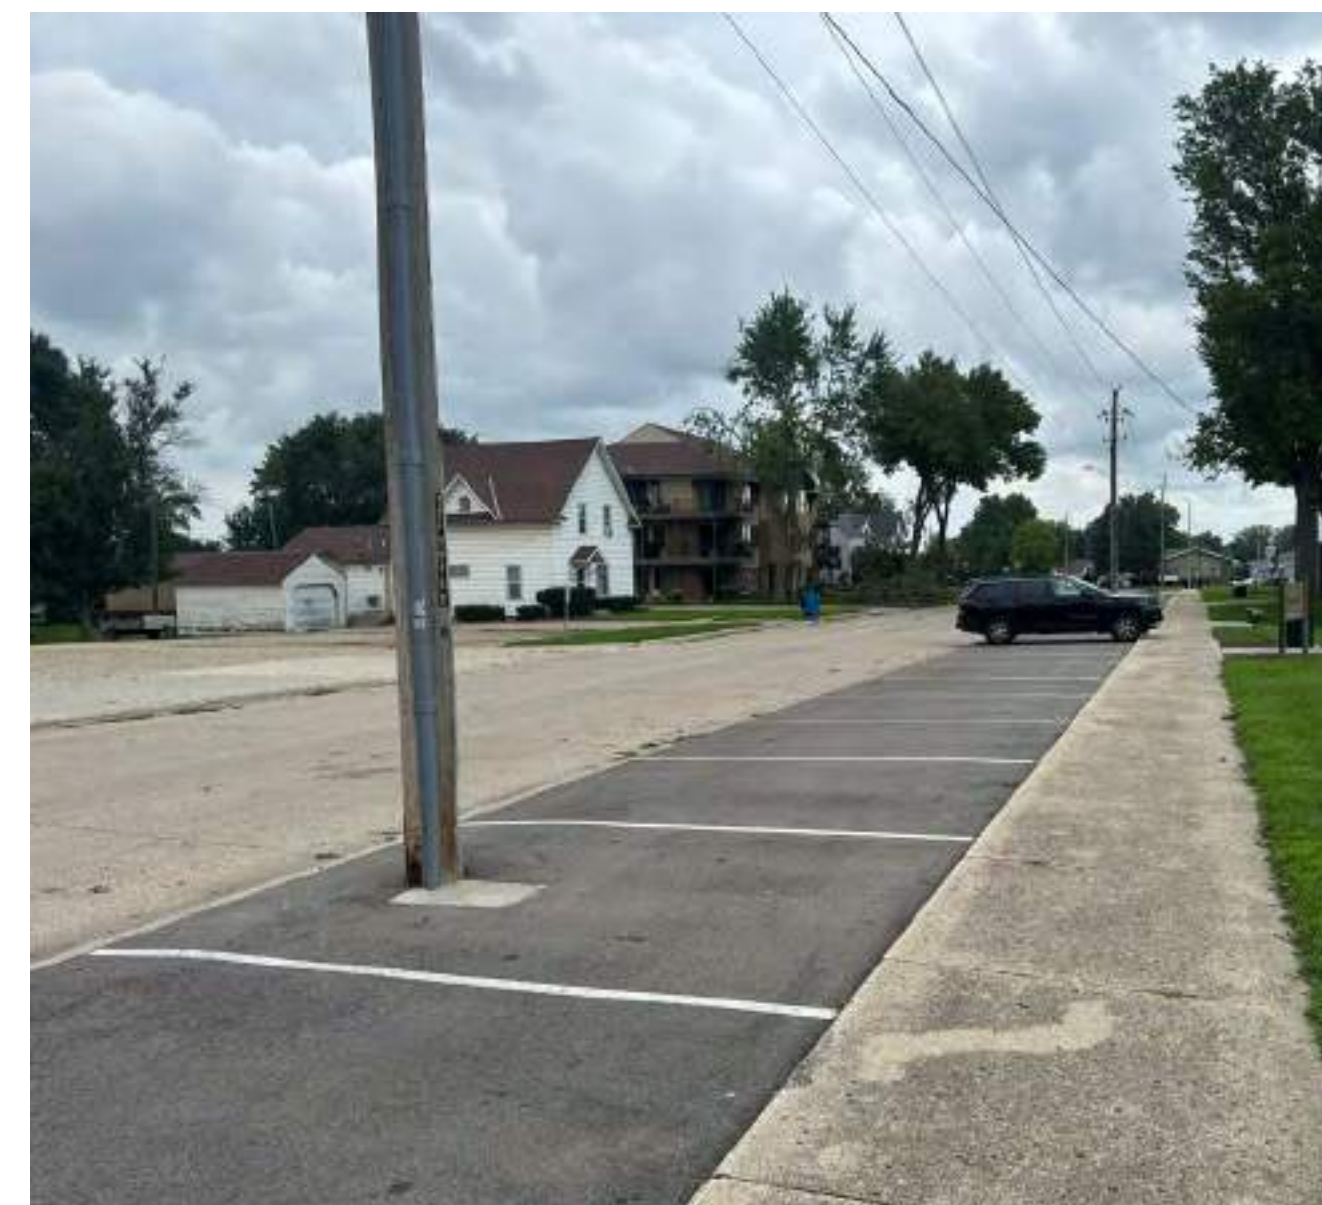
4TH AVENUE STREET PARKING

- Recently overlaid pavement is in fair condition. Stall depths are too shallow (14') with non-compliant ADA stalls. Overhead utility poles located within parking stalls without "no parking" striping or signage. Curb and gutter in disrepair on the North end.

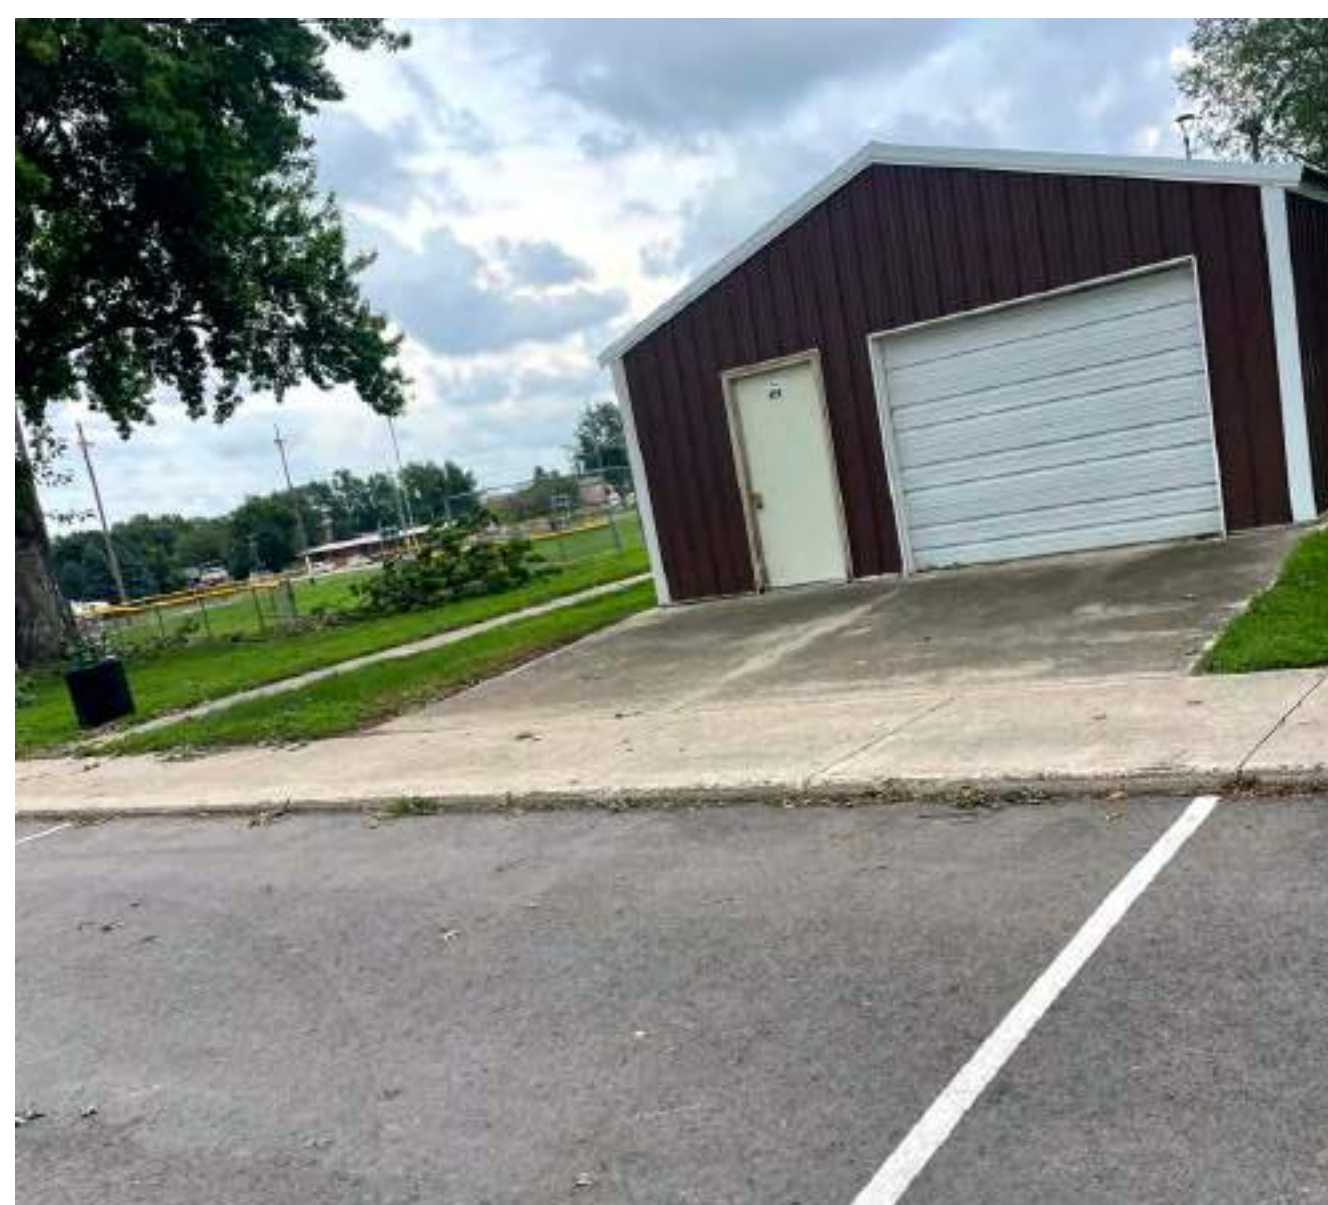
WEST GARAGE DRIVEWAY

- Driveway is functional but lacks an even entrance to the garage (currently a vertical sidewalk face).

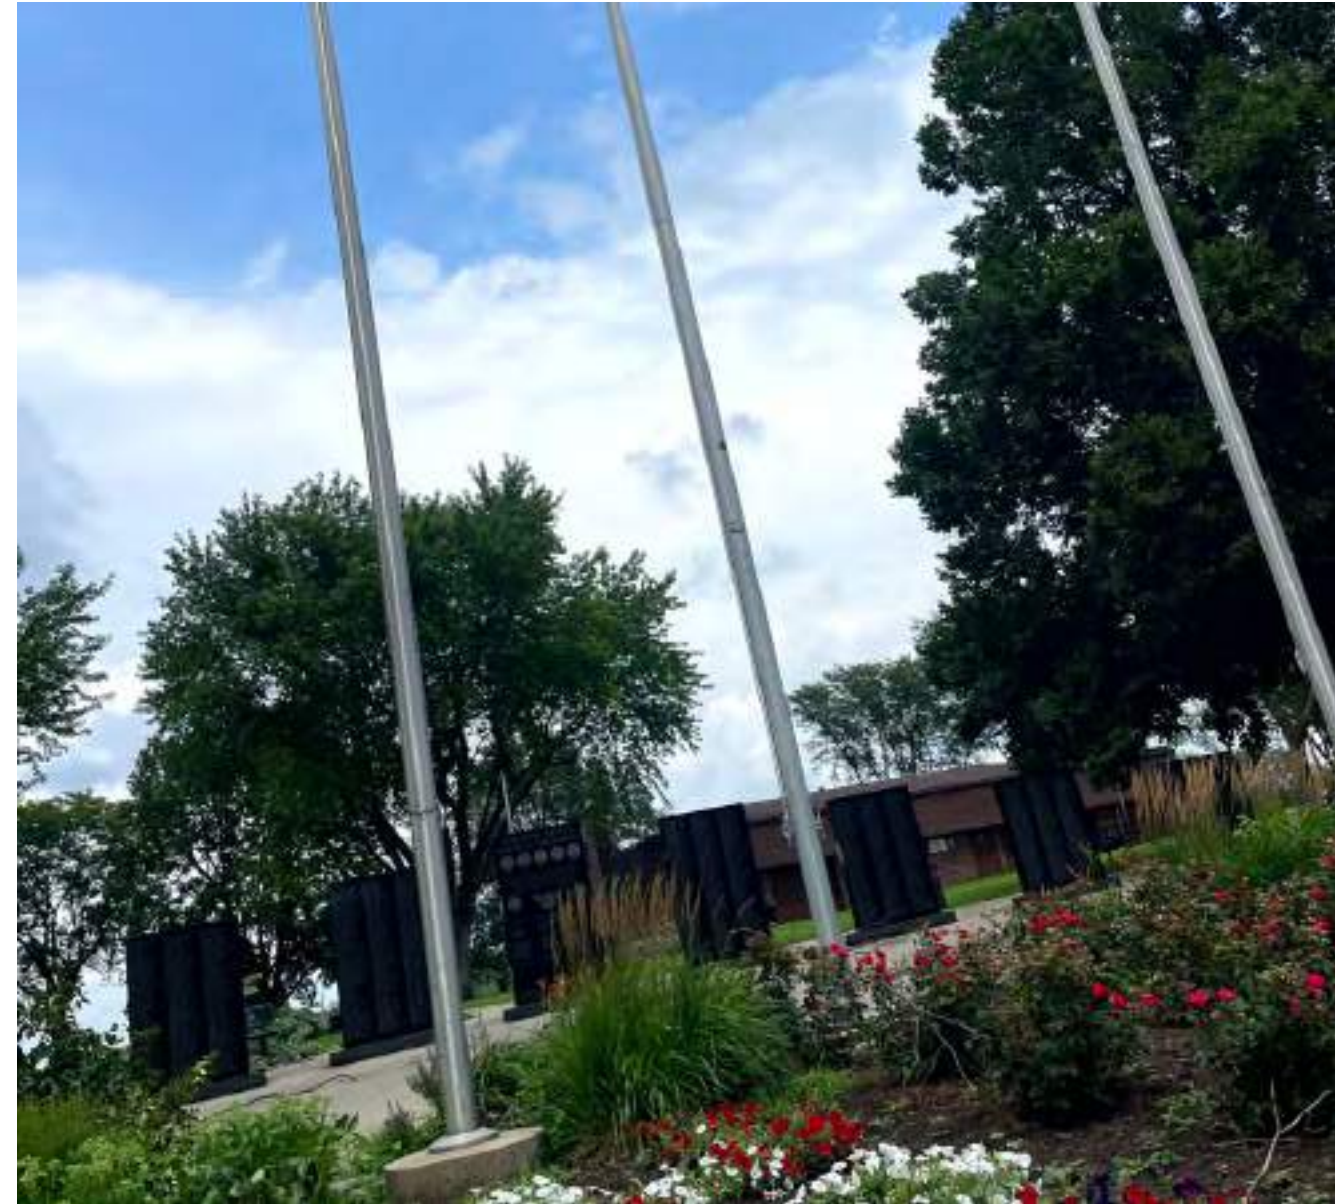
VETERANS MEMORIAL

- The memorial is in fair condition, with access issues along 6th Street (deteriorating curb and ramps). The nine black granite monuments, two granite benches, and three flagpoles are in excellent condition. Lighting appears aged, and the rock monument foundation is poor. Planting beds are mostly well maintained, and the site includes a fire pit in fair condition.

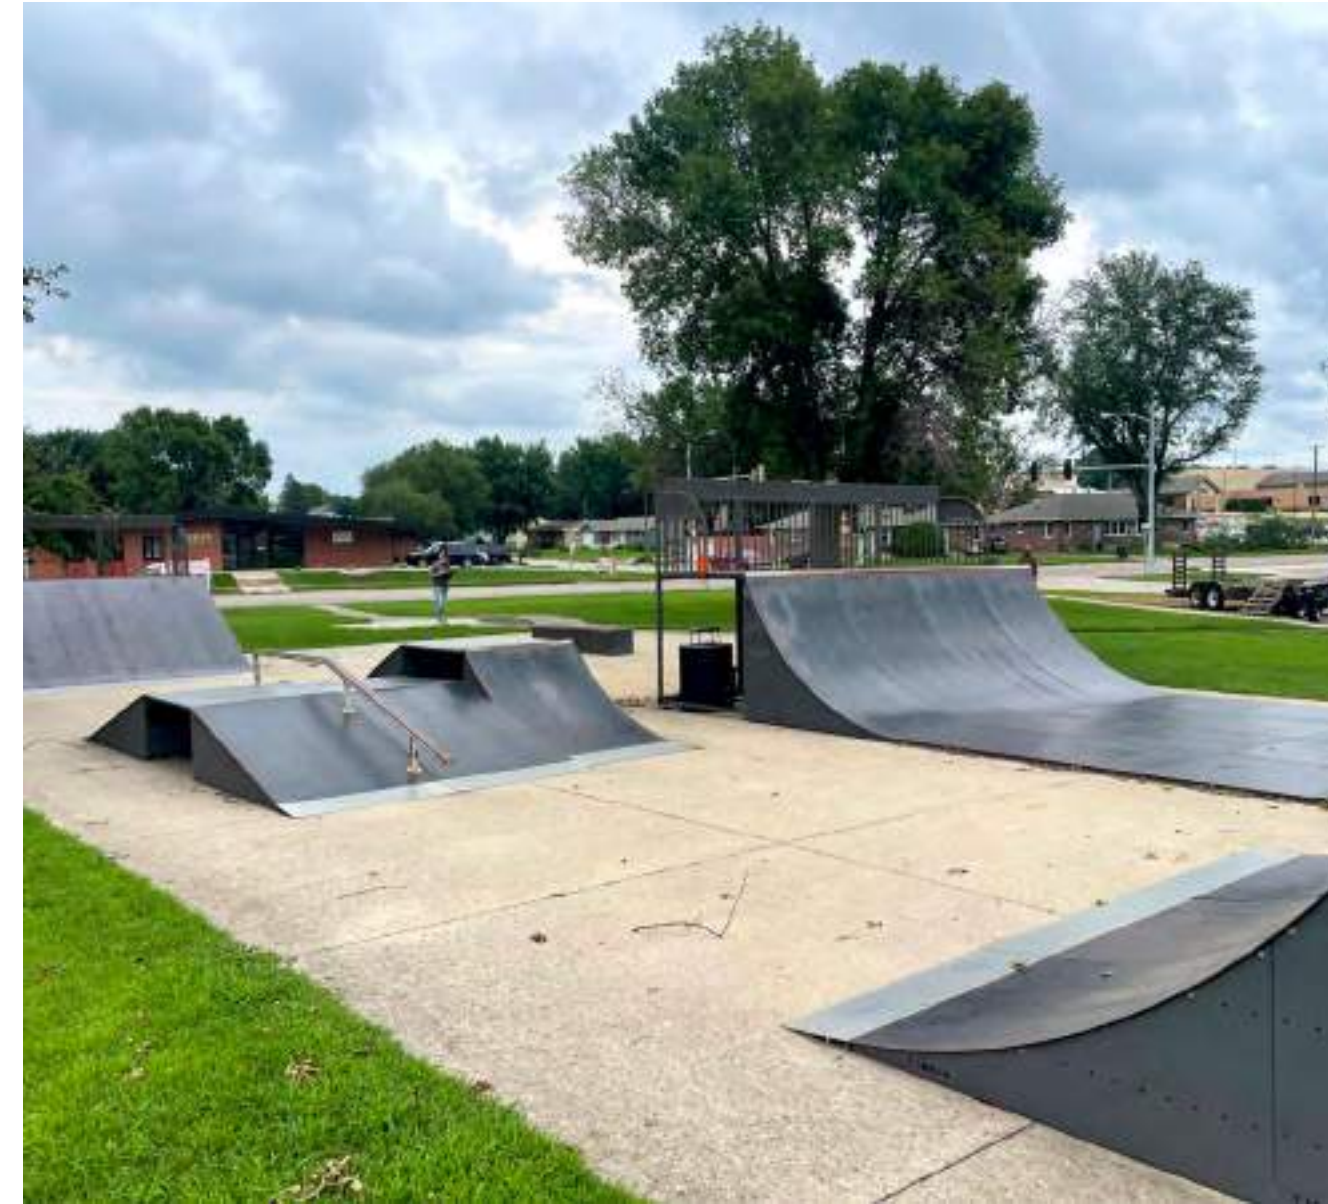
SKATE PARK

- The equipment shows significant wear and rust from age and limited use. Some concrete areas have minimal overgrowth from vegetation and contain noticeable trash and debris, while some equipment surfaces also display graffiti and paint.

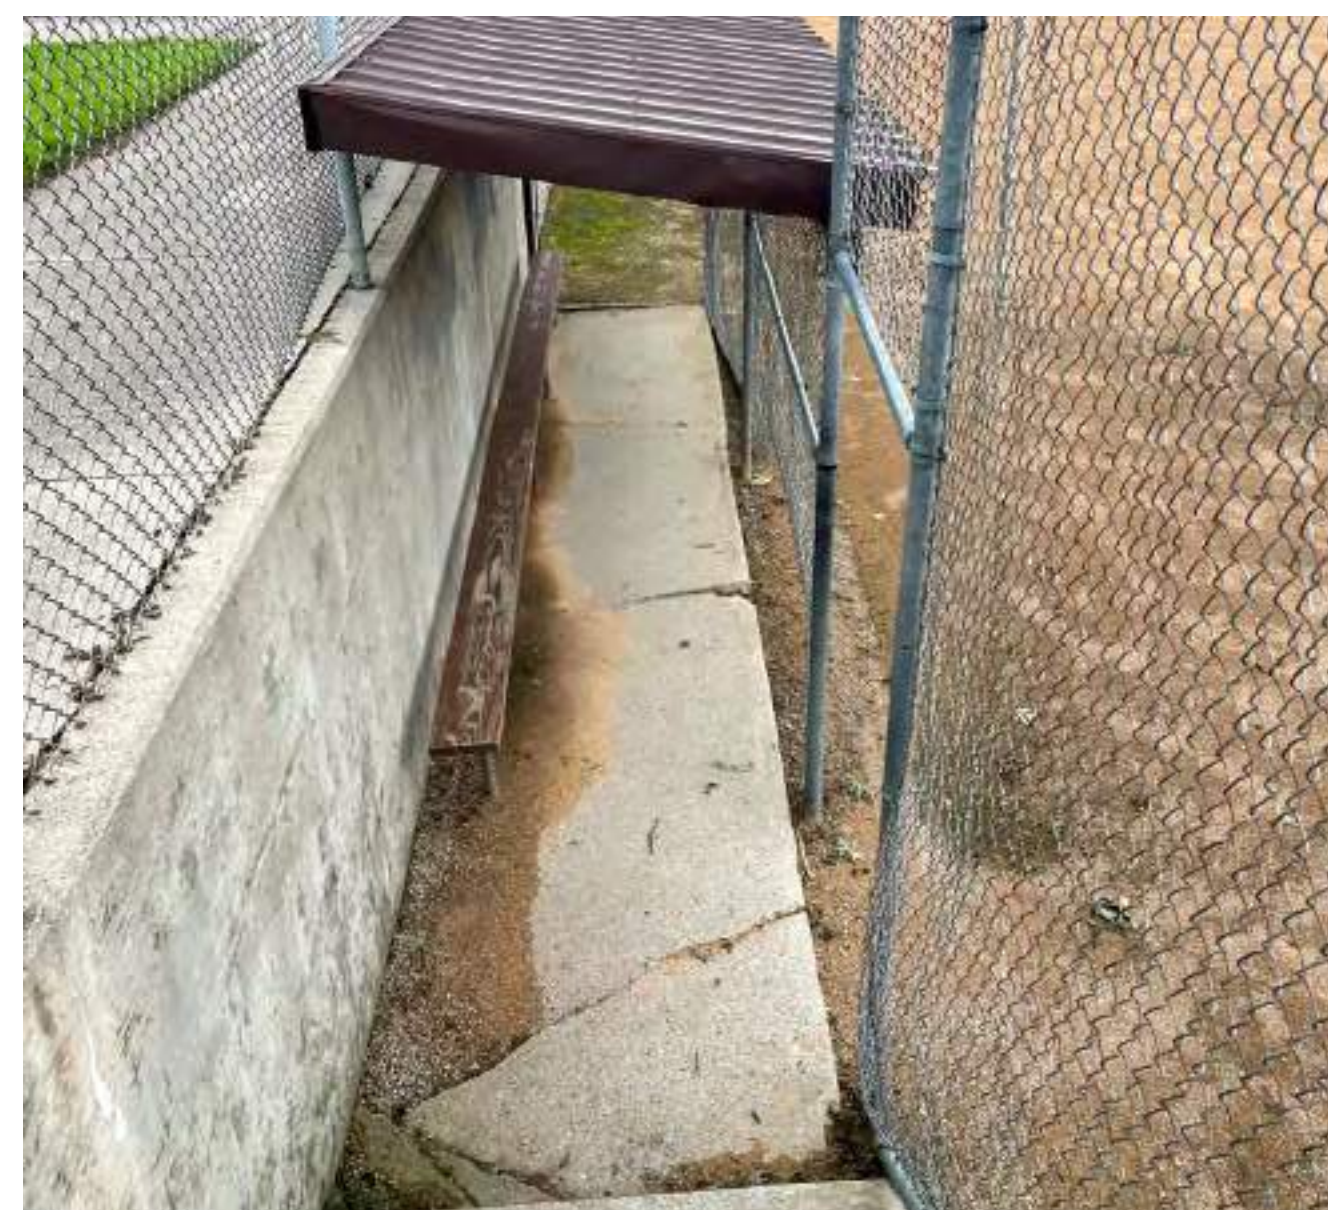
BASEBALL / SOFTBALL FIELDS

- The fields are usable but most associated amenities are in poor condition. Dugouts have cracked and warped panels, likely from poor drainage. The retaining wall and perimeter fence are deteriorating, posing potential safety concerns. Concrete and bleacher pads show cracking, heaving, and ponding water, while the bleachers themselves are in fair condition.
