# City Park Master Plan

CITY OF SHELDON, IOWA

CITY COUNCIL PRESENTATION - DECEMBER 3, 2025

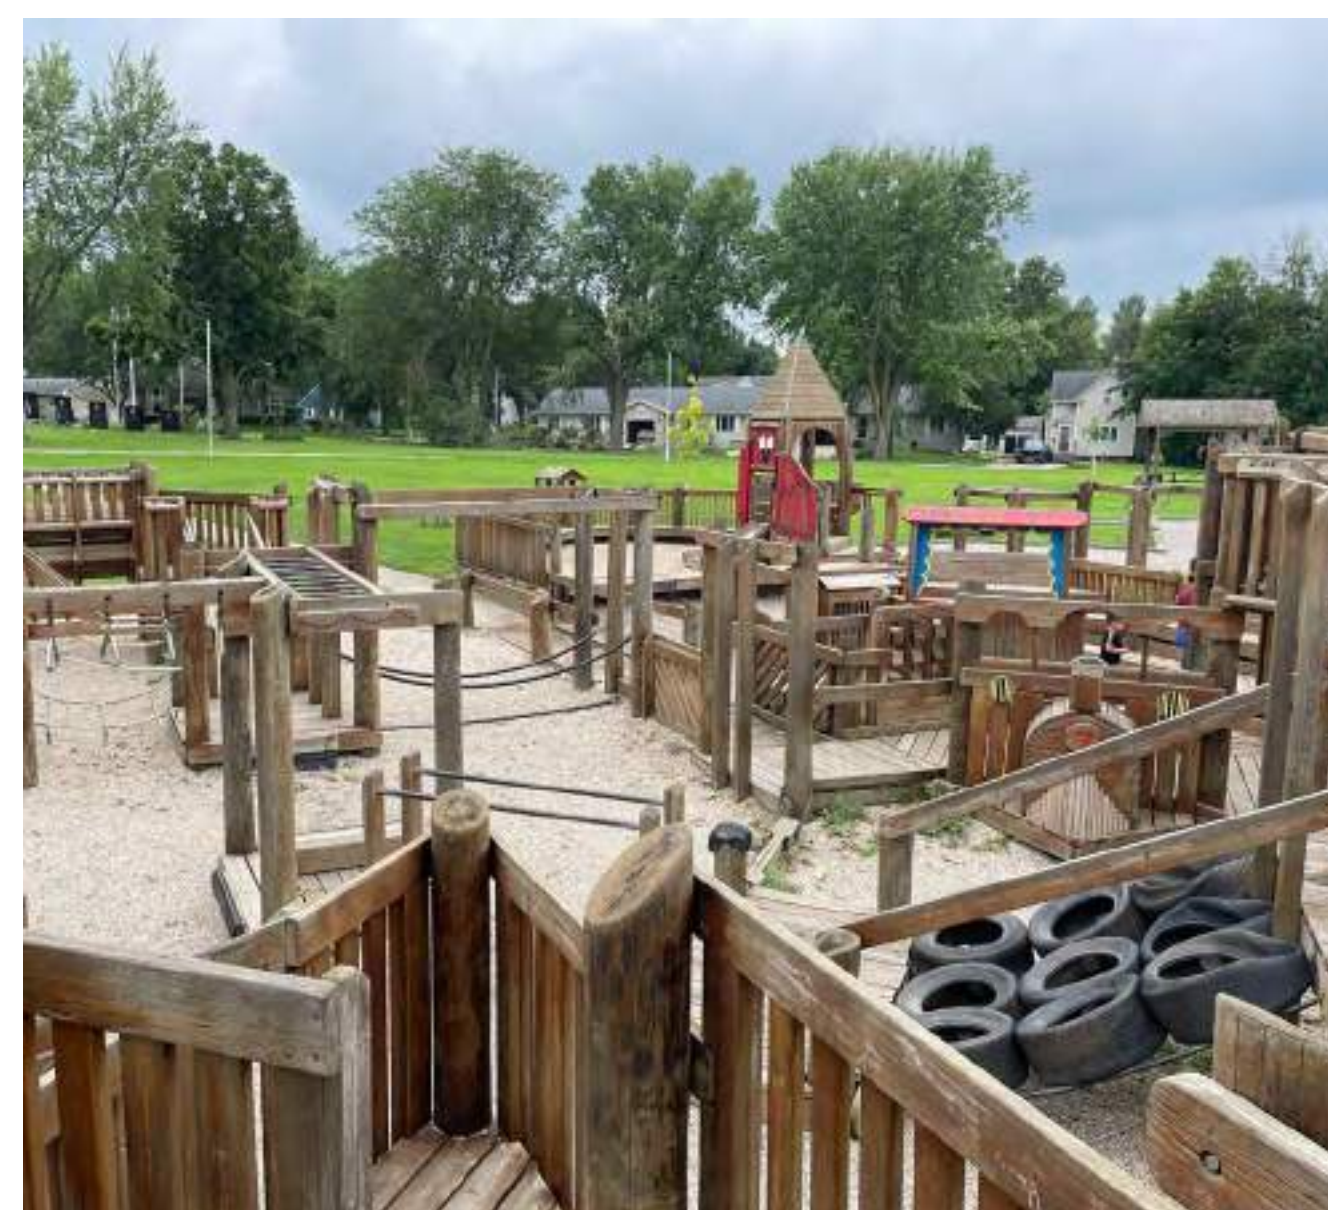
PLAYGROUND

- The playground is in fair condition and appears well used, though most equipment is outdated, consisting of wood, ropes, and tires arranged in ways that do not meet current safety standards. Play elements focus on obstacle-course and adventure / exploration-style activities, with some wood surfaces beginning to splinter. Surfacing is split between pea rock and wood mulch, both in poor condition with ponding water and vegetation overgrowth. Seating elements are functional and used while colorful animal murals add vibrancy to the space. However, wood edging around the perimeter is deteriorating, and the playground overall lacks accessibility, making it largely unusable for individuals with disabilities or mobility impairments.

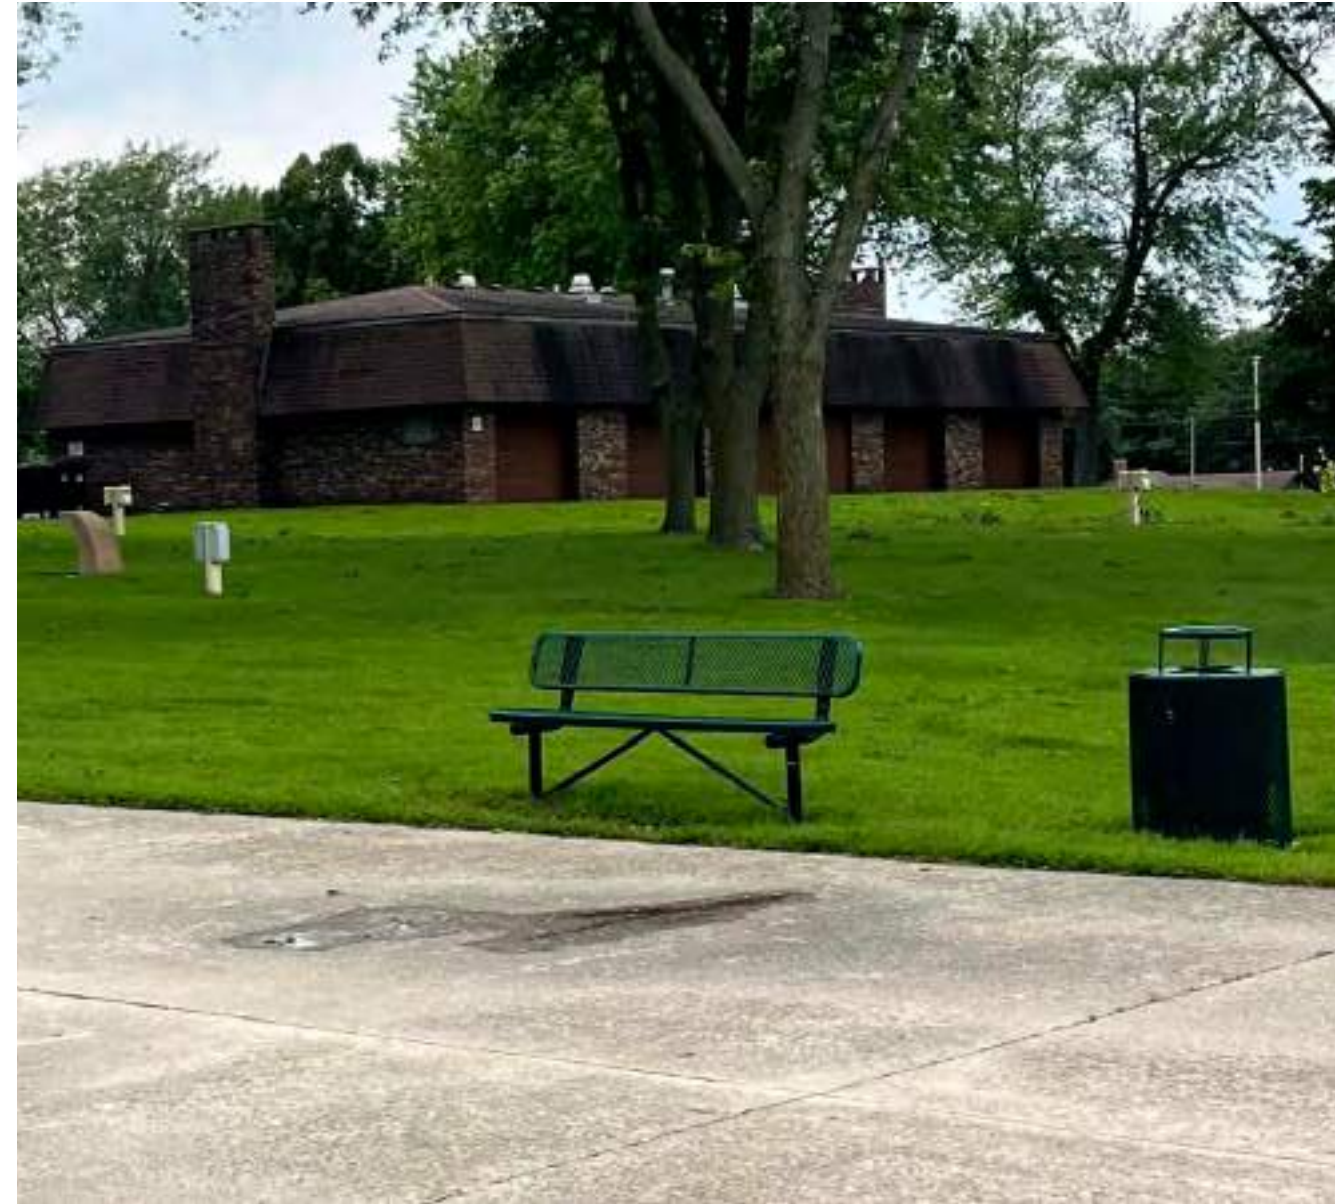
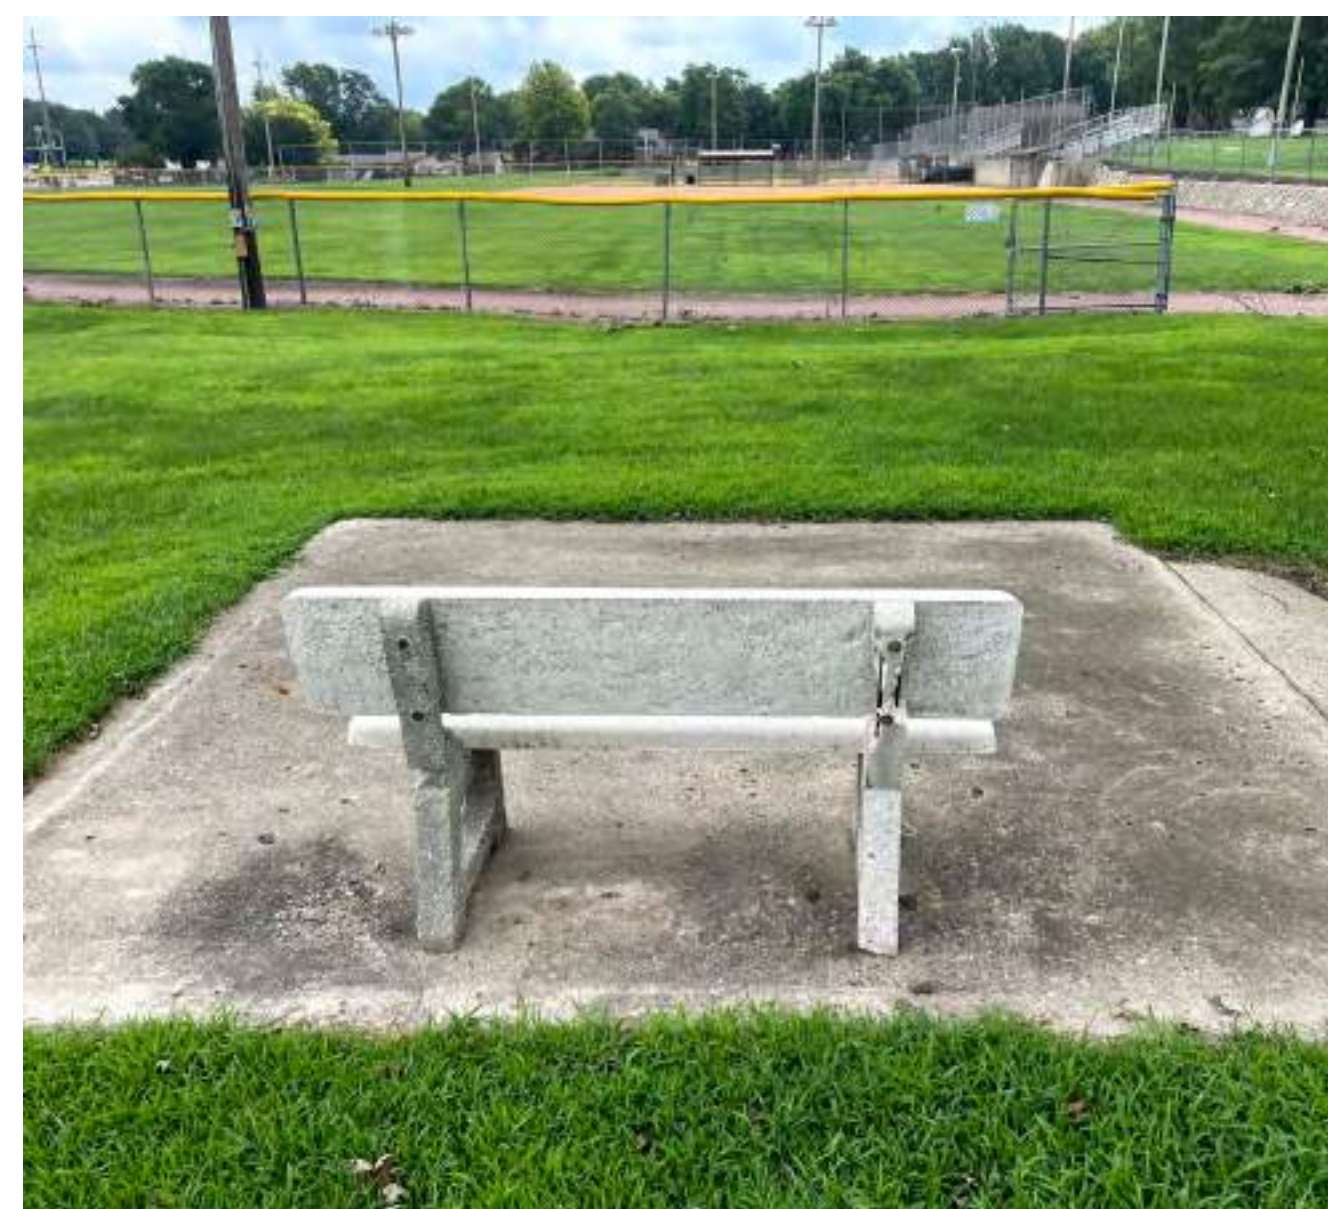
SEATING

- Seating elements (outside of major site amenity areas) appear to be in mostly good condition with some seating areas in poor condition. Seating is placed somewhat strategically throughout the site but is not ADA accessible in many areas. Seating variety is narrow, being mostly comprised of ground-mounted or moveable benches.

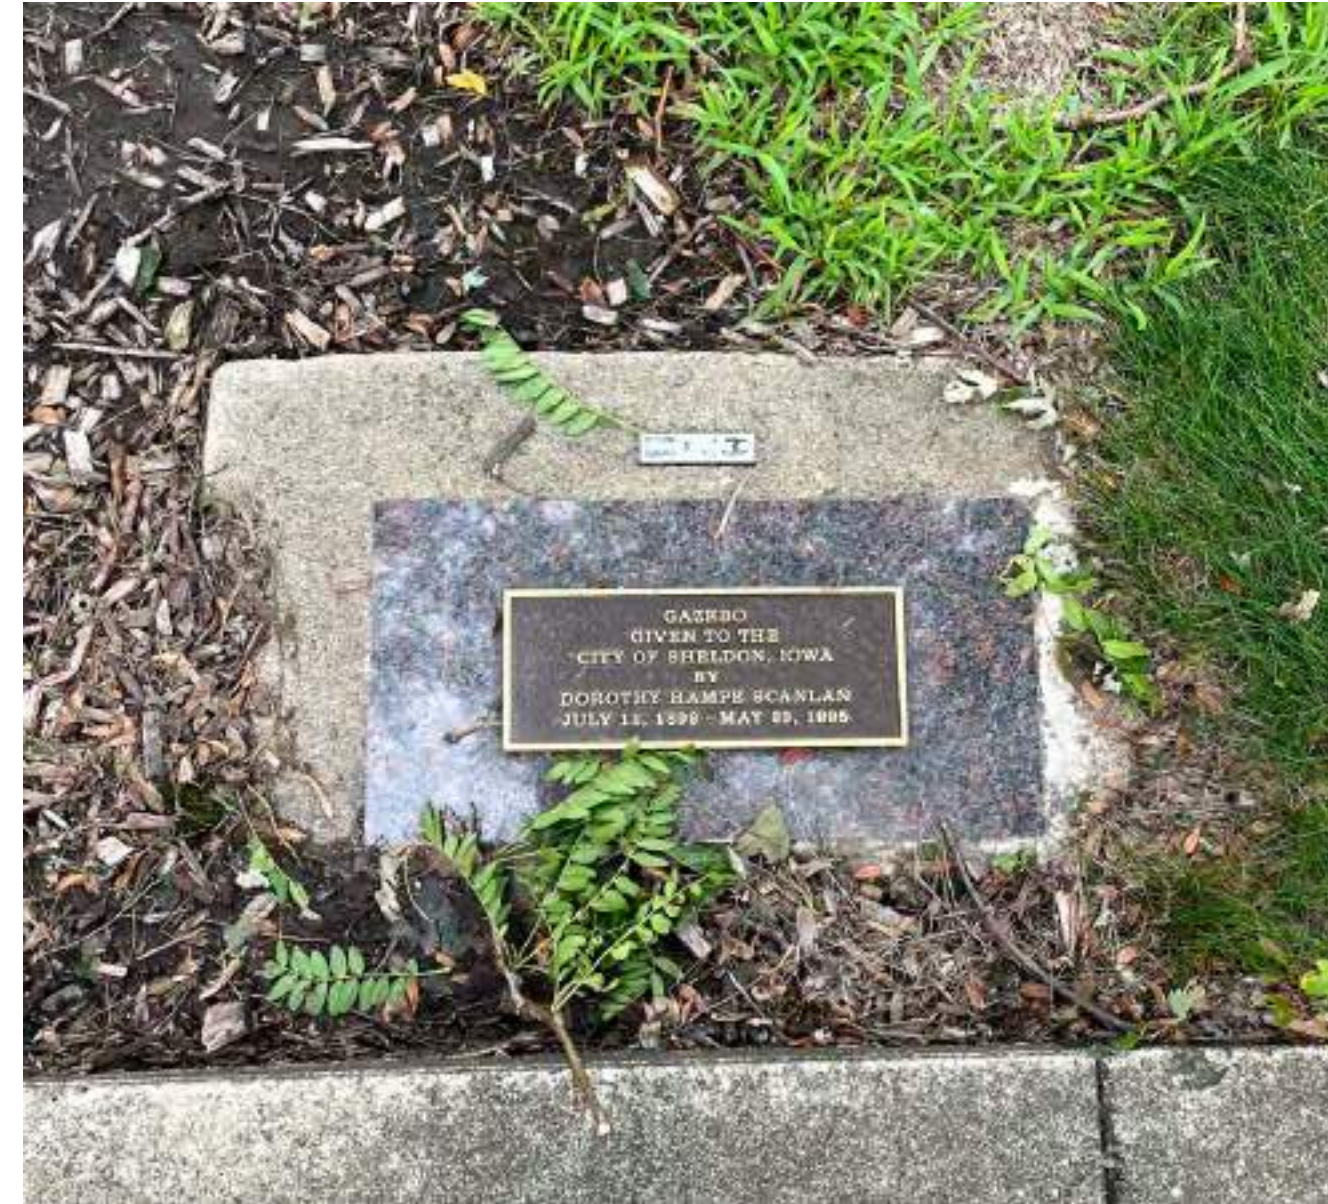
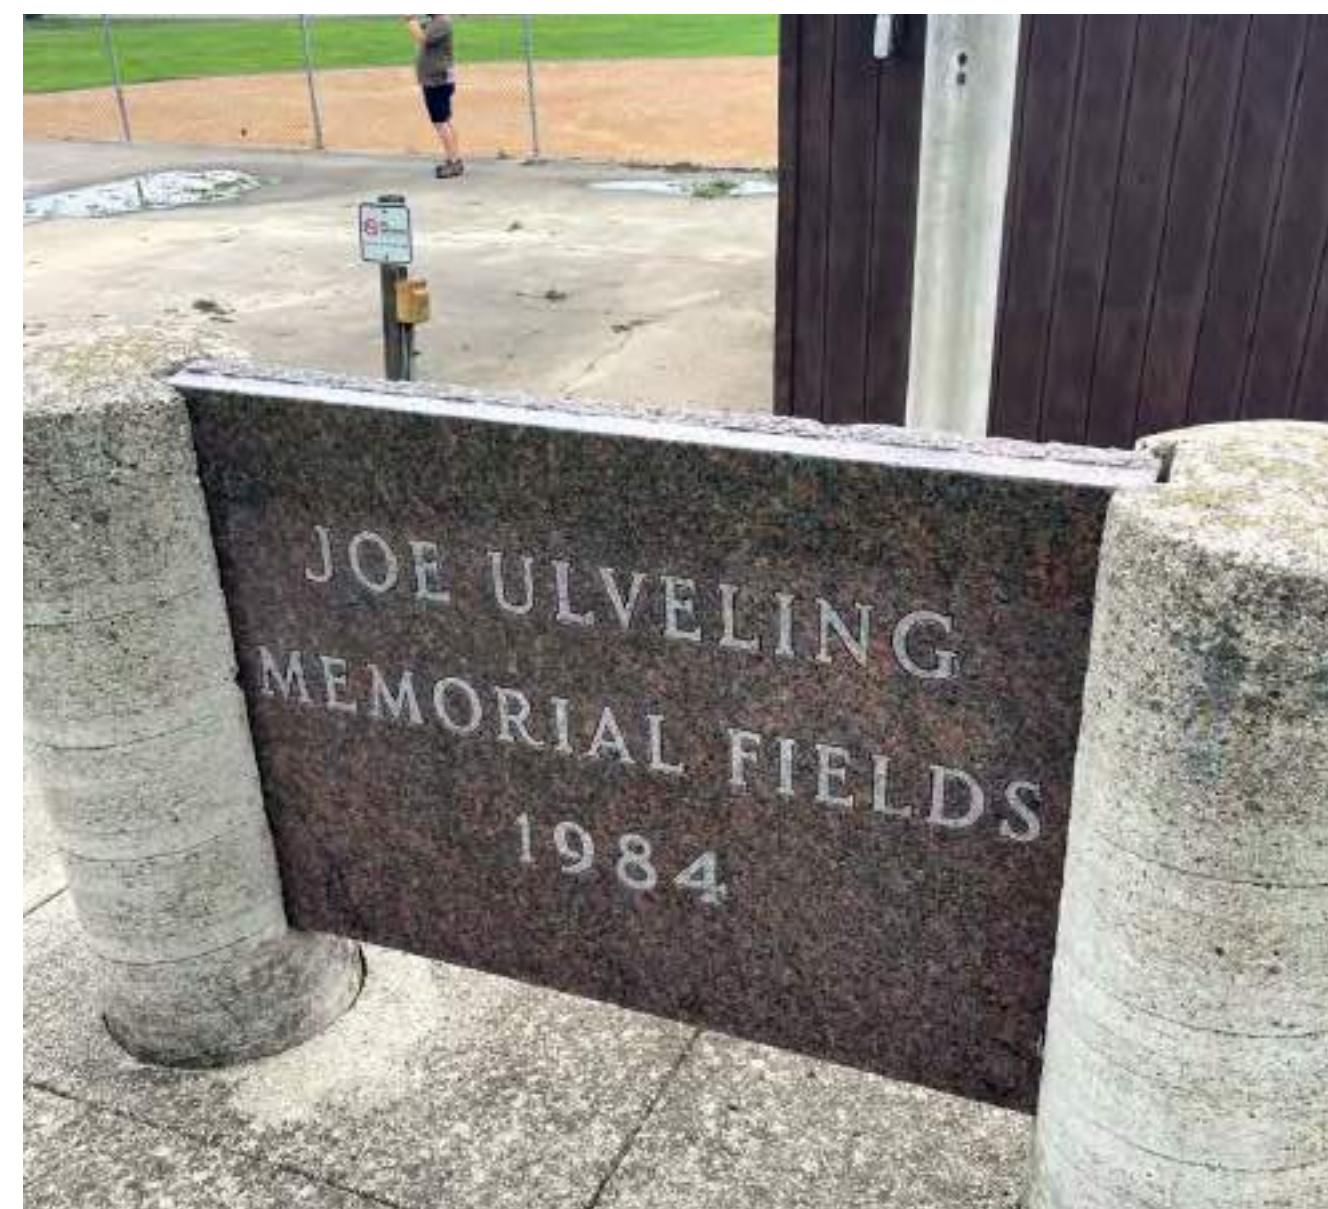
MEMORIALS / MONUMENTS

- The site includes various memorials, plaques, and monuments throughout the site aside from the veteran's memorial itself. Many of which are out of sight in planting beds or embedded into a concrete pad in the lawn. Monuments are in optimal and fair condition but most of which show noticeable signs of wear and weathering.

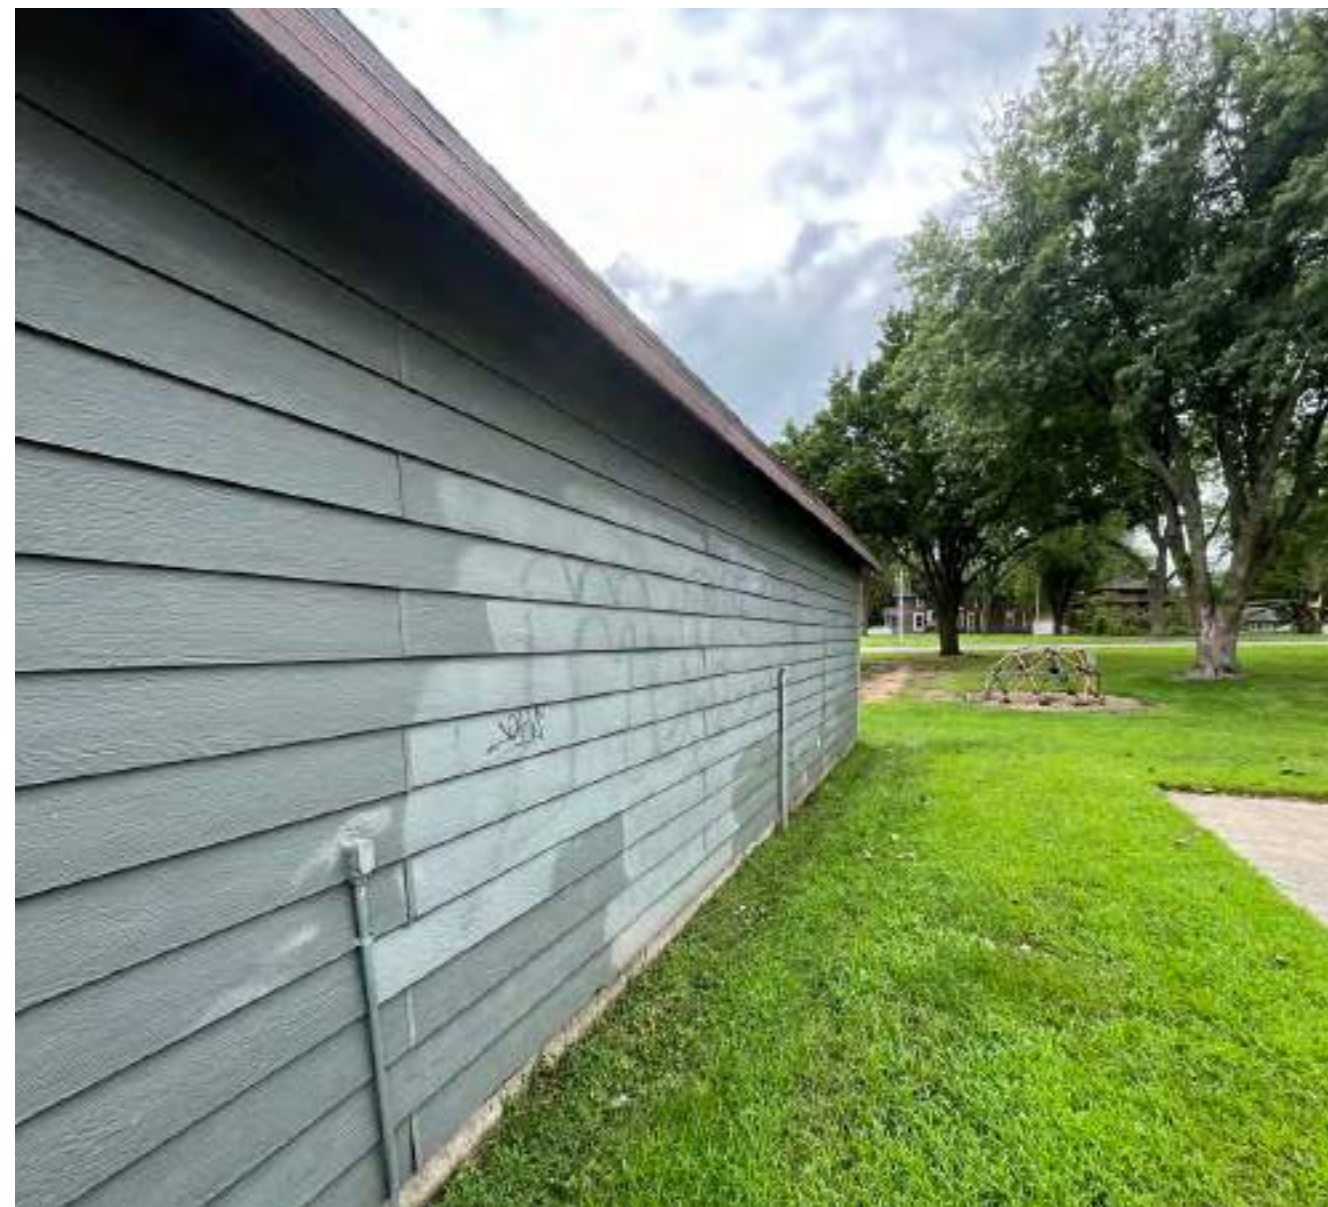
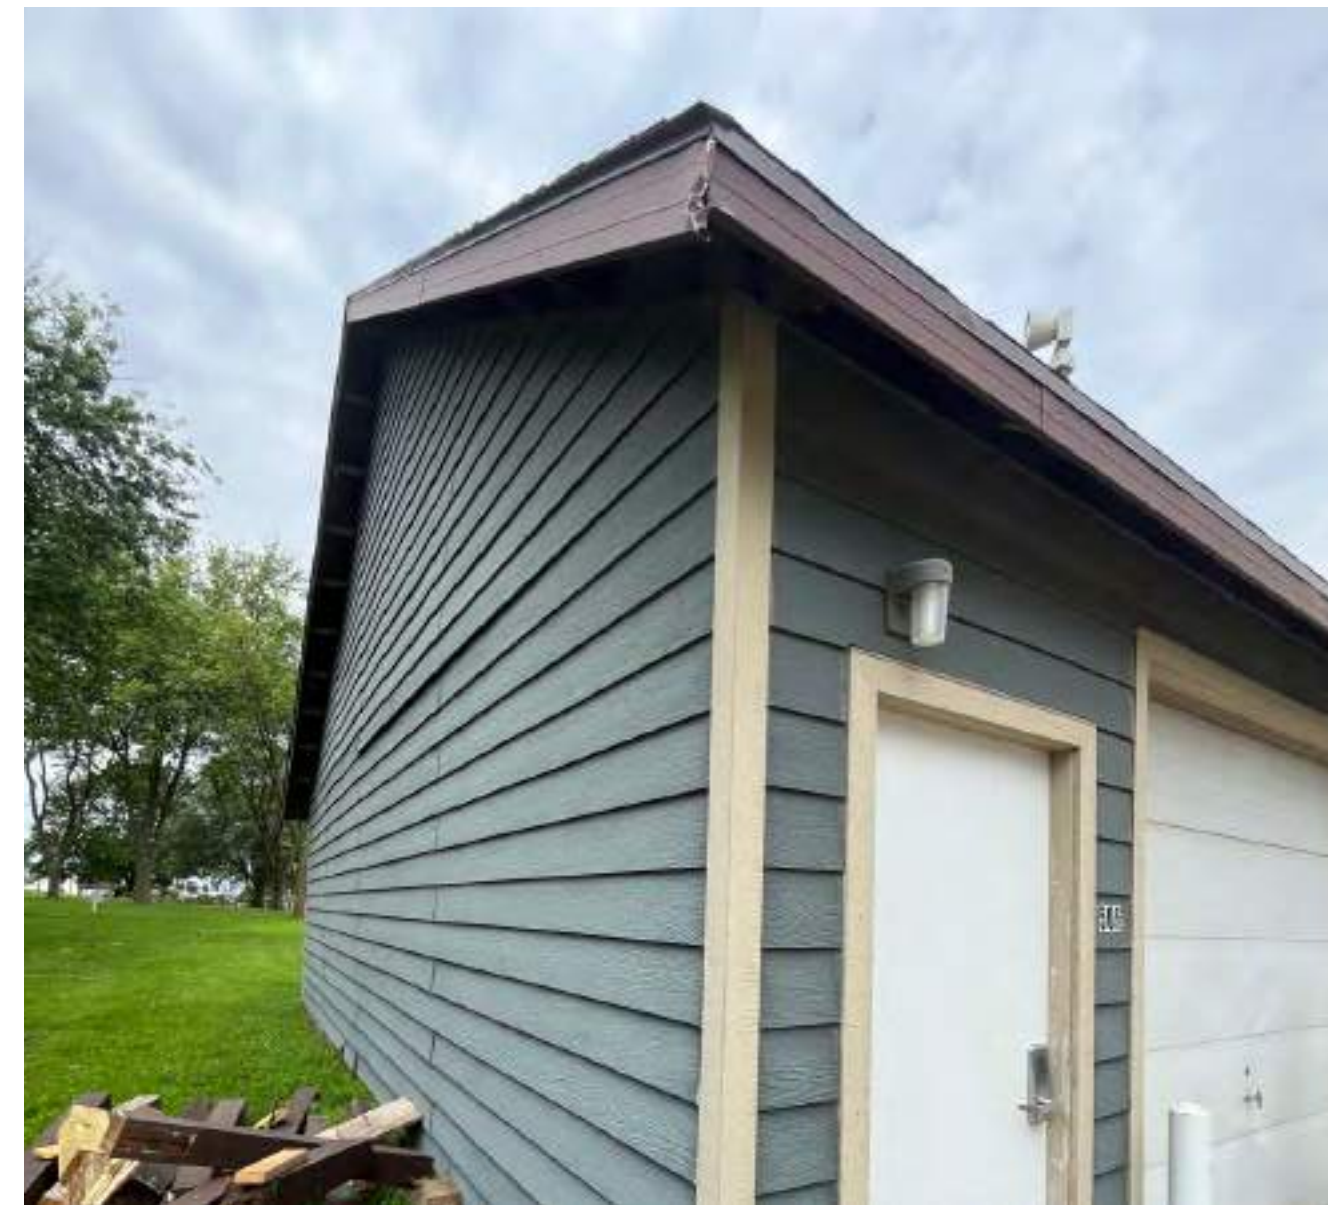
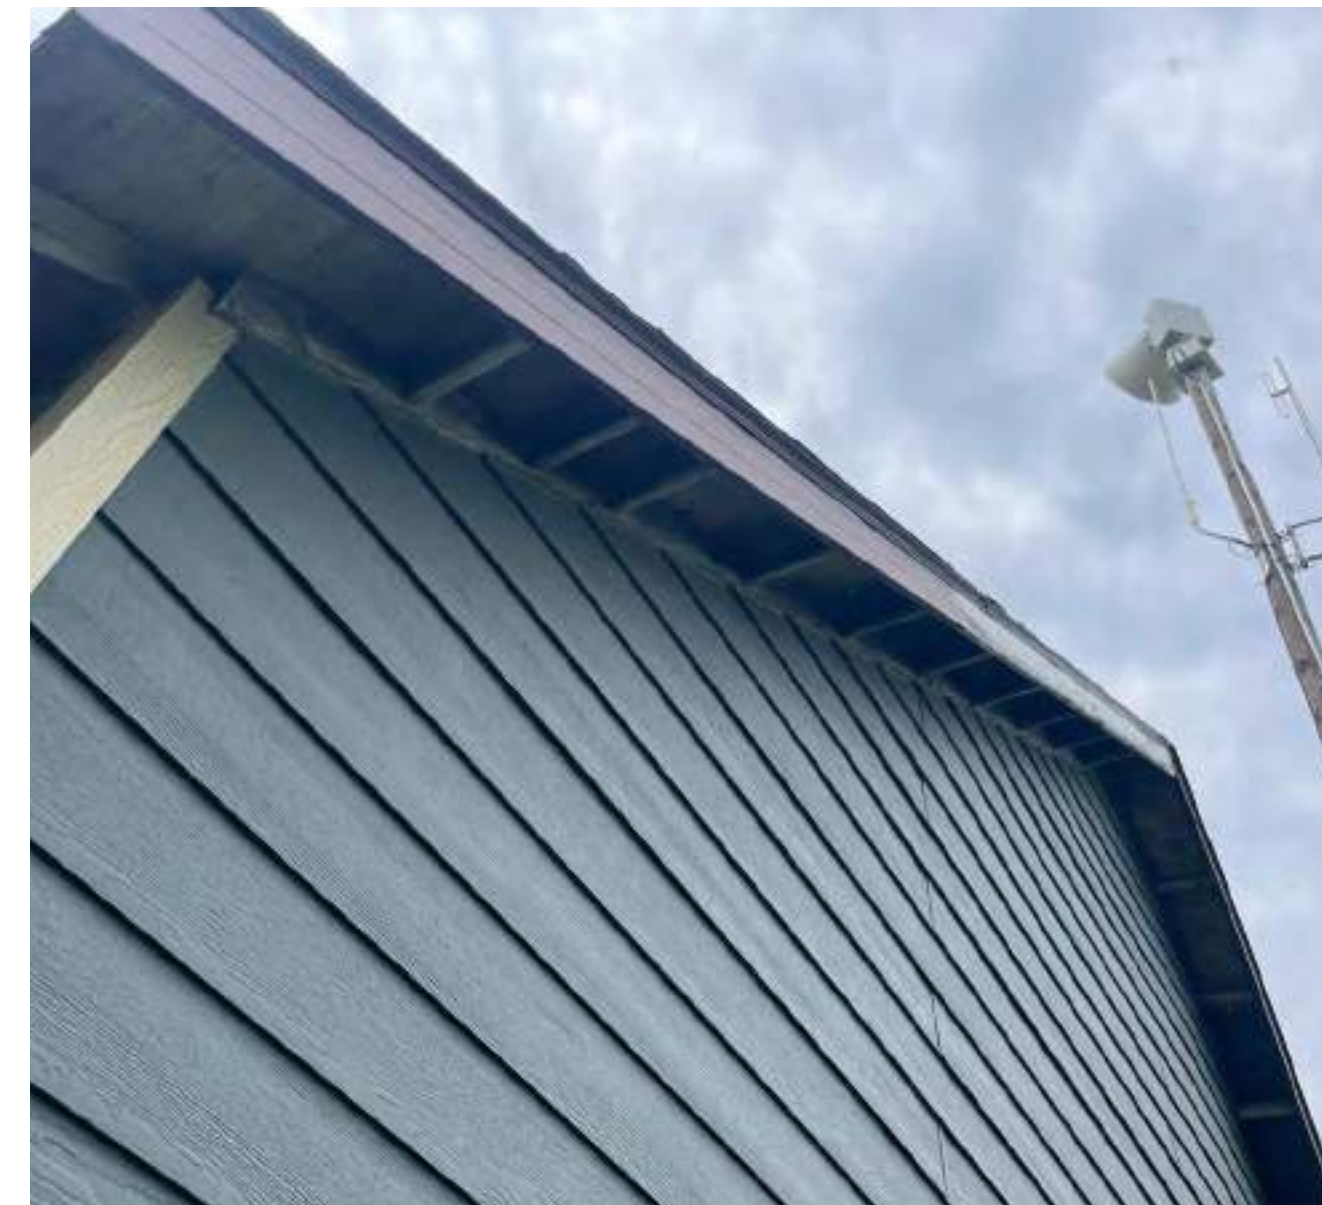
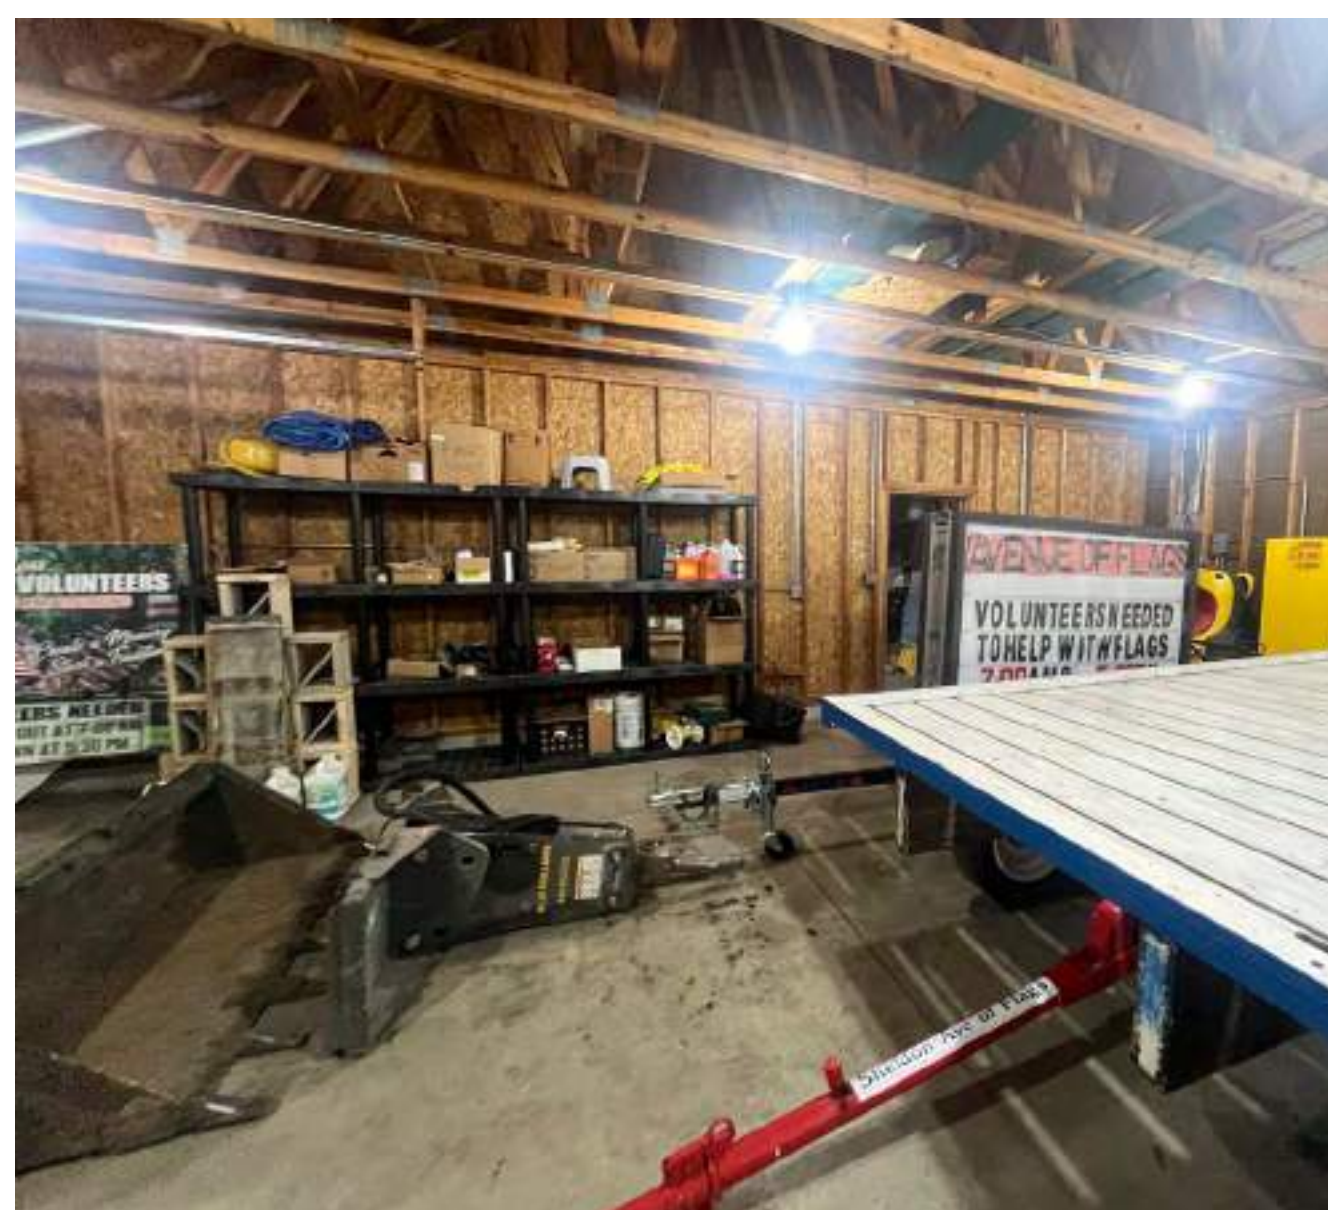
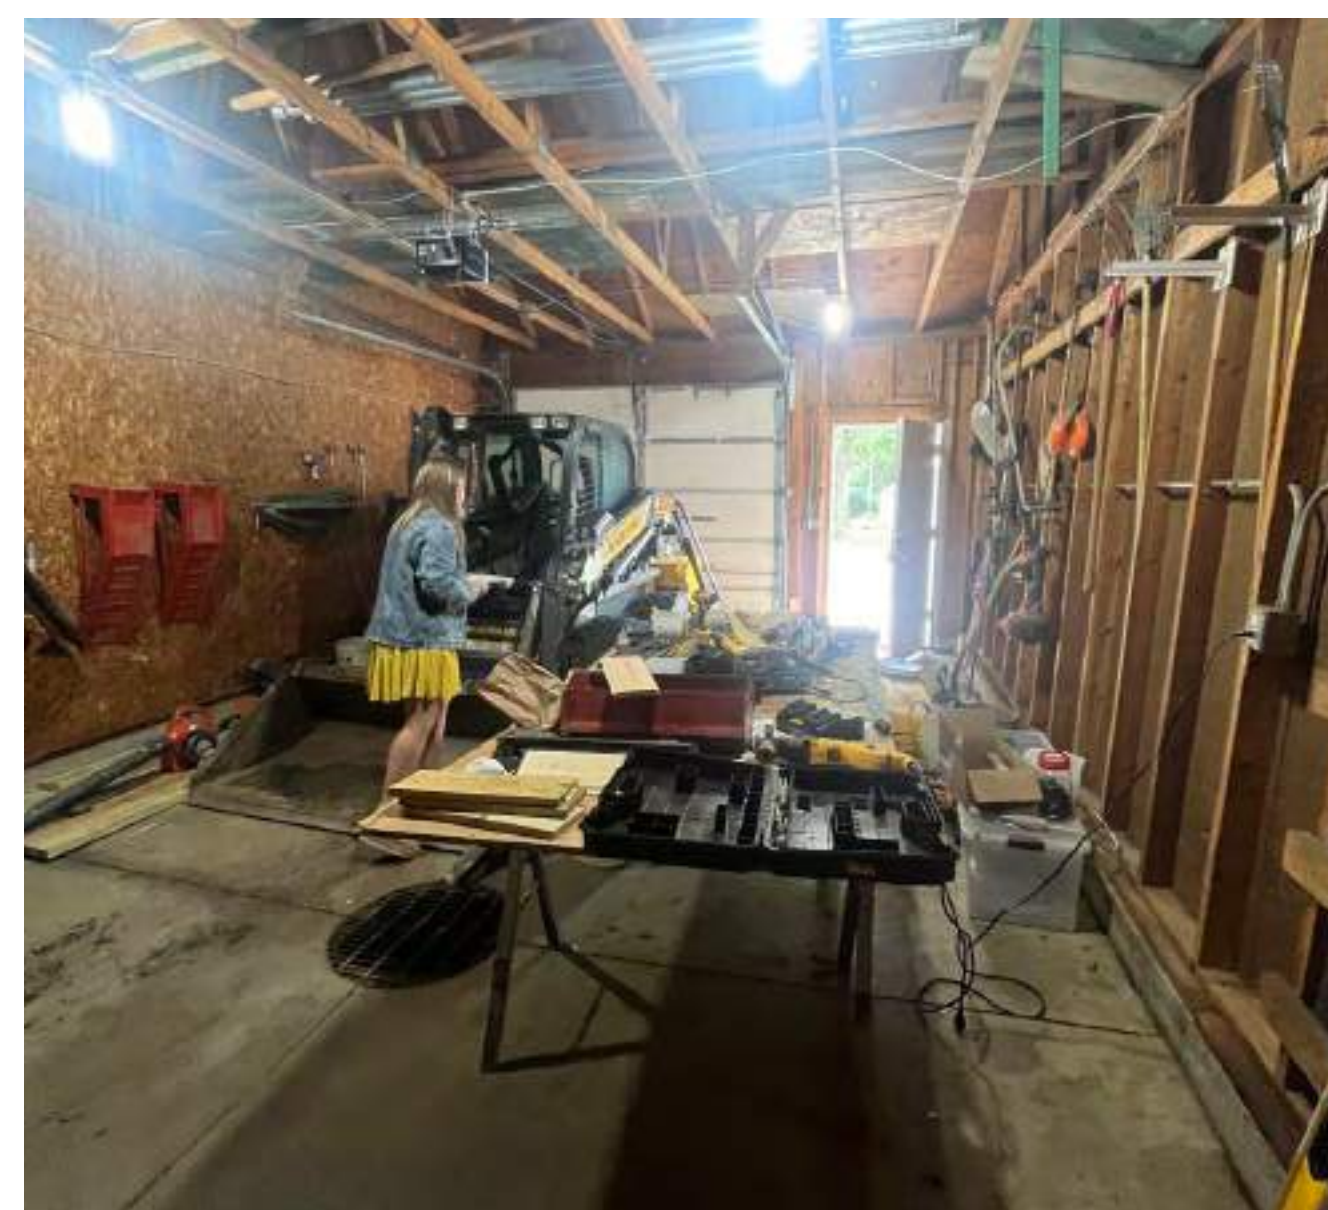
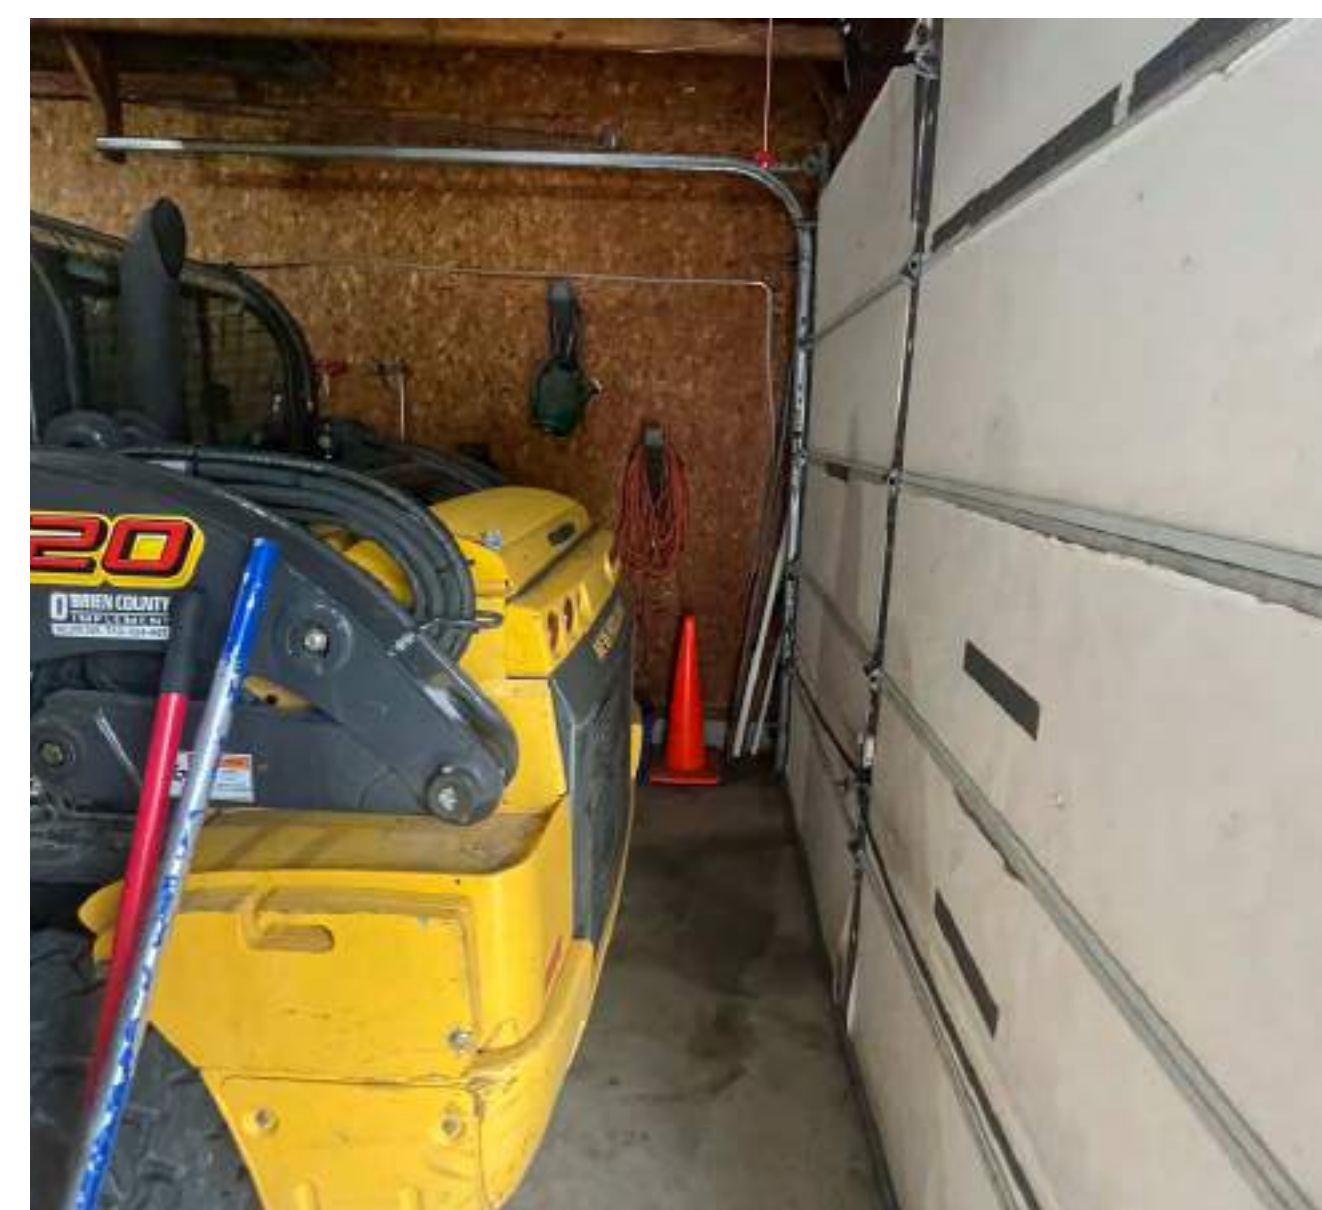
EAST GARAGE

- Several areas of the exterior trim show water damage, particularly near the ground level.
- The soffits are missing from all overhangs.
- Cracking / expansion where exterior pavement meets foundation.
- Portions of the siding are damaged, with exposed bare wood visible.
- Graffiti is present on sections of the building.
- Areas where graffiti has been painted over are discolored and inconsistent with the surrounding finish.
- Building appears to be in generally good condition for its use of storage.
- Building driveway is in poor condition.
- Interior of the building is in good condition.

- Overall, the building is functional and remains in good condition. The exterior siding shows signs of deterioration and rot, likely due to inadequate weather protection. The facility is primarily used for storing holiday and seasonal decorations, as well as various pieces of heavy equipment.

- Re-side and re-paint building.
- Add vented soffits to overhangs
- Add joint filler where exterior pavement meets foundation.
- Remove and install new fascia and metal flashing.
- Remove and install new entry door.

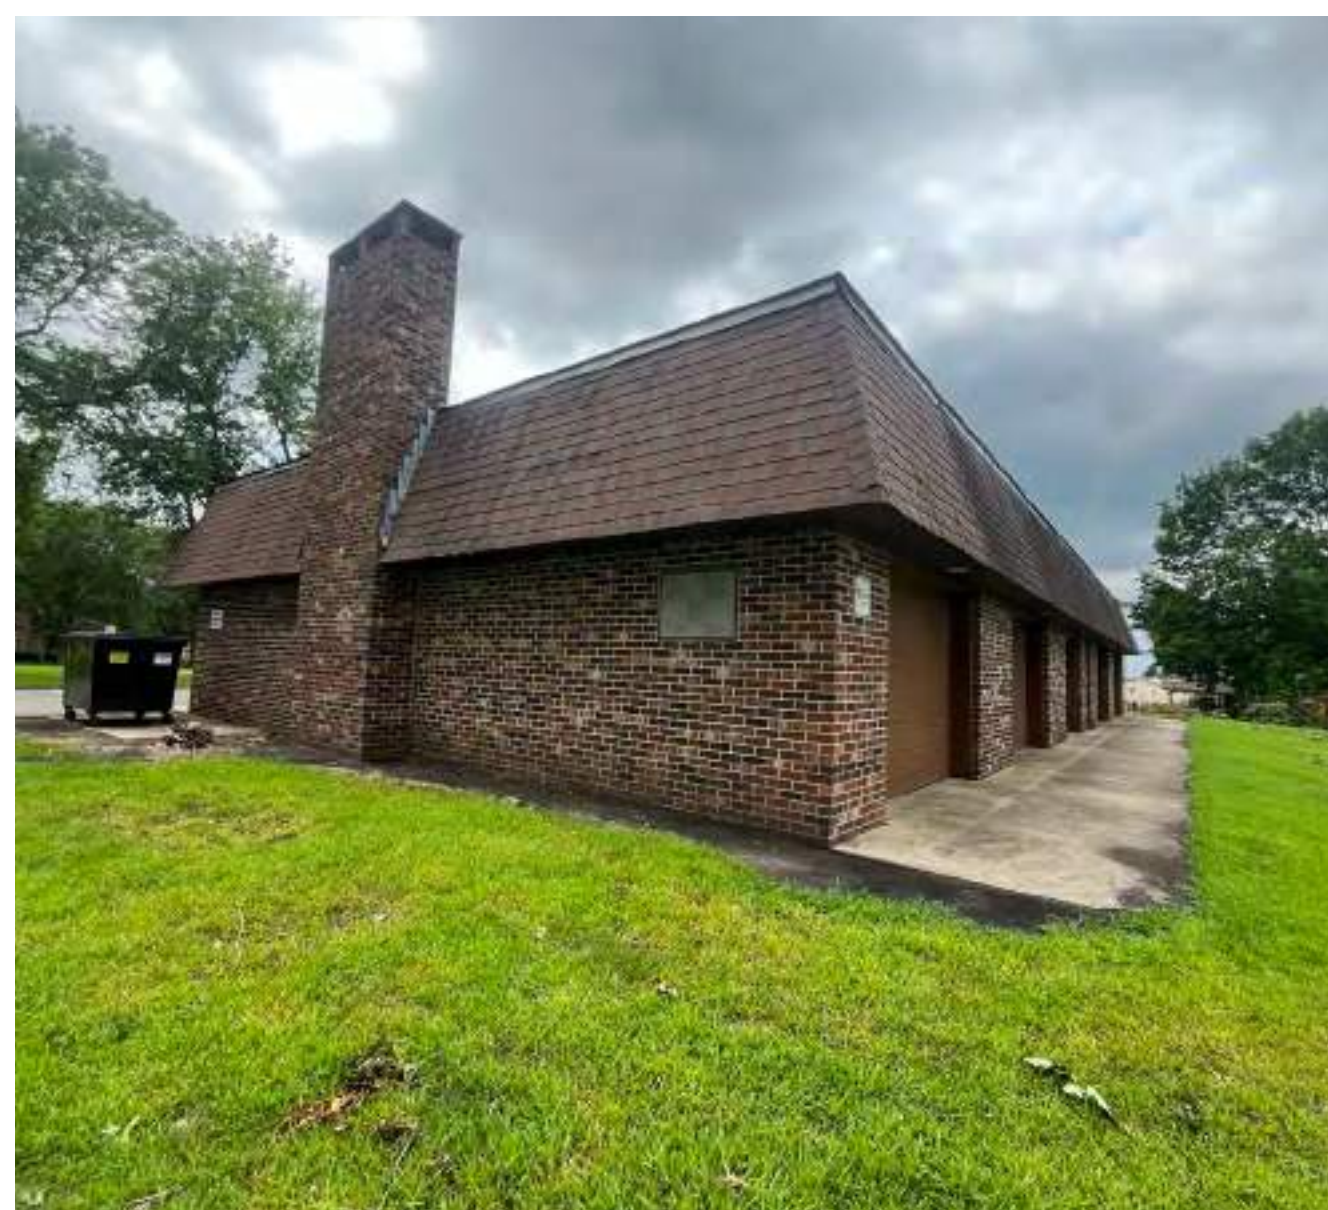
MULTI-USE SHELTER

- Shingles are missing in several areas, and some remaining shingles show noticeable discoloration.
- The chimney is missing flashing on one side.
- Gutters are incomplete, with missing downspouts and one side of the roof lacking gutters entirely.
- Standing water is present in the mechanical area and along sections of the interior walls.
- Brick surfaces show discoloration consistent with water damage.
- Lighting fixtures appear outdated.
- Door hardware is non-compliant with current accessibility standards.
- The building lacks code-compliant egress doors.
- Building contains two functional event spaces.
- Restrooms recently renovated and in excellent condition.
