# City Park Master Plan

CITY OF SHELDON, IOWA

CITY COUNCIL PRESENTATION - DECEMBER 3, 2025

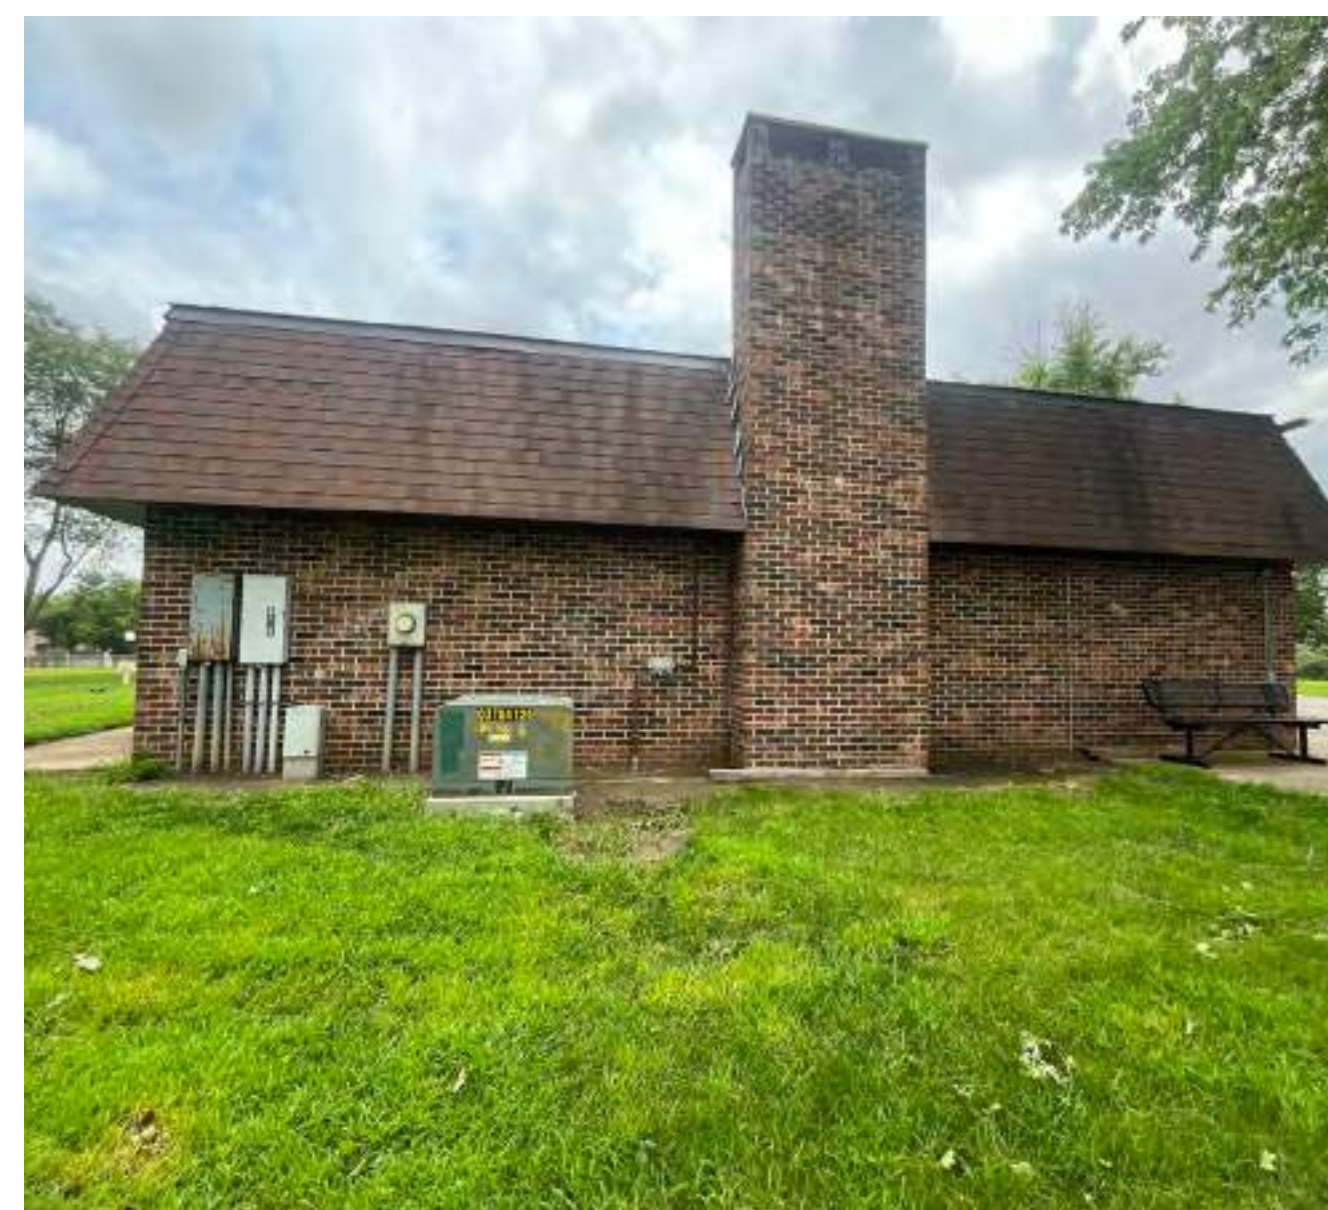
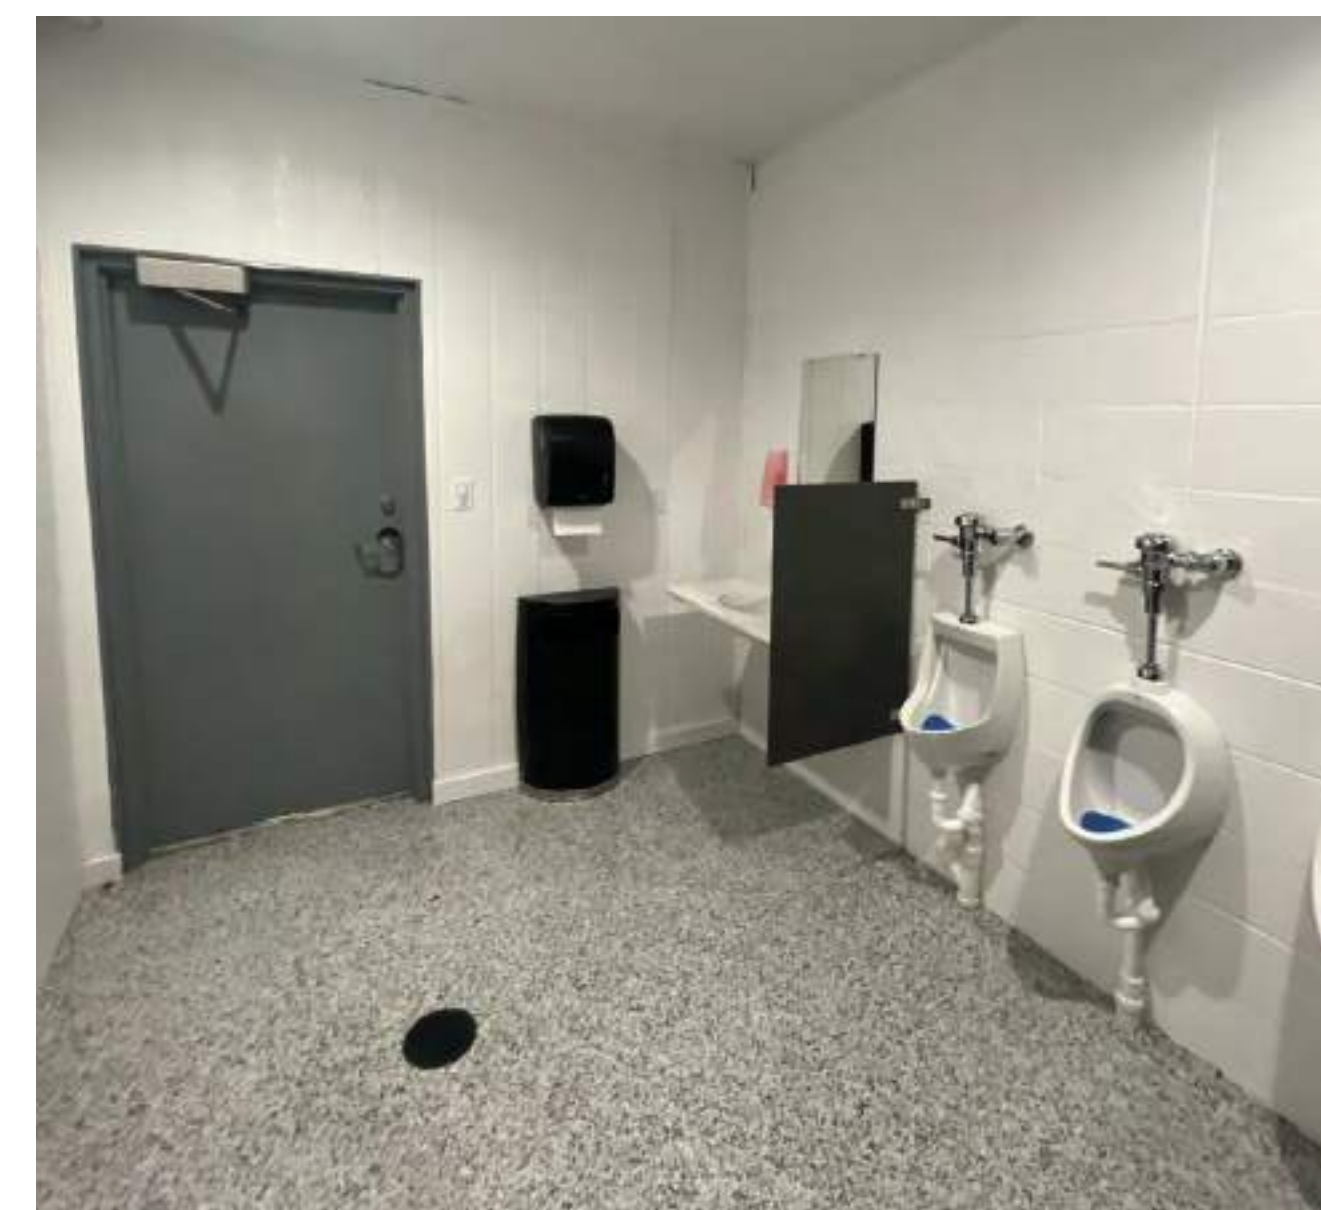
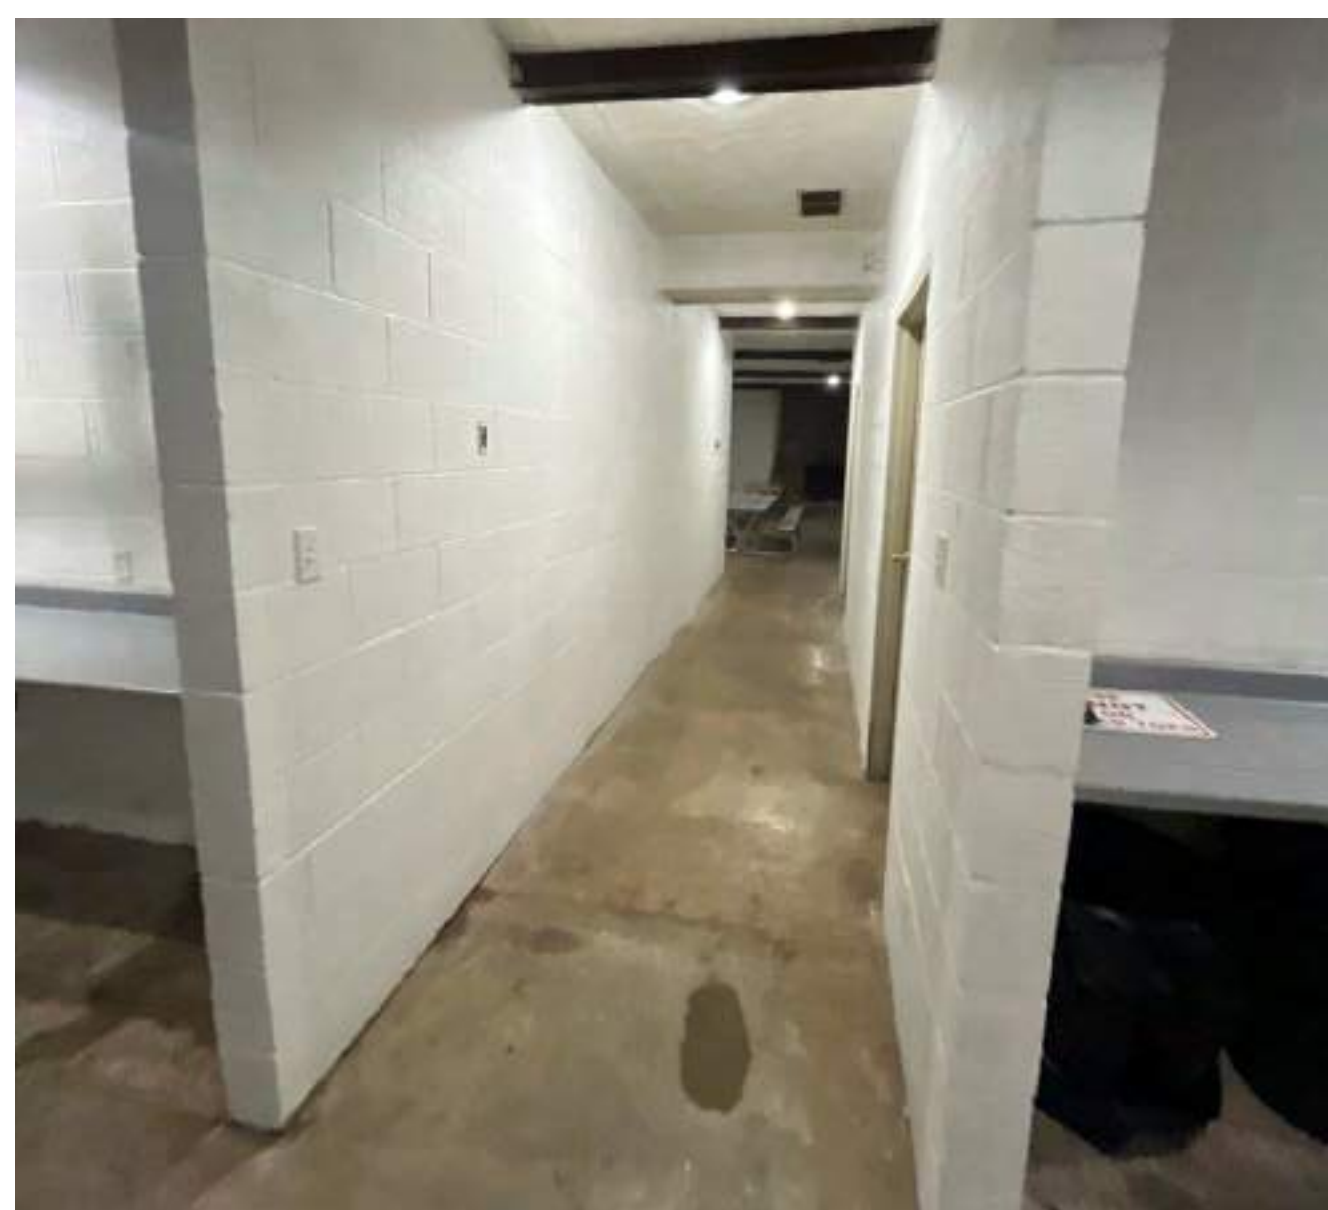
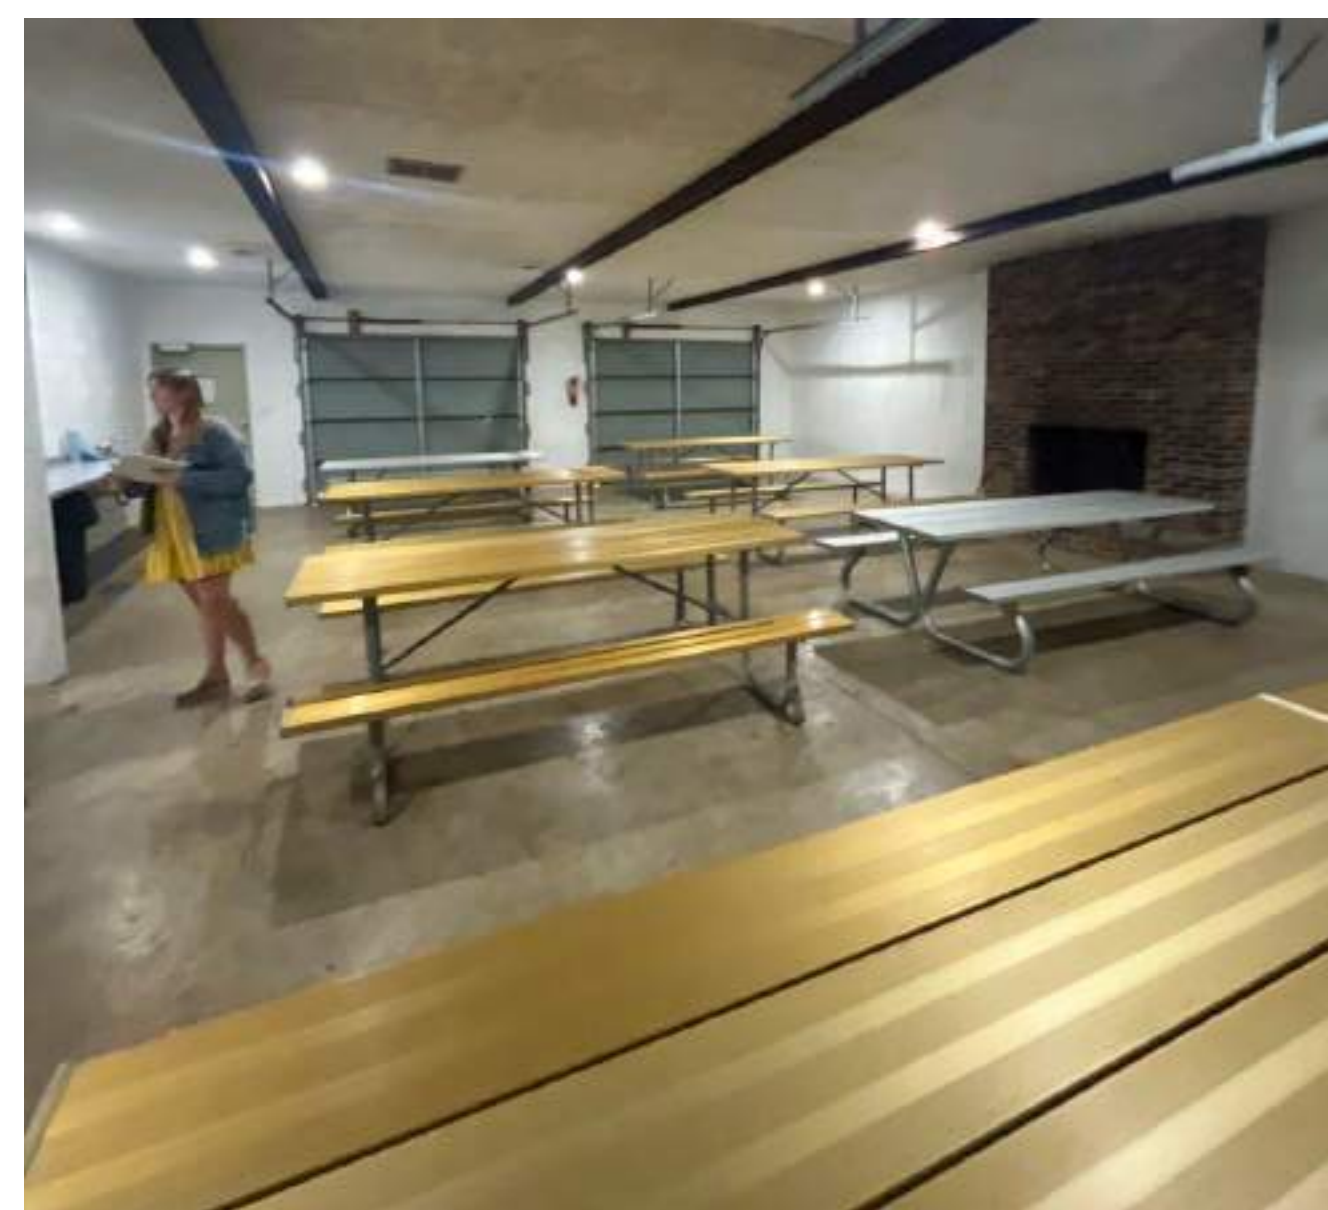
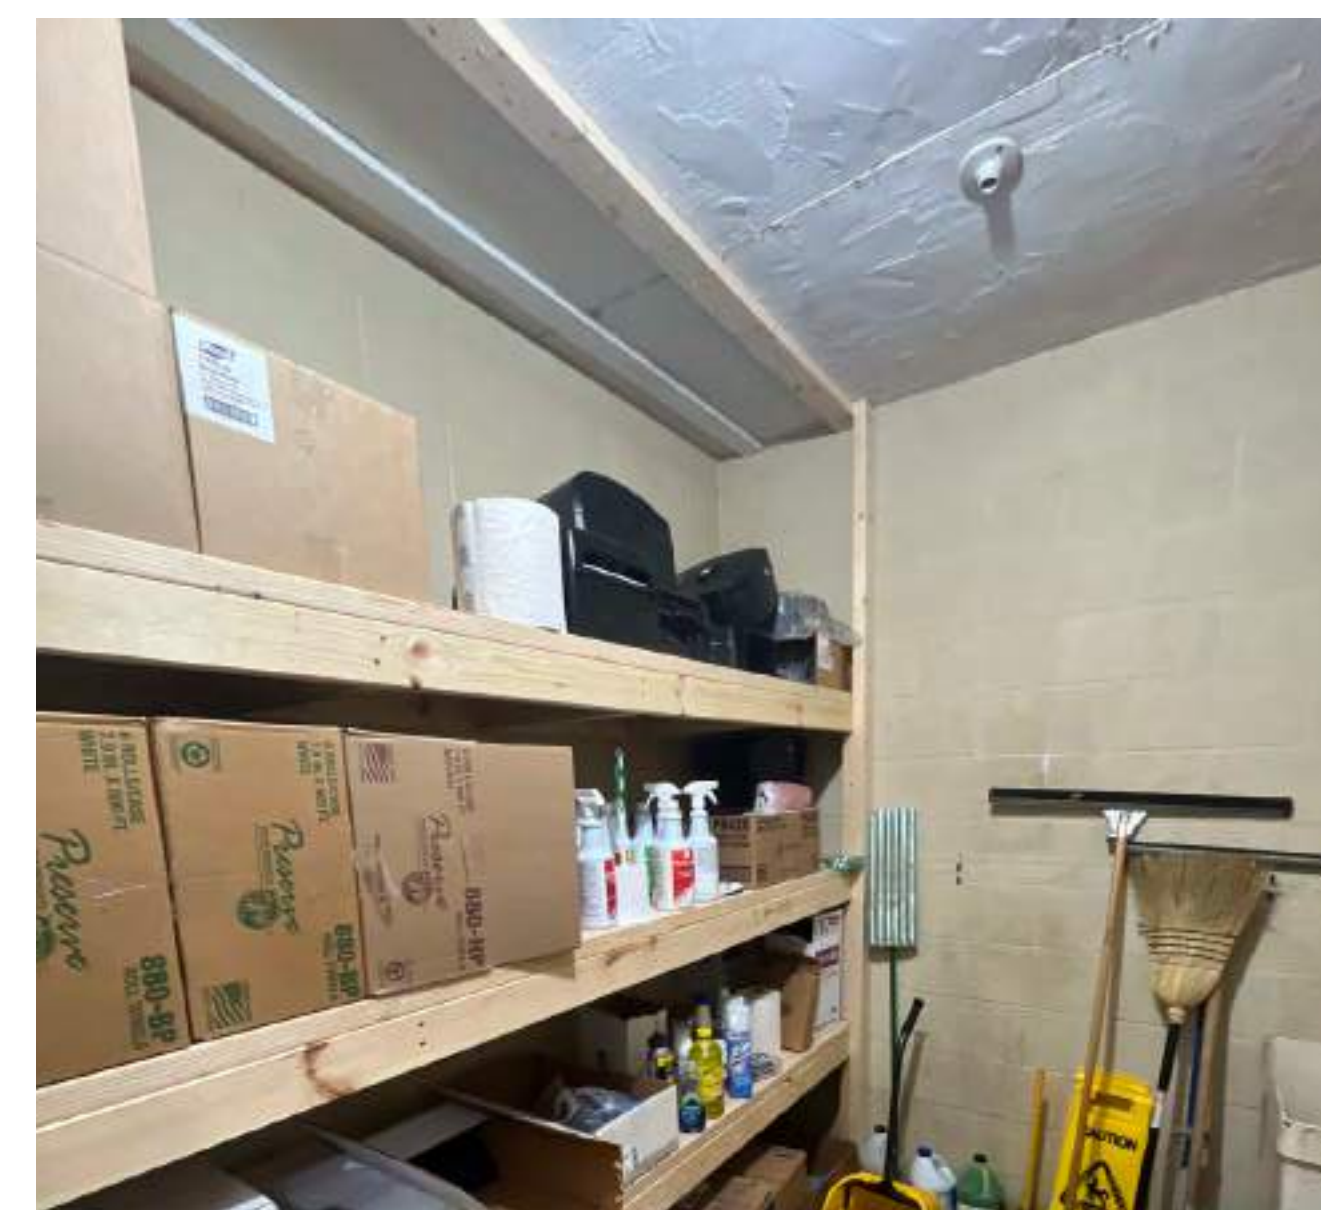
- Shingles are missing in several areas, and some remaining shingles show noticeable discoloration.
- The chimney is missing flashing on one side.
- Gutters are incomplete, with missing downspouts and one side of the roof lacking gutters entirely.
- Standing water is present in the mechanical area and along sections of the interior walls.
- Brick surfaces show discoloration consistent with water damage.
- Lighting fixtures appear outdated.
- Door hardware is non-compliant with current accessibility standards.
- The building lacks code-compliant egress doors.
- Building contains two functional event spaces.
- Restrooms recently renovated and in excellent condition.

- Serving as a gathering space and a venue for community events, the multi-use shelter is in mostly good condition. While the restrooms have been recently renovated, the remainder of the facility has not received significant upgrades. The building materials show signs of aging; however, the overall structure appears to remain sound and in good condition.

- Remove and replace shingles and chimney flashing.
- Remove and replace gutters.
- Update light fixtures.
- Install ADA and code compliant egress doors and door hardware.
- Update overhead doors with windows in door panel.
- Replace weather stripping on bottom of overhead doors.

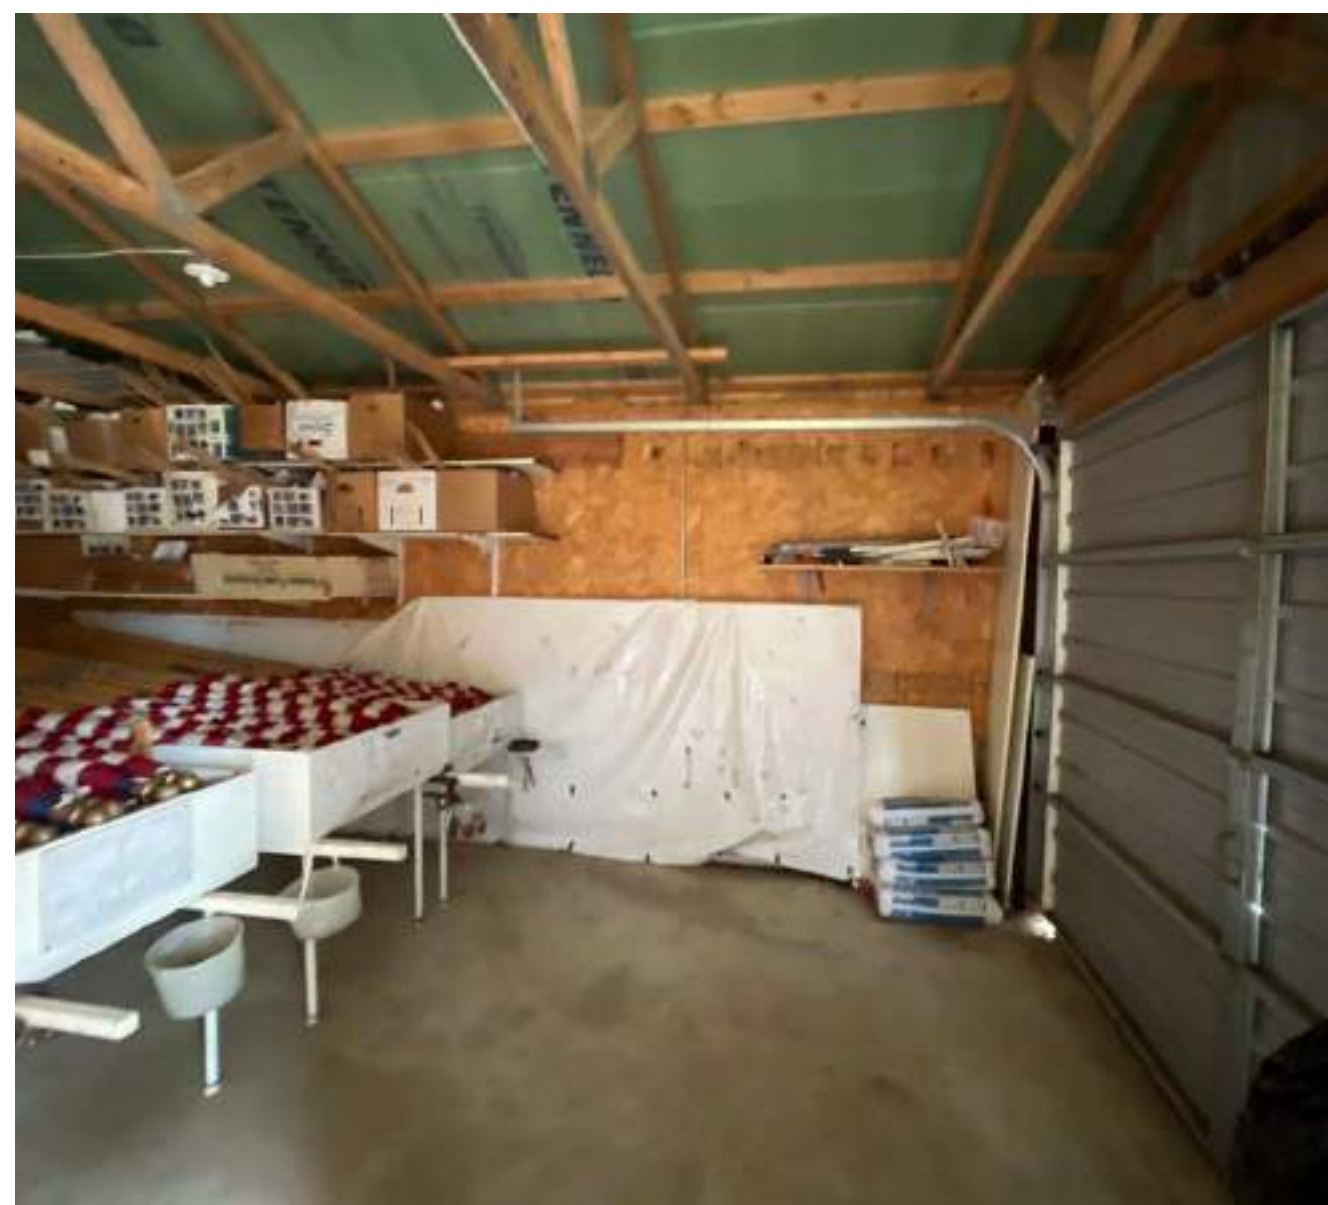
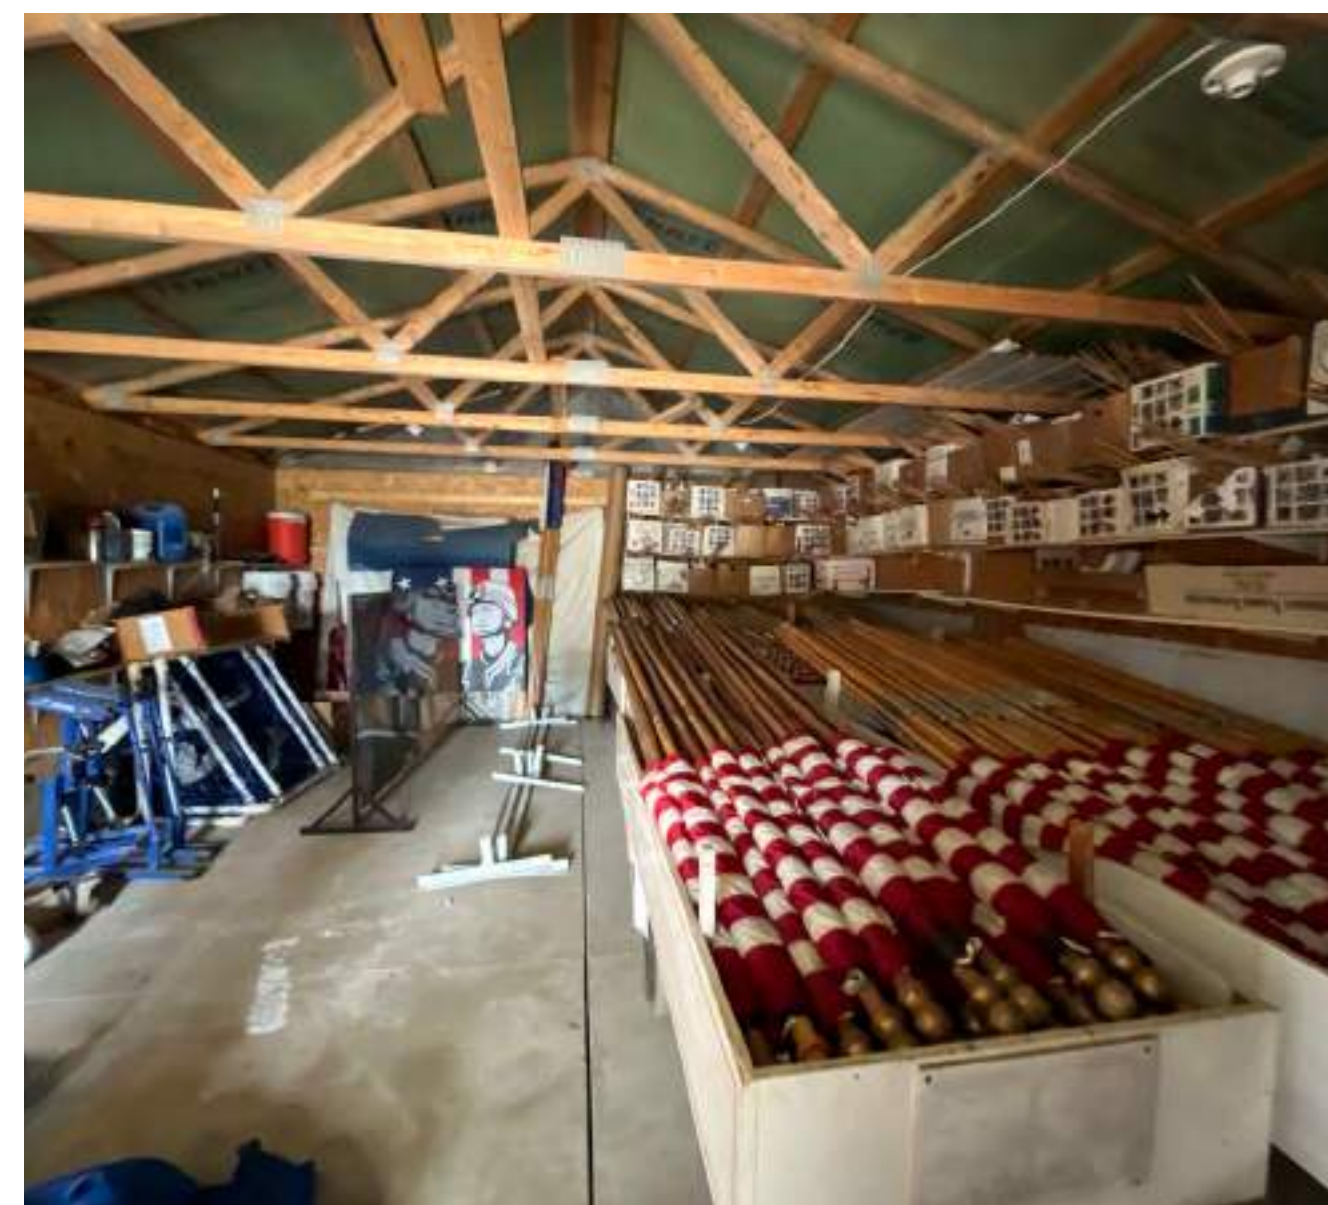
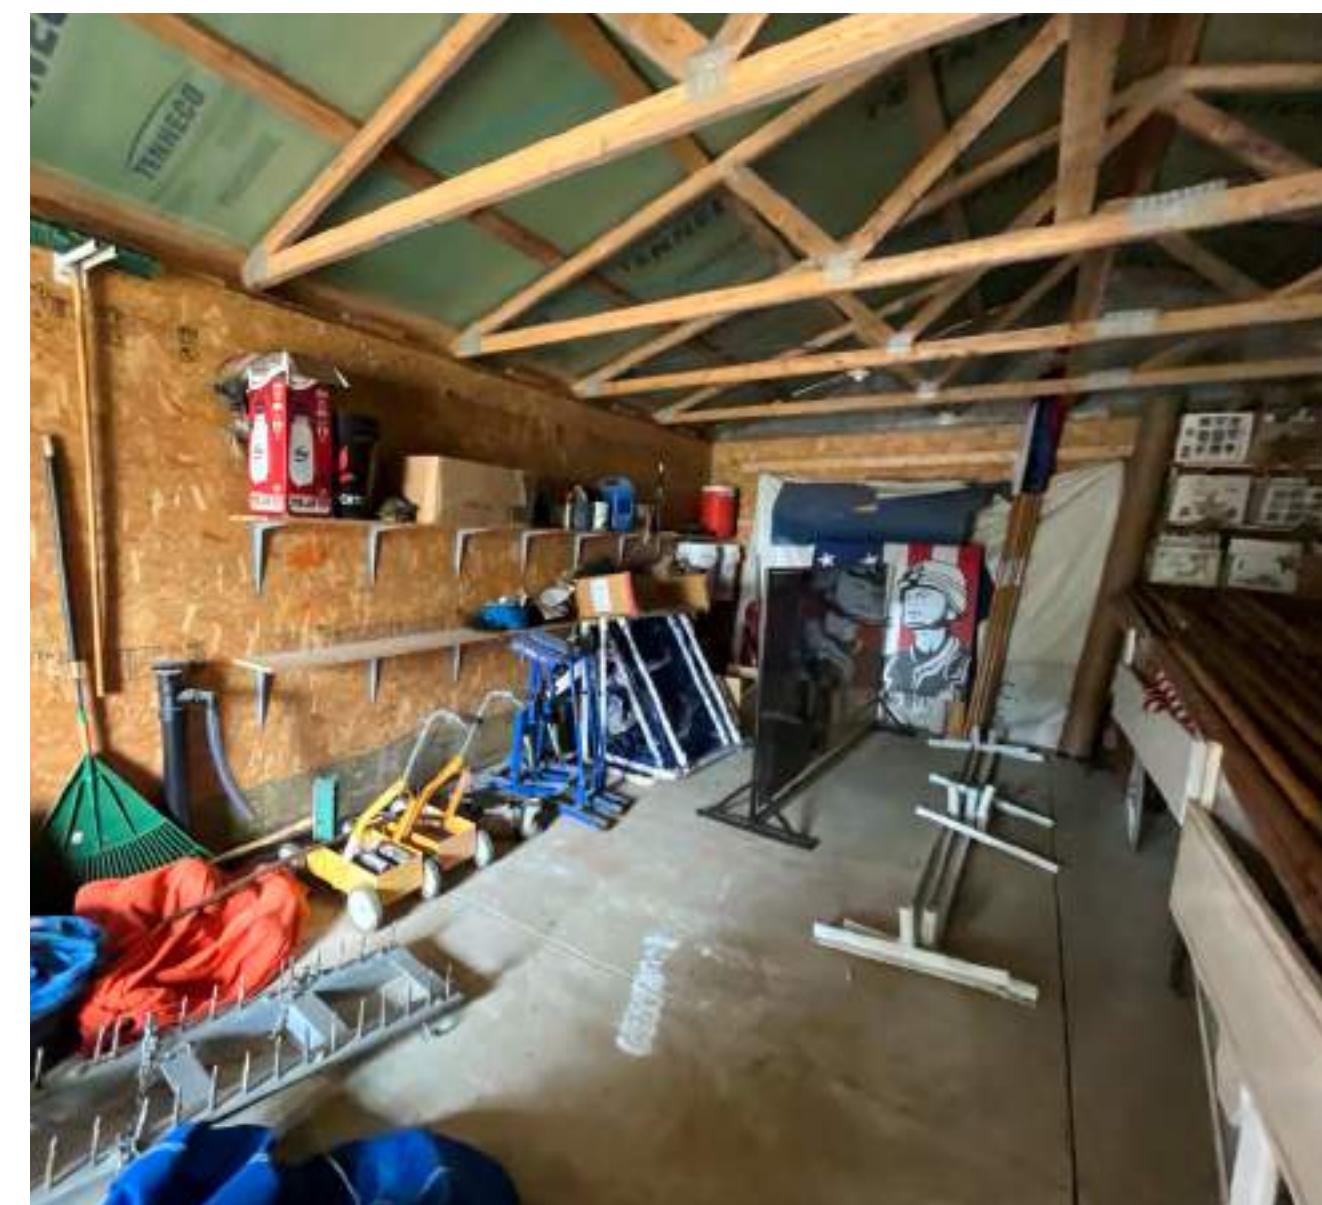
- Aging trim along door.
- Minor damage to exterior metal panels.
- Primarily used for storage.
- Required to hop a curb at driveway entrance.
- Building interior in good condition.

- The West Garage is in good condition and is used mainly as storage for holiday and seasonal items.

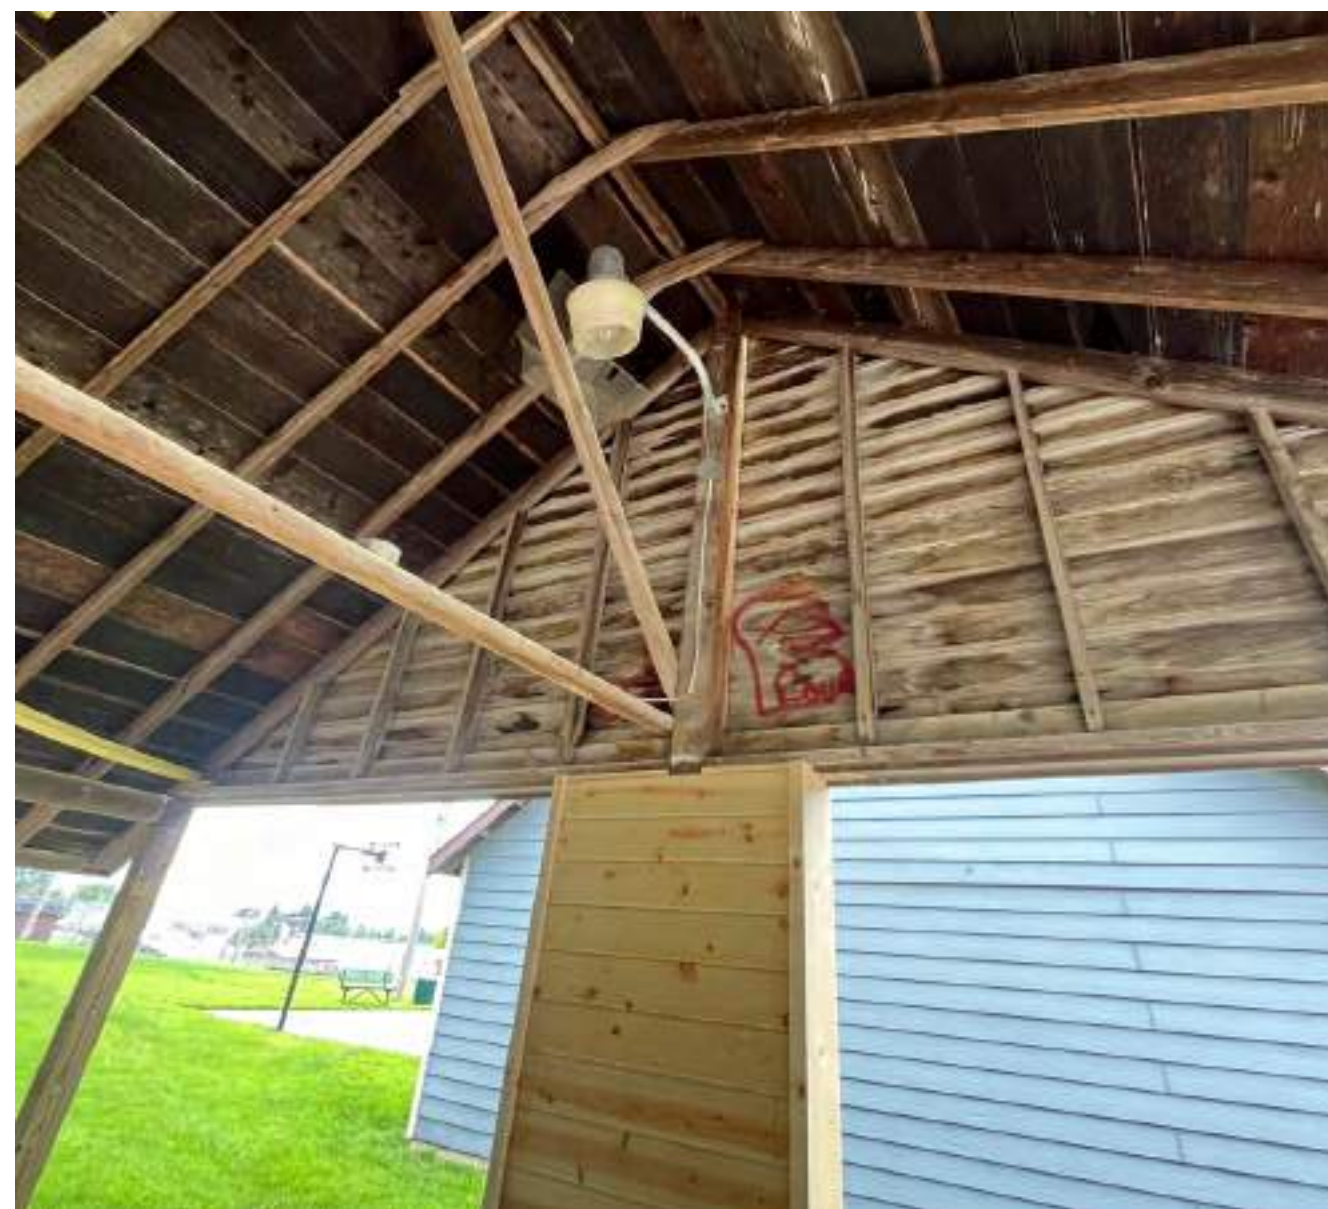
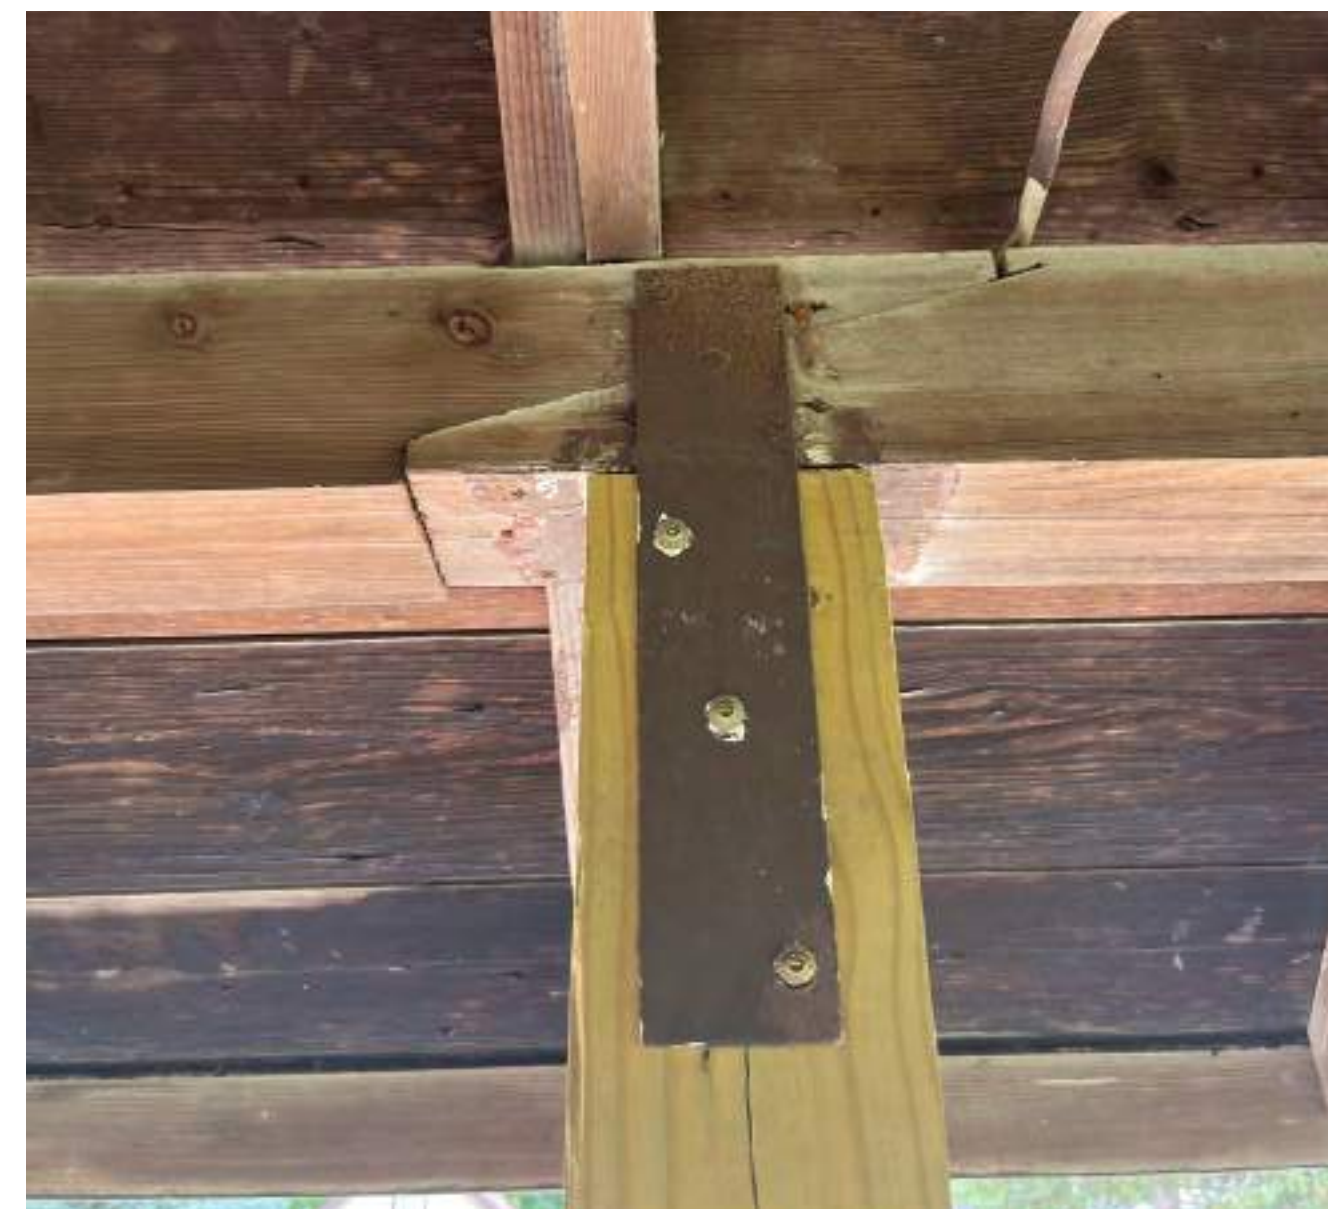
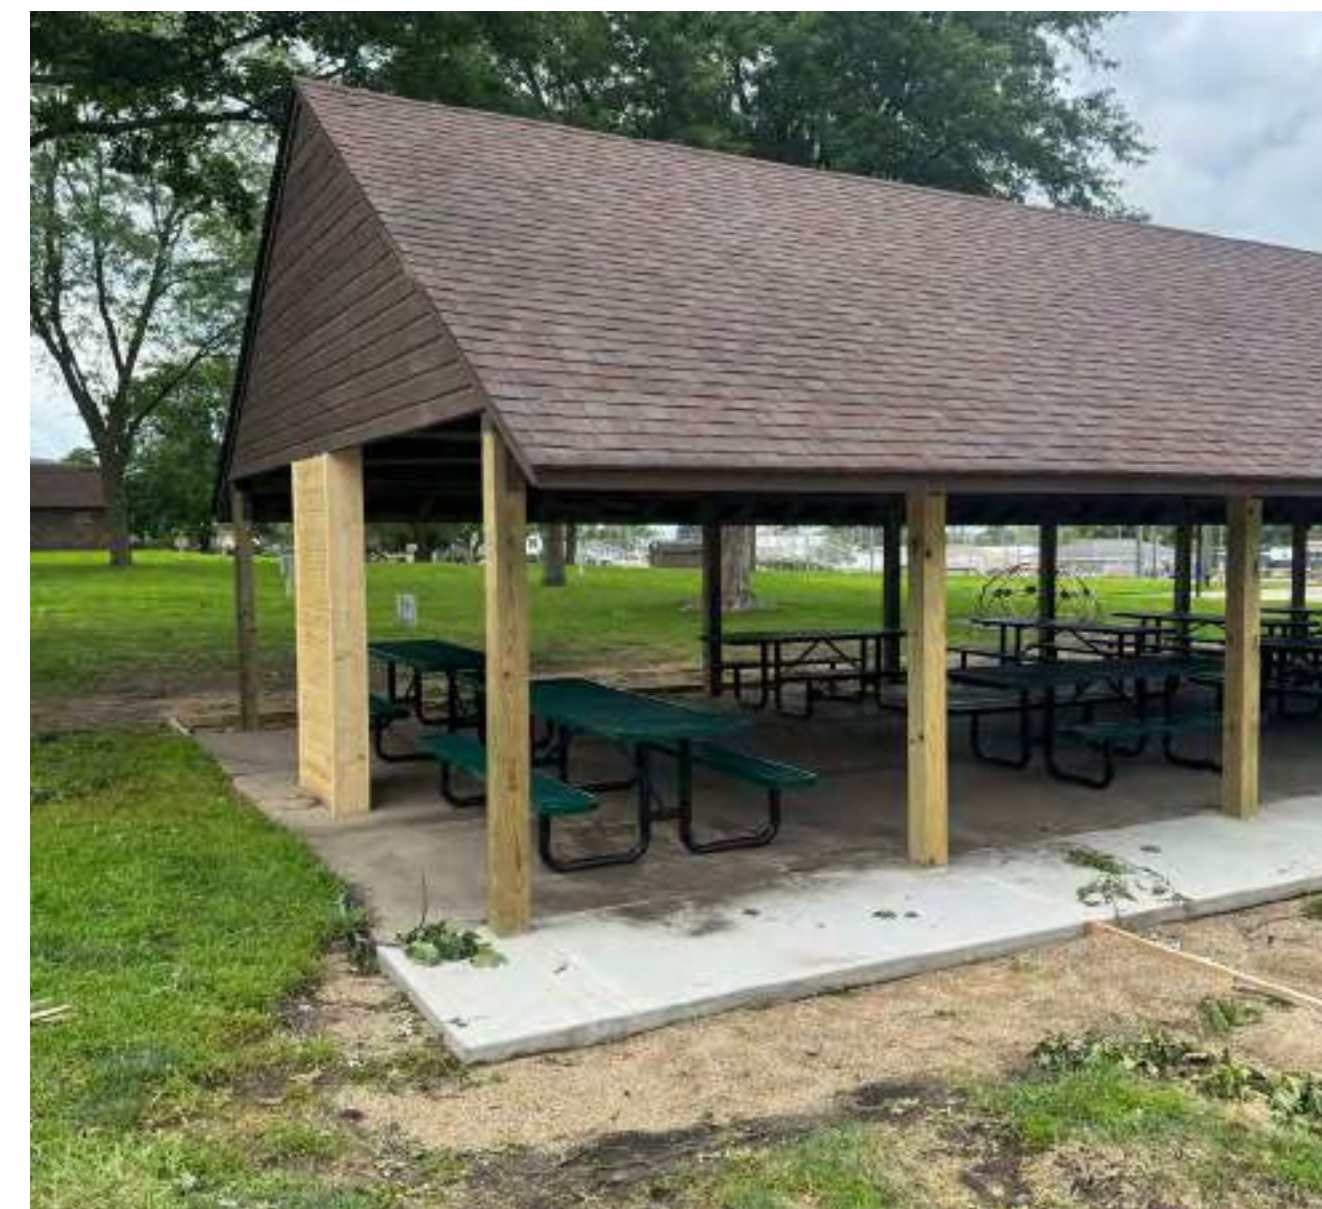
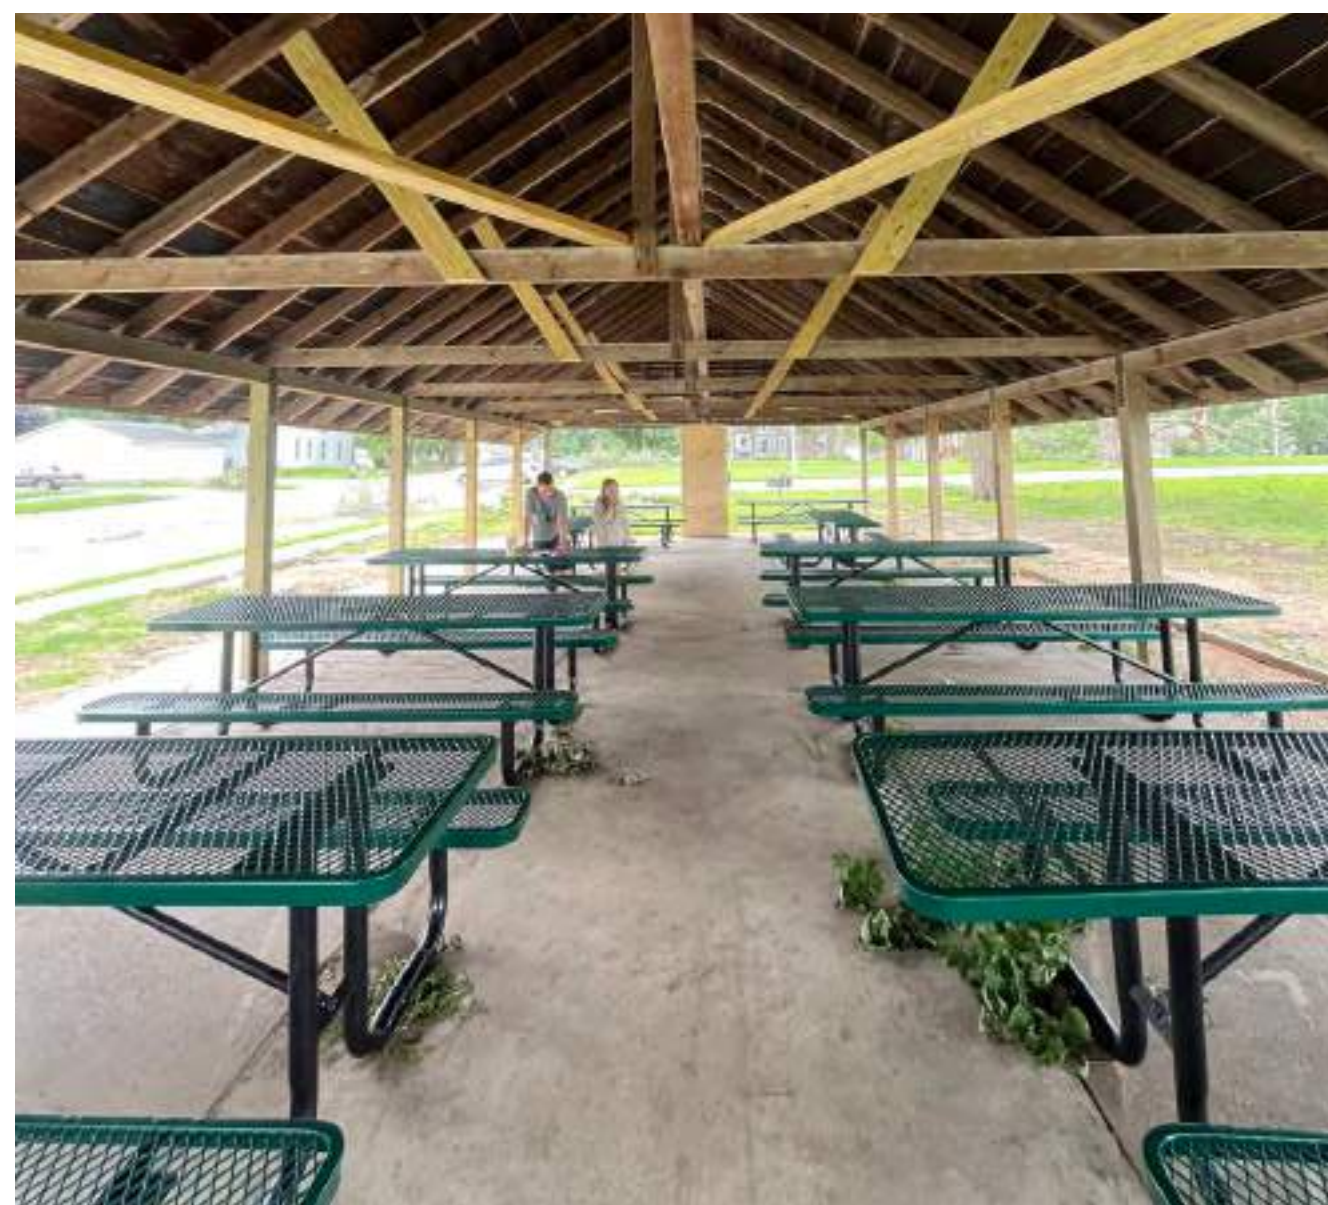
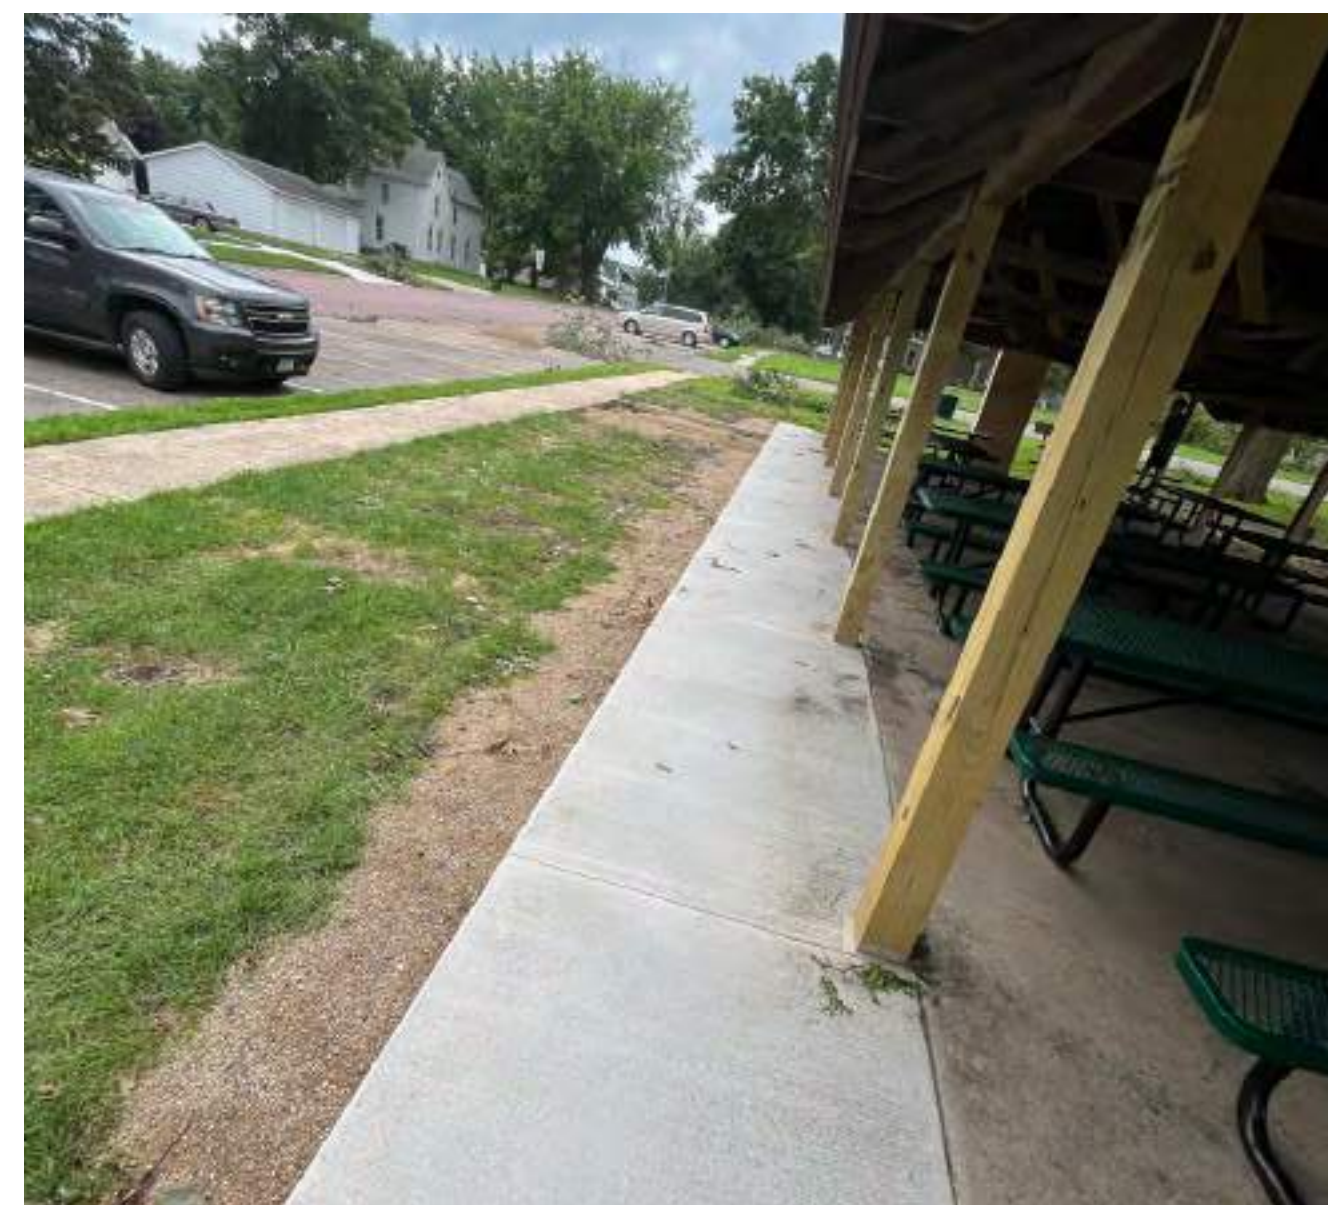
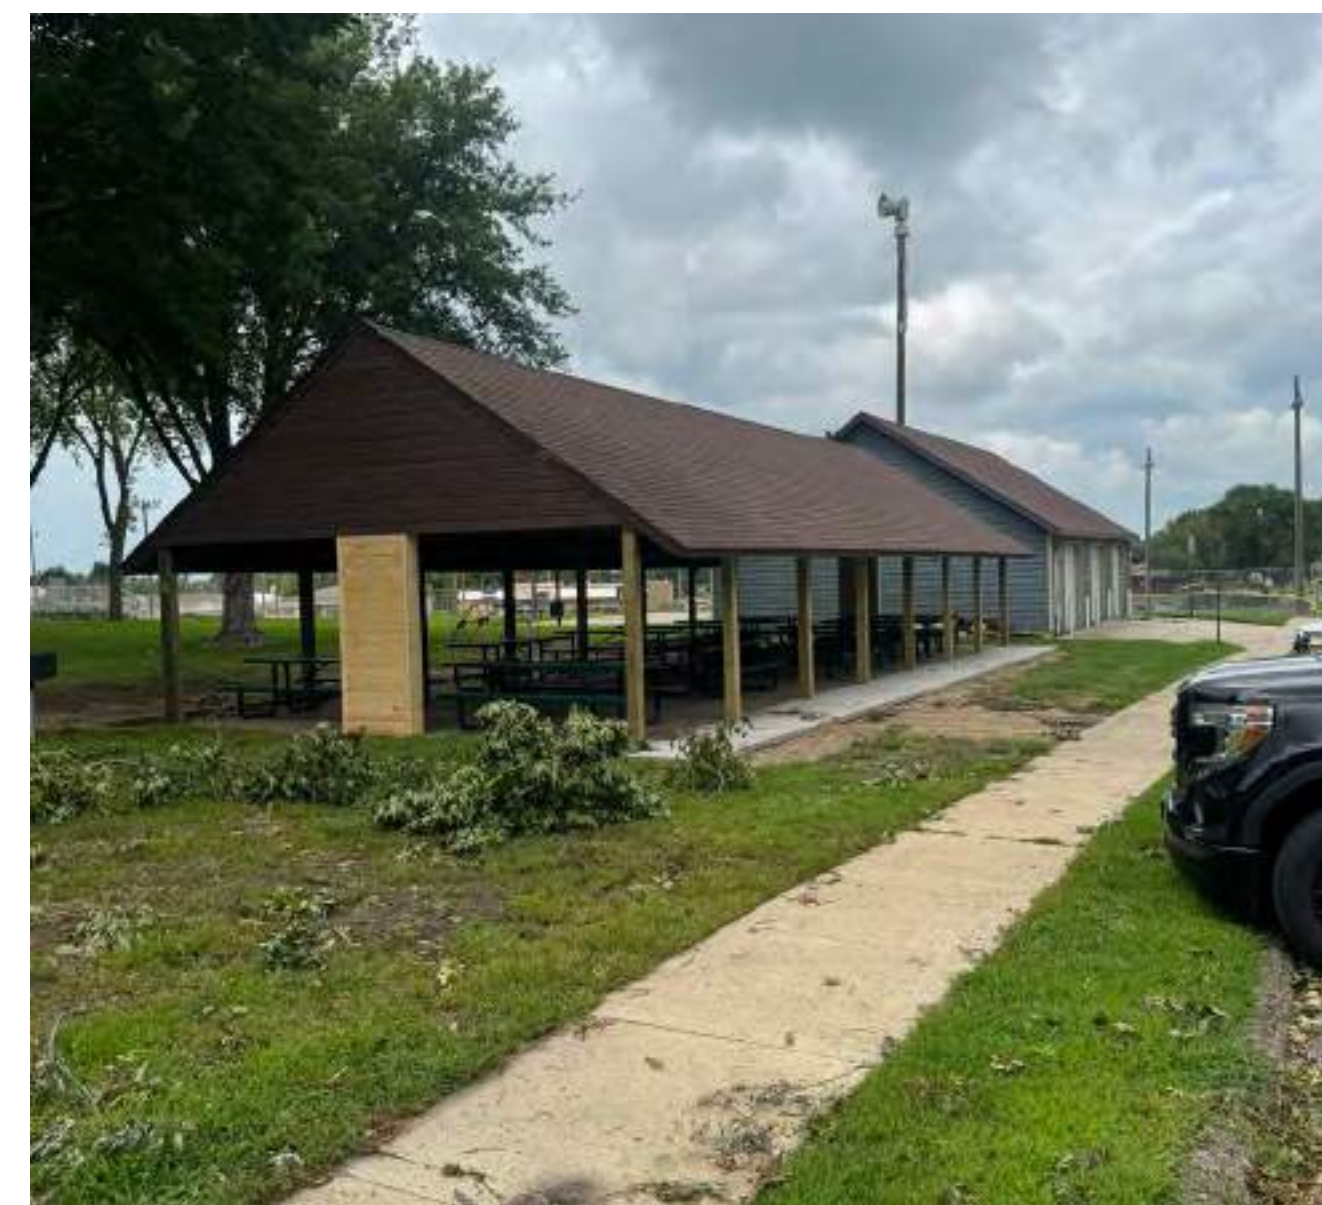
- Exposed wire connection near lights can pose safety issues.
- Siding and framing are heavily weathered and aged.
- Added structure built from weathered wood.
- Low roof overhang (does not meet ADA head height).
- Outdated lighting throughout.
- Deteriorating wood connections.
- Kids climbing into structure using tables poses safety issues.
- Not currently accessible.
- Currently undergoing sidewalk upgrades around the perimeter.
- Currently undergoing interior upgrades in the north and south ends.
- Shelter house contains a large quantity of benches.
- Exposed nails on the bottom side of roof can pose safety issues.

- The Shelter House has been functional for a long time but is showing many signs of aging, weathering, and overall deterioration. The shelter house is still functional as it can provide a shaded seating area out of the sun and protection from rain events. However, the shelter house has many safety risks and concerns such as exposed wiring, nails, and access into the trusses due to a low roof height. The repairs underway are a step in the right direction but further repair or upgrades are needed.
