# City Park Master Plan

CITY OF SHELDON, IOWA

CITY COUNCIL PRESENTATION - DECEMBER 3, 2025

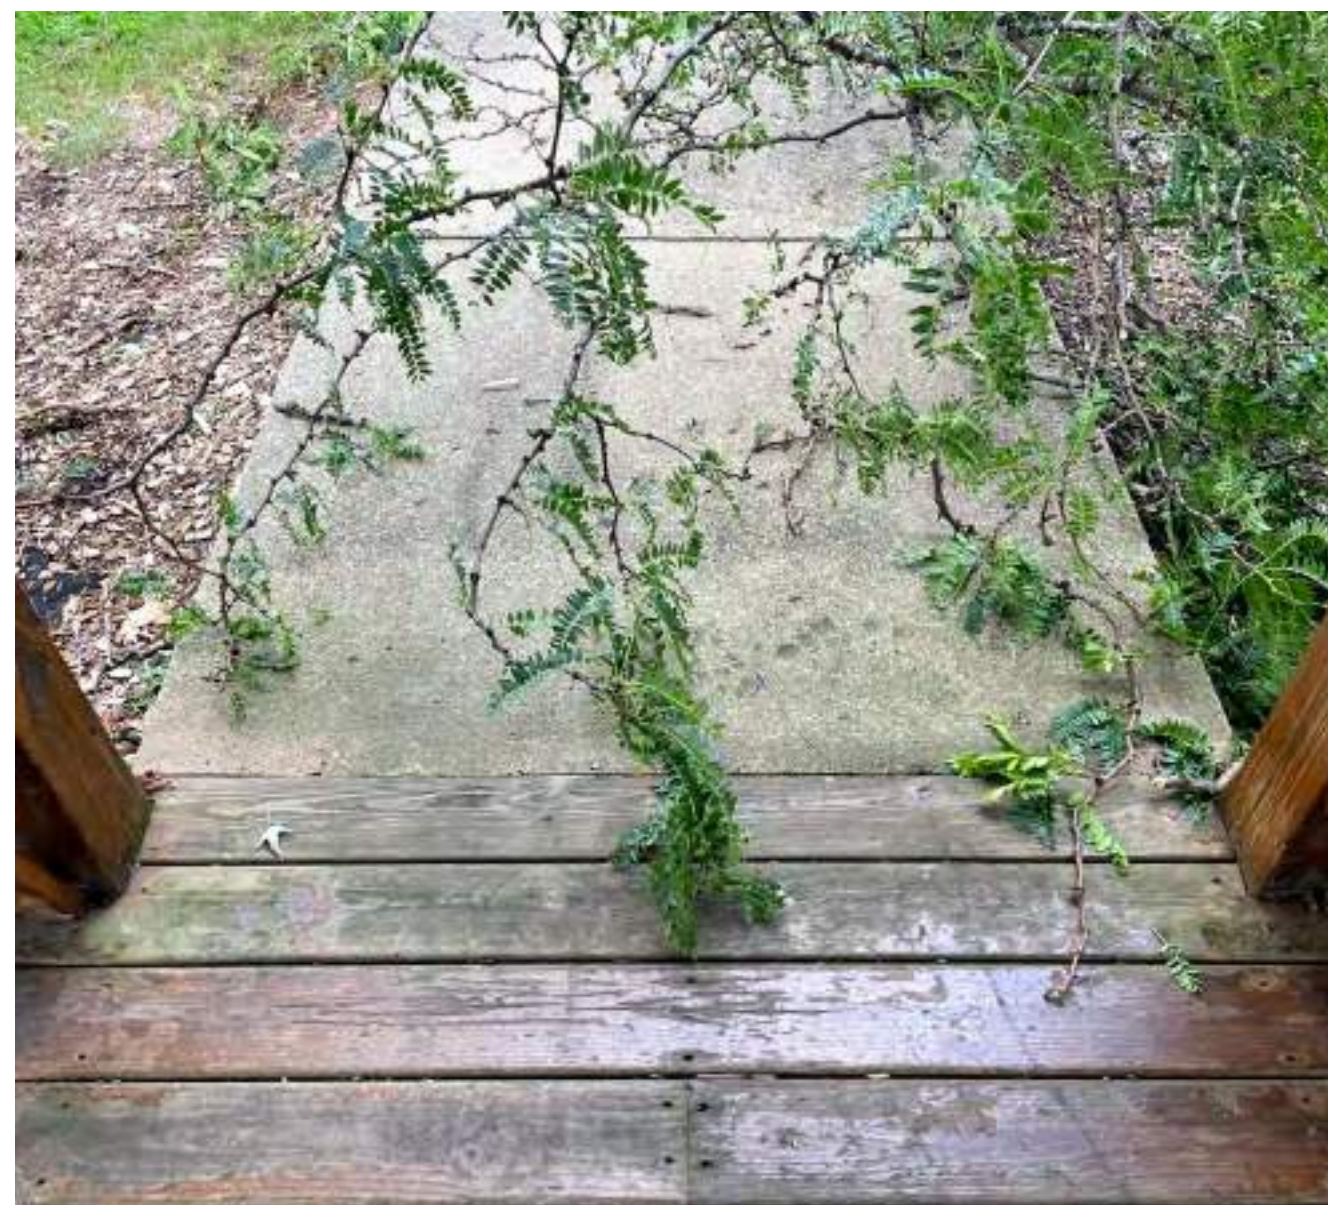
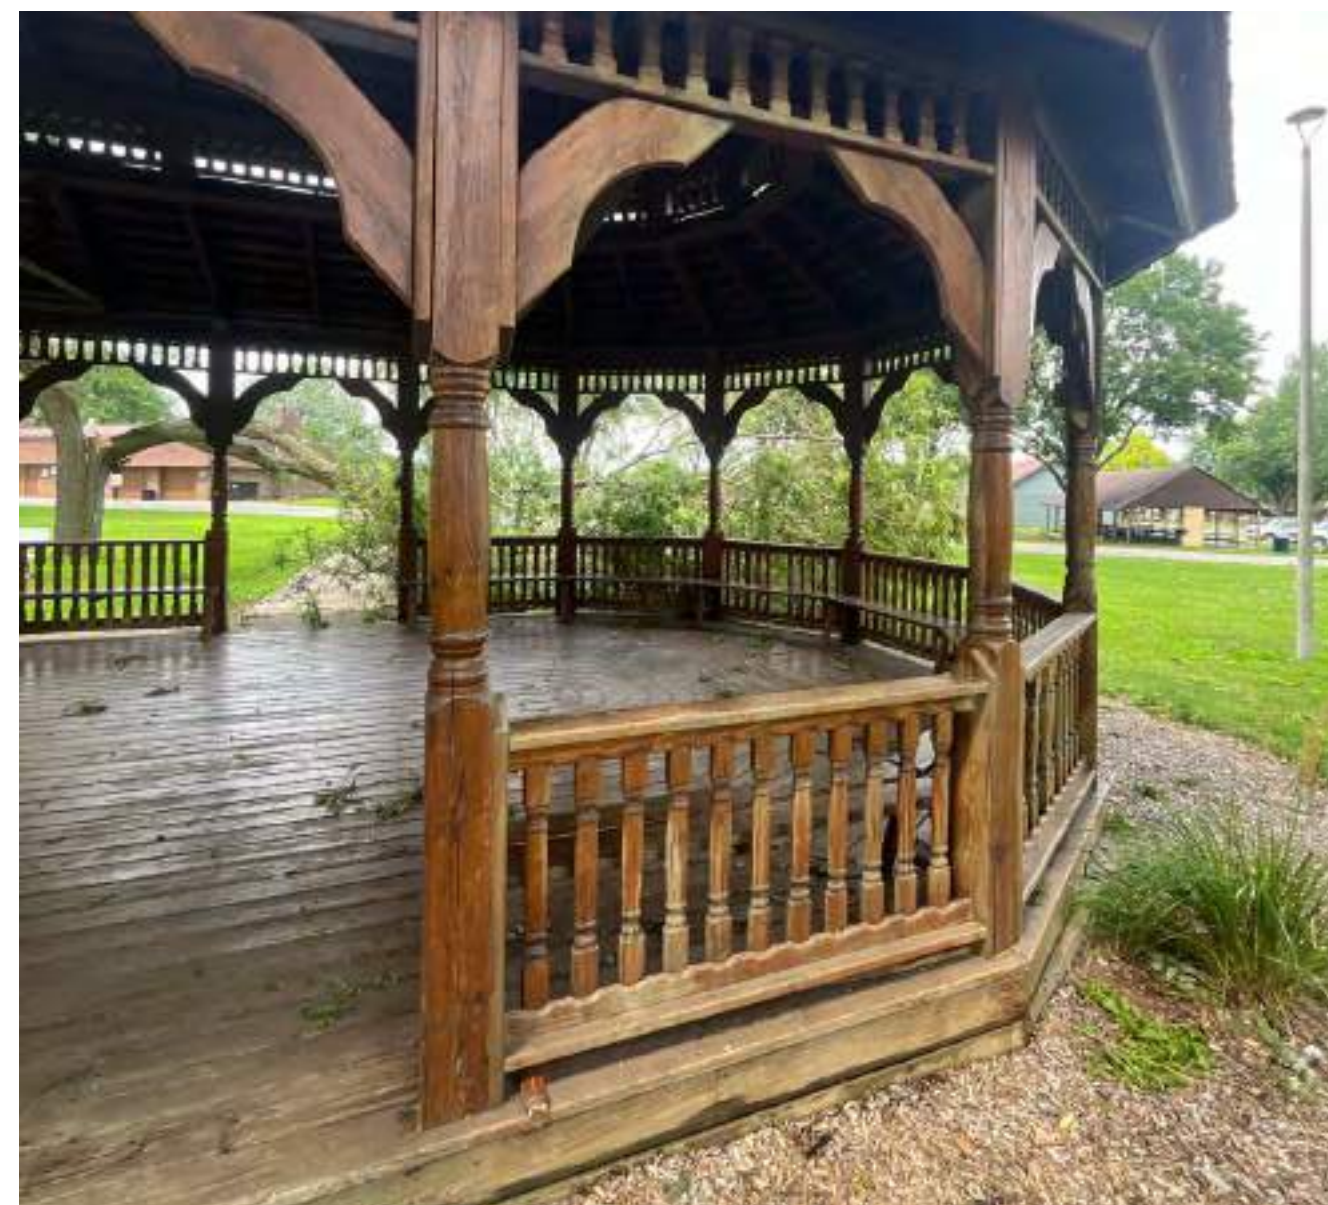
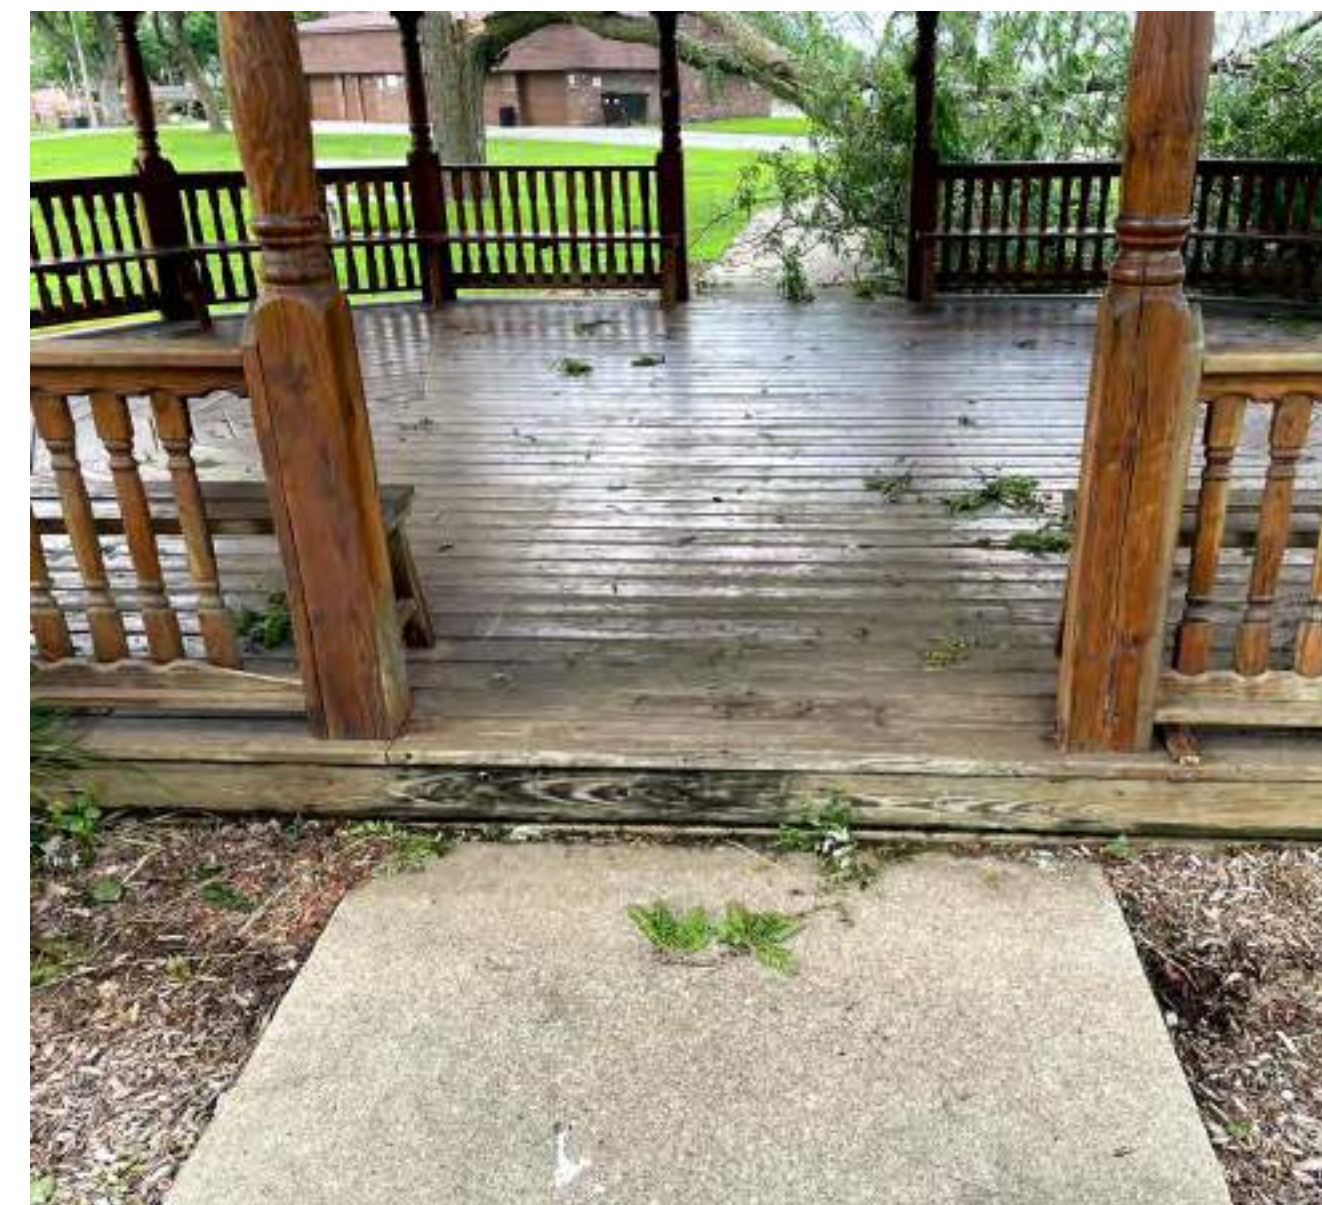
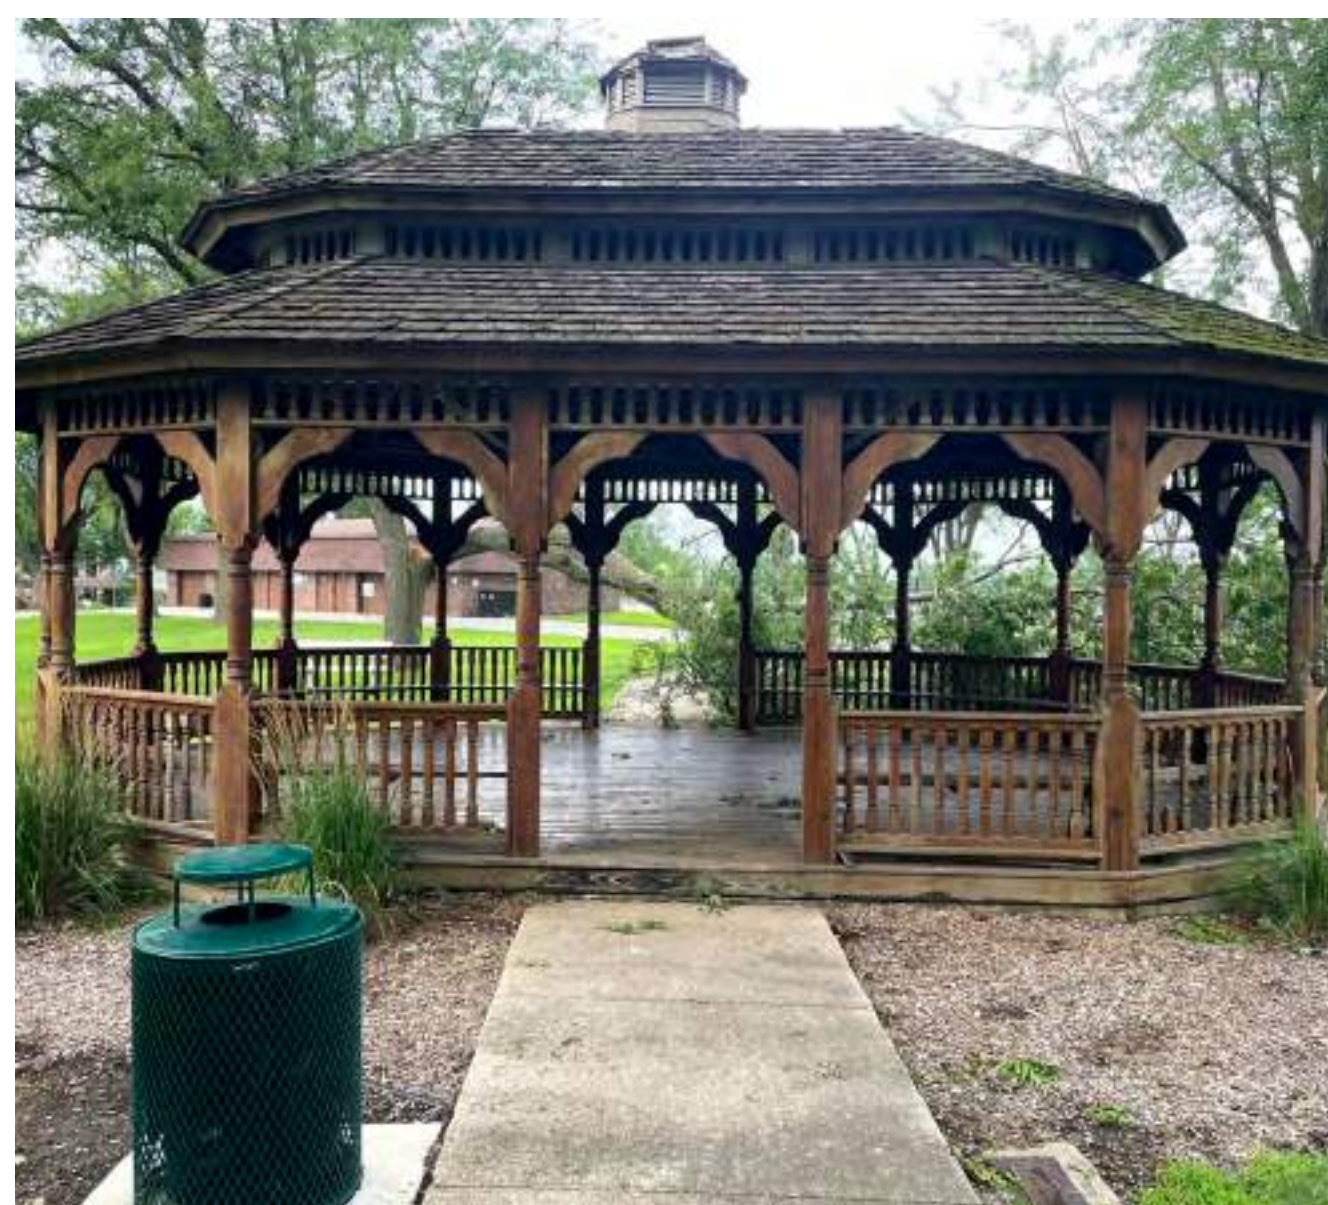
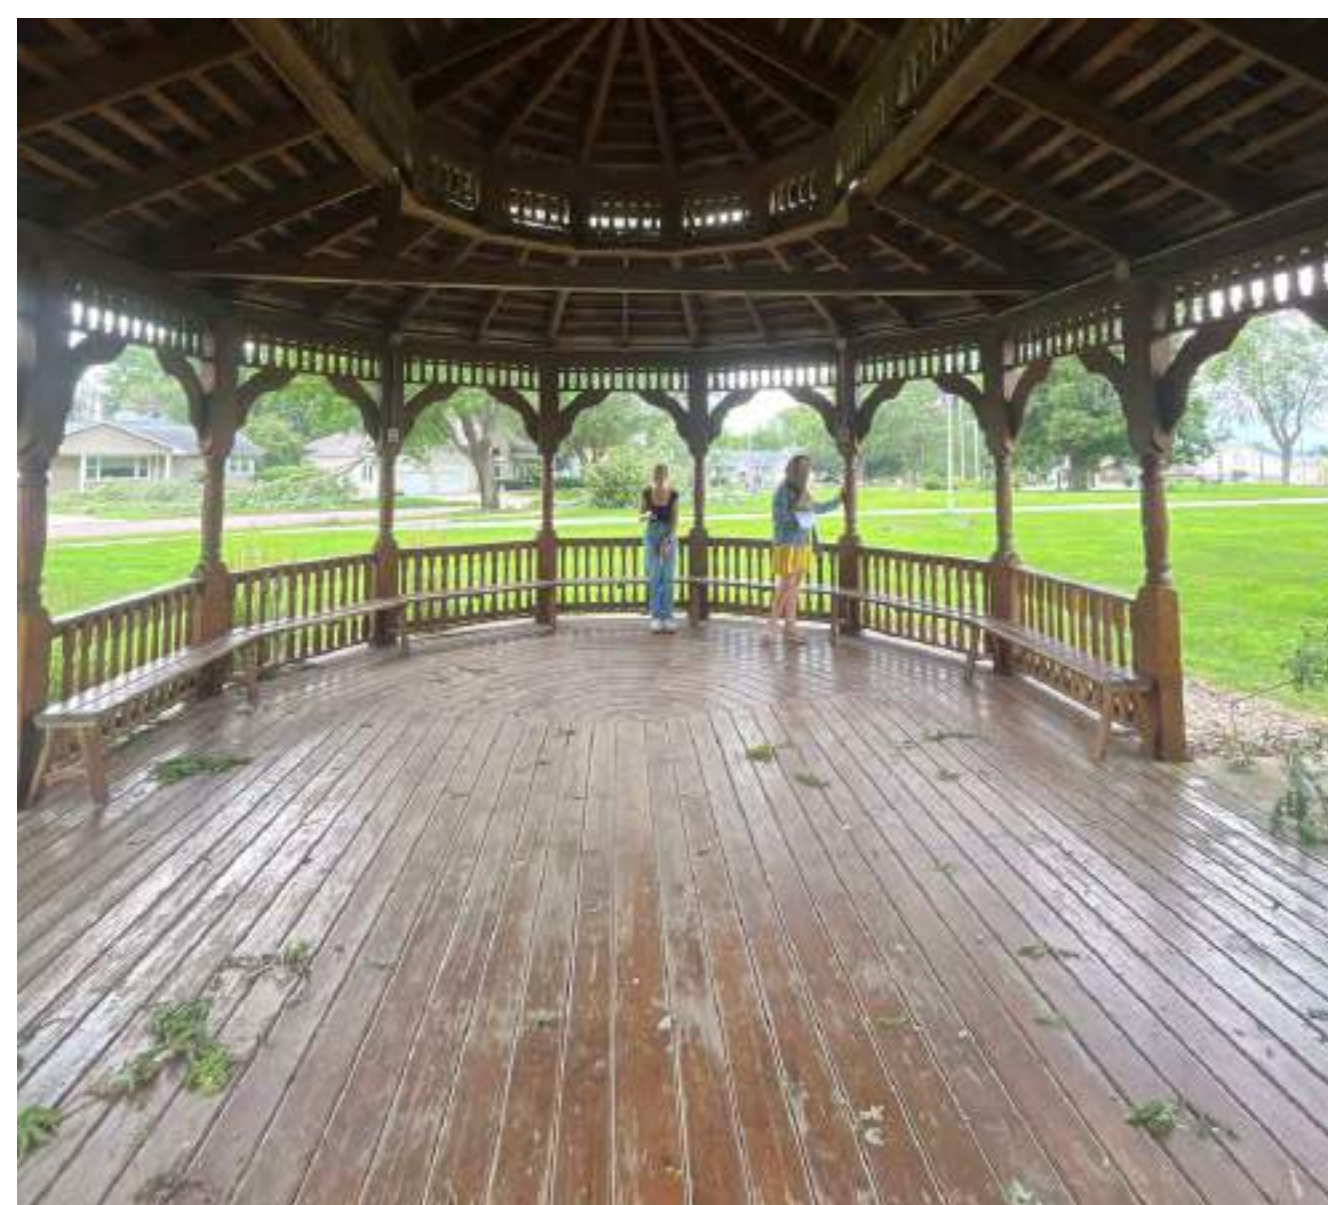
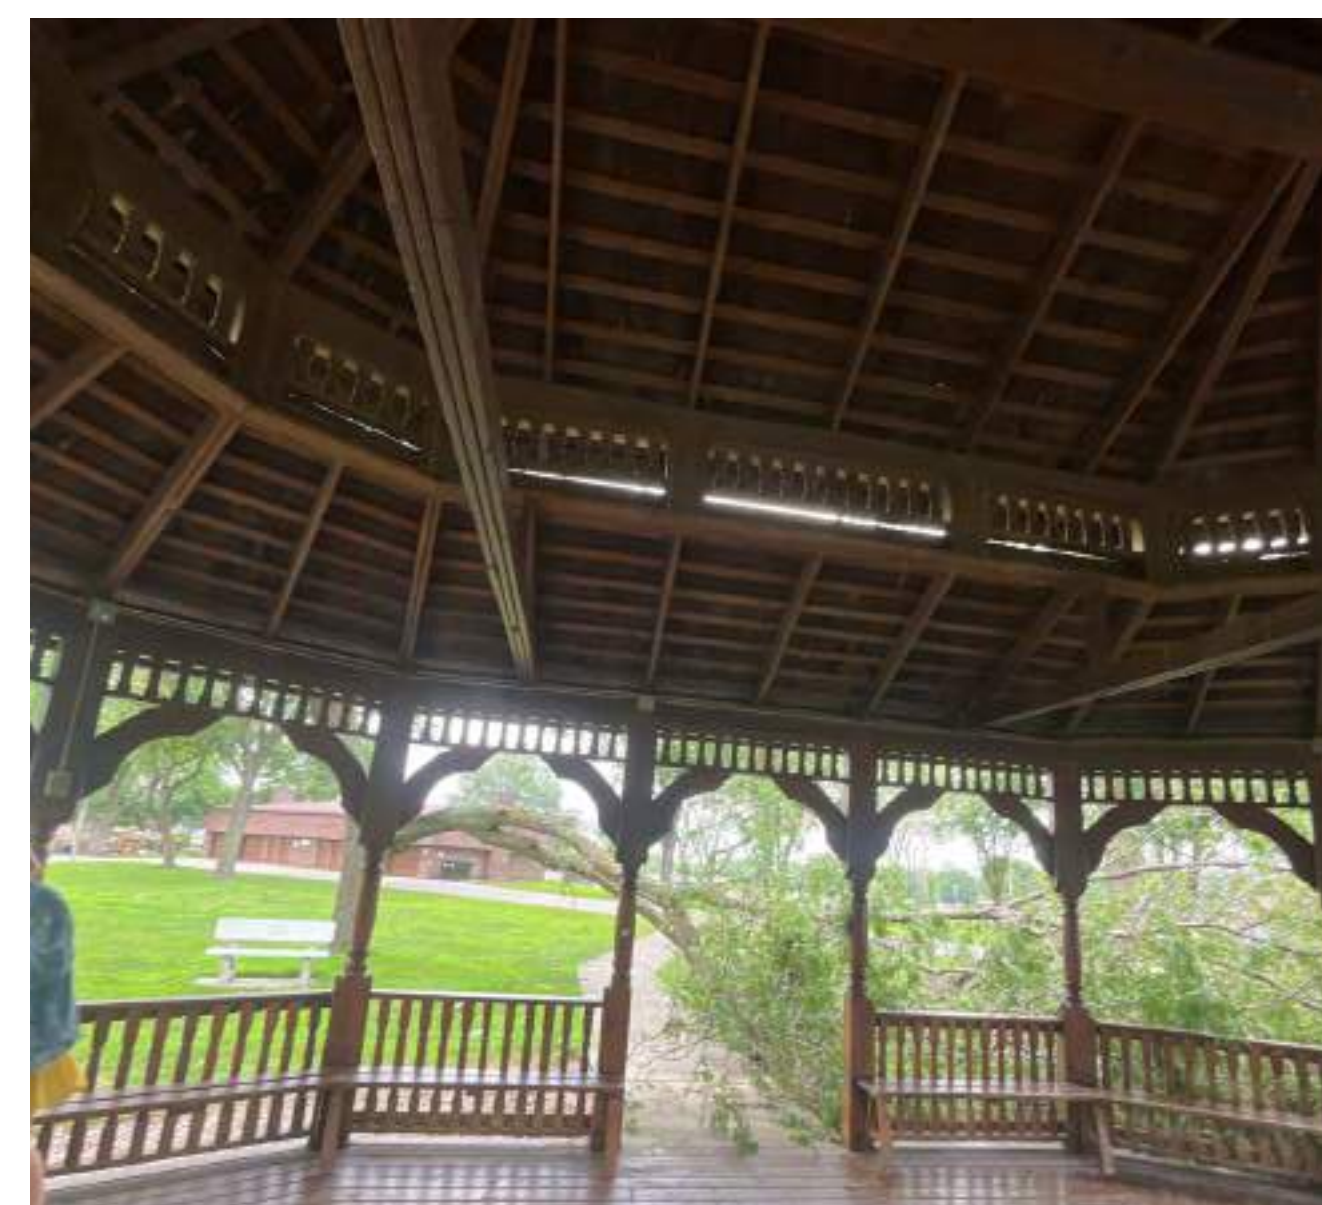
- Cupola missing louvers.
- Shakes in poor condition with excessive moss buildup.
- Missing balusters along the bottom railing.
- Rotting is present around the wood at the base of the gazebo.
- Entire structure should be restrained / resealed.
- Structure is ADA accessible on one side but not on the other.
- Structure contains functionable seating on the interior.
- Wood flooring appears to be in fair condition.
- Rock mulch and plantings around the exterior add a nice accent to the gazebo.
- Cupola is in poor condition and may need replacement.

- The gazebo appears to be in fairly good condition but could benefit from upgrades. It still appears solid and functional for its use. A deeper assessment of the structure along with upgrades including staining and sealing could help the gazebo's long-term lifespan and appearance.

- Re-finish and repair cupola, posts and railings.
- Re-seal entire structure.
- Refinish floor.
- Remove and replace wood shakes on roof.

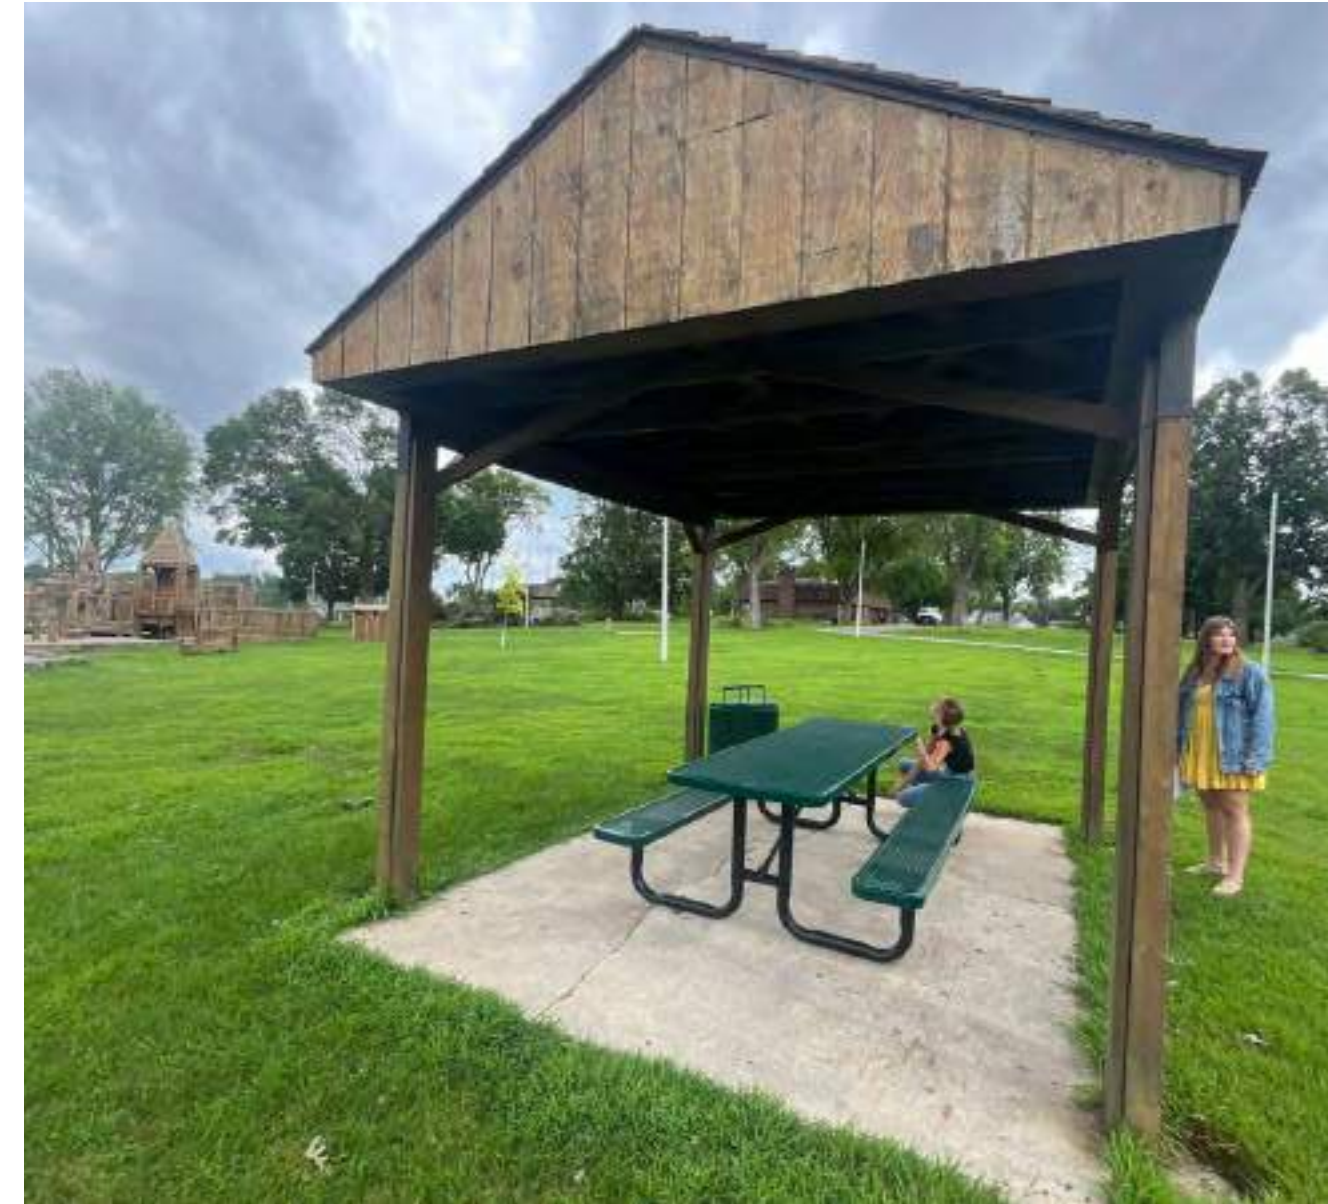
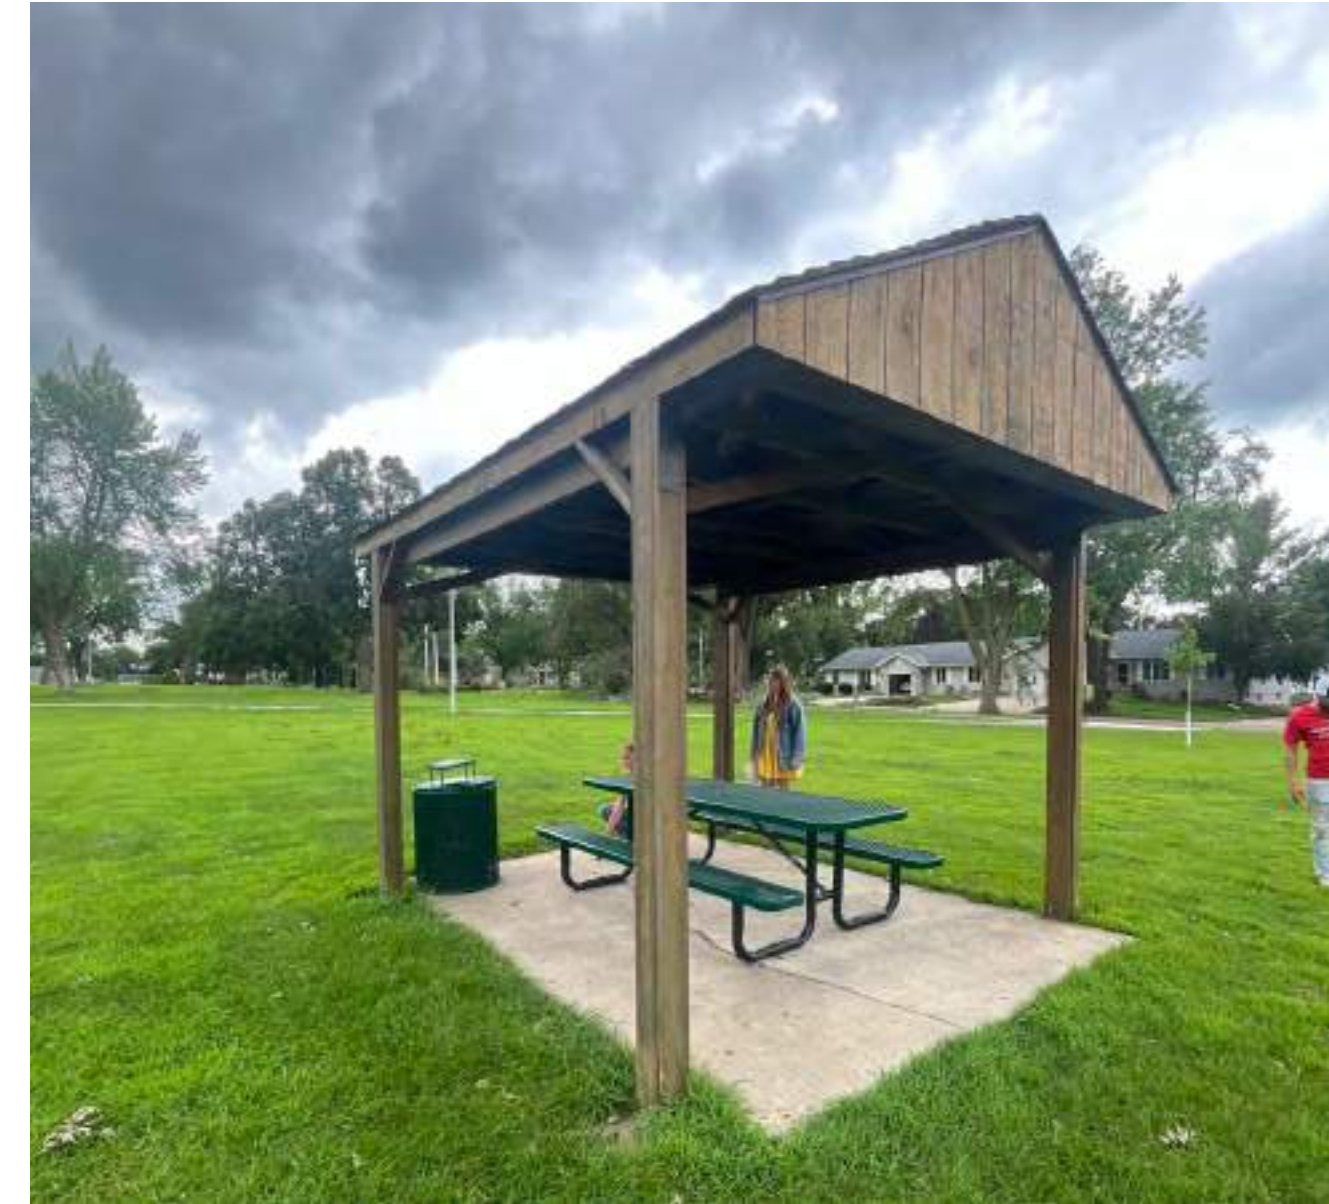
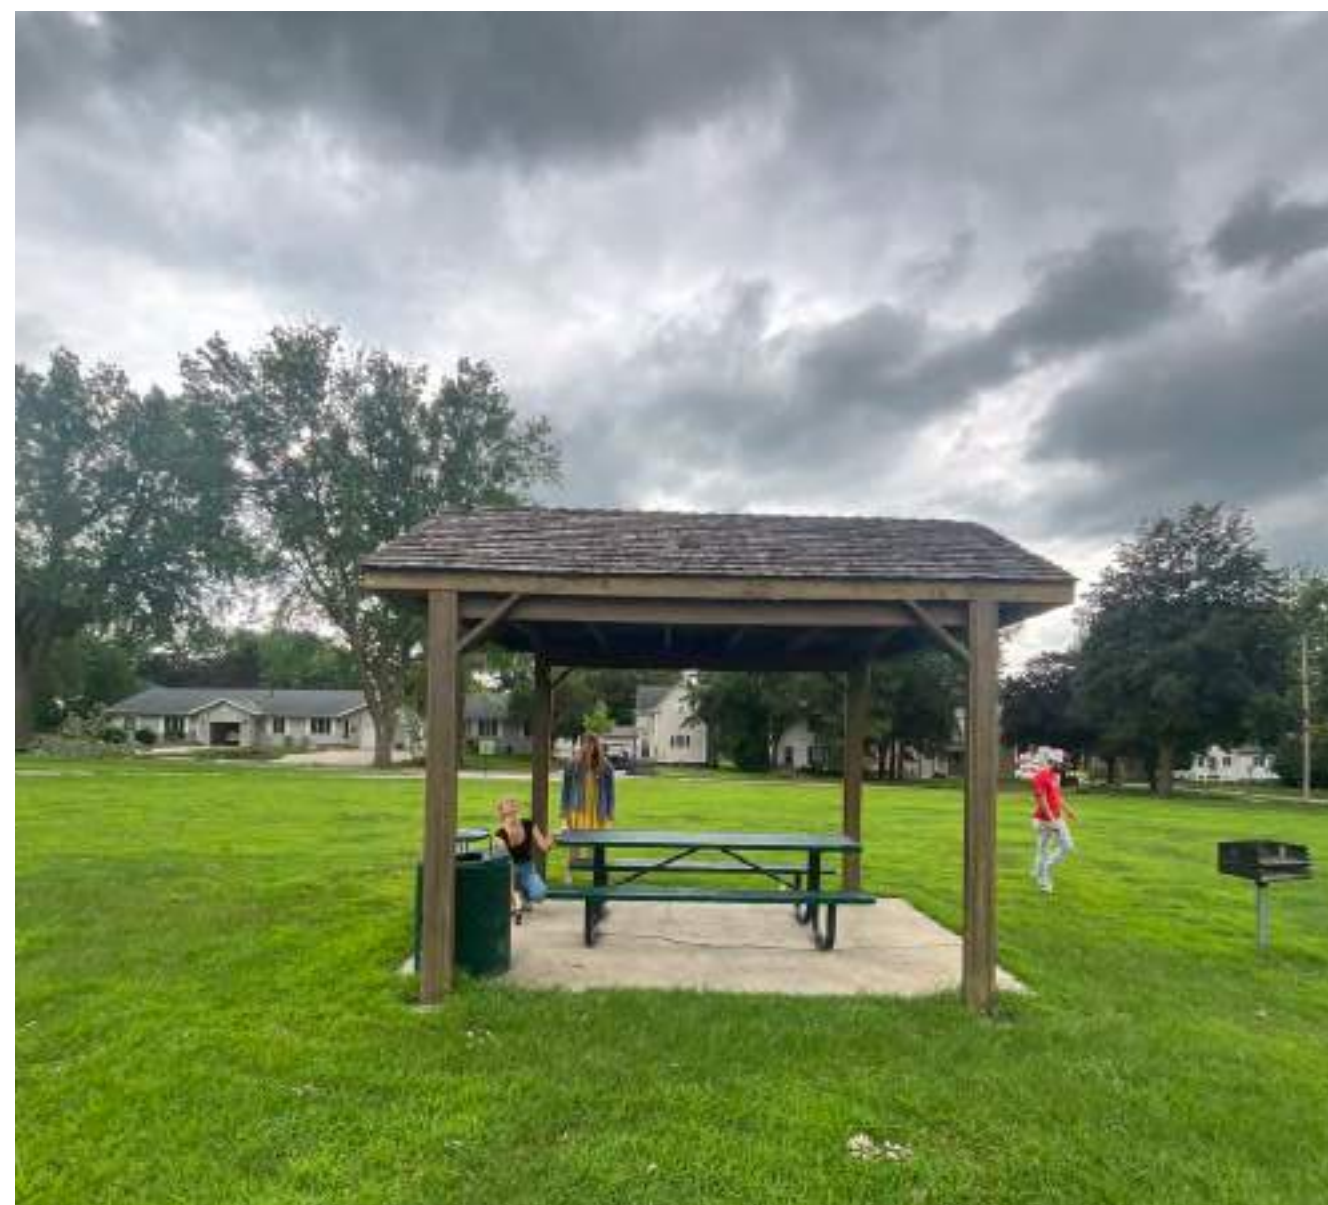
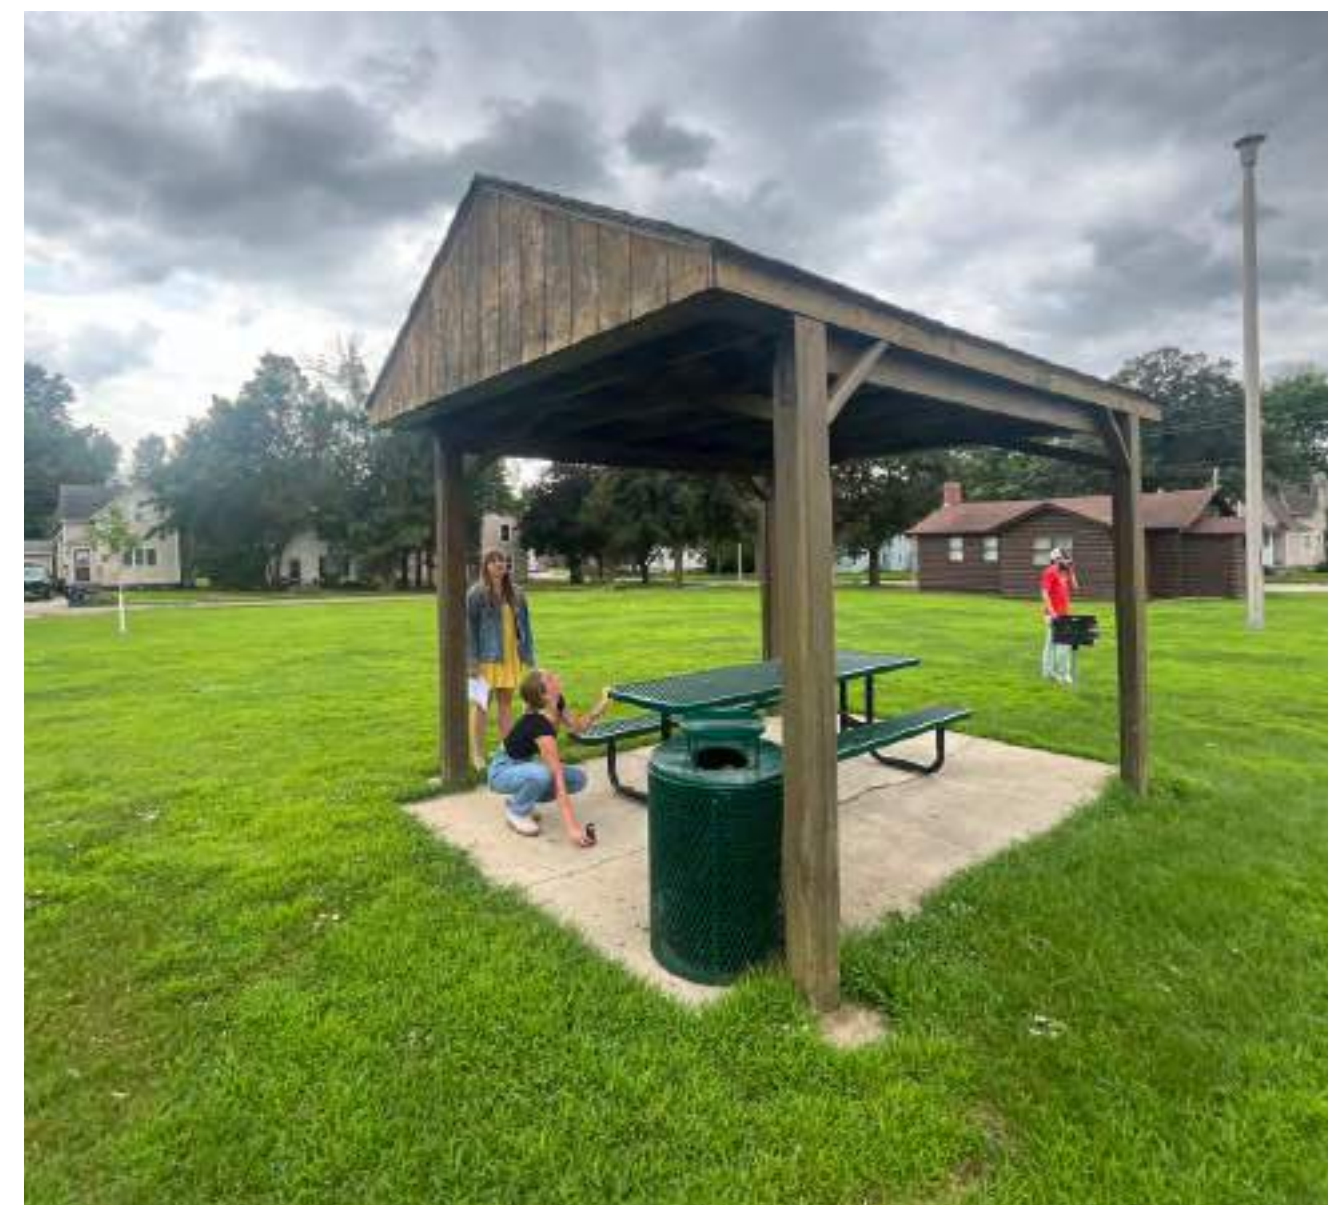
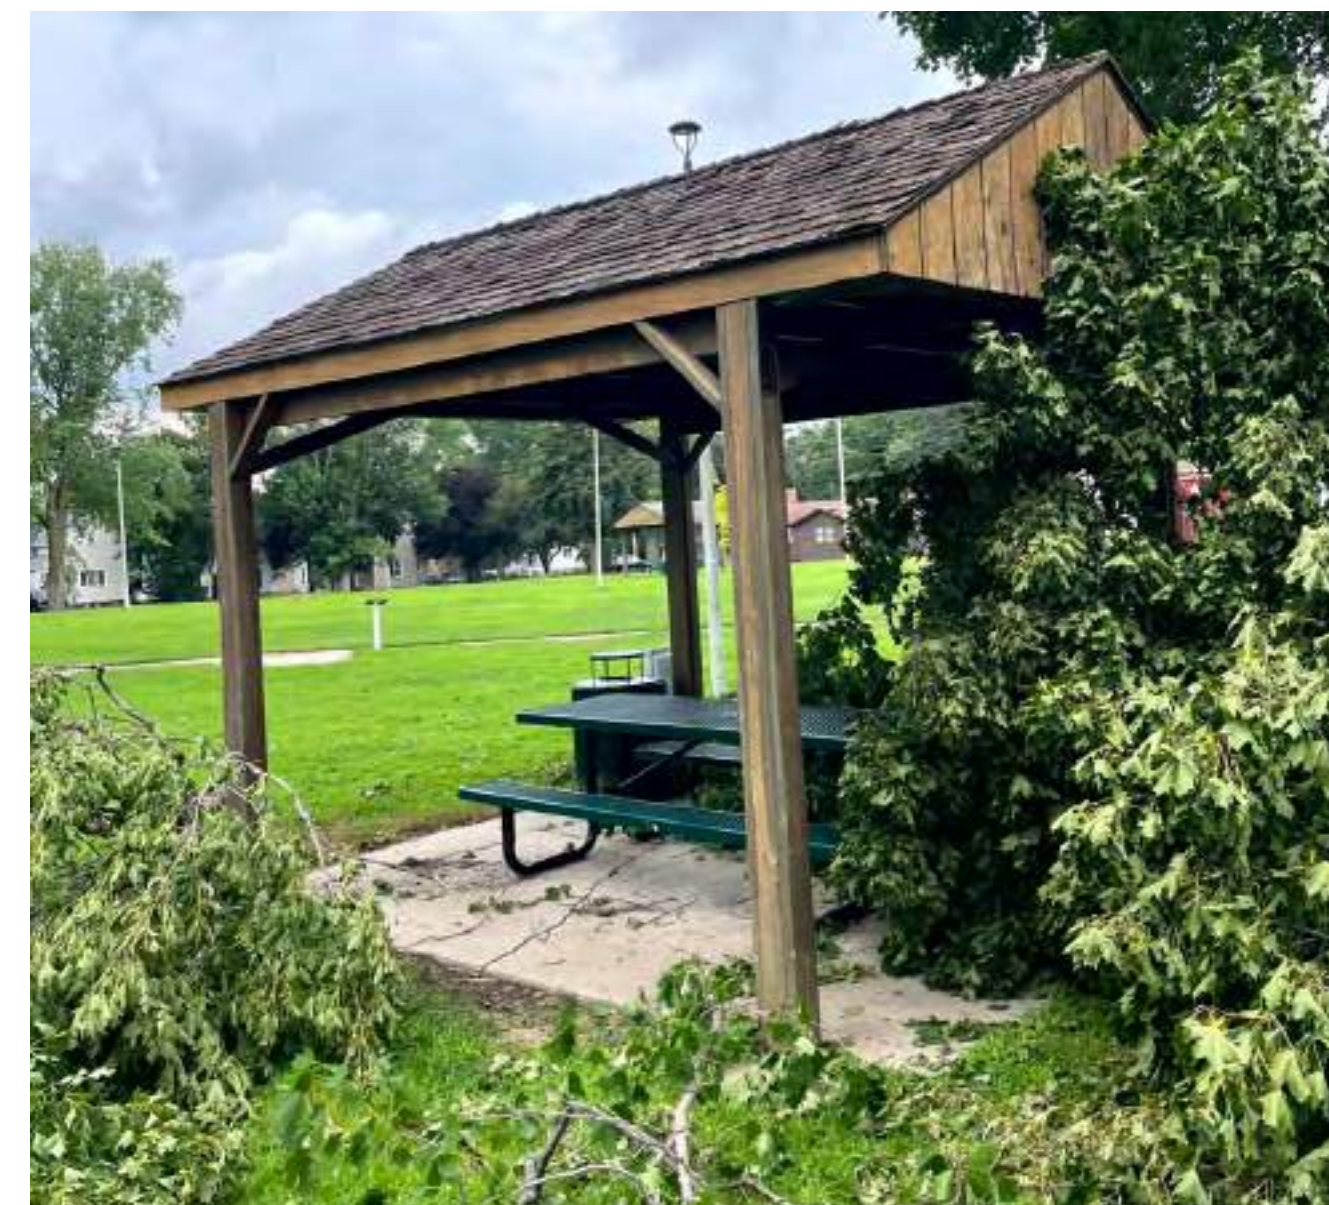
- Exterior T1-11 sheathing in poor condition.
- Roof in poor condition.
- Wood showing age.
- Concrete pads cracking and in poor condition.
- Each shelter house contains a bench and trash receptacle.
- No accessible ADA route to shelter houses.

- Small park shelters are well used by the communities and are in fair condition overall. No accessible route is available to the park shelters.

- Replace roof shingles and touch up trim.
- Full removal and replacement of concrete pad beneath structures
- Add accessible pathway to existing concrete pad (40' length north shelter, 60' length south shelter).
