# City Park Master Plan

CITY OF SHELDON, IOWA

CITY COUNCIL PRESENTATION - DECEMBER 3, 2025

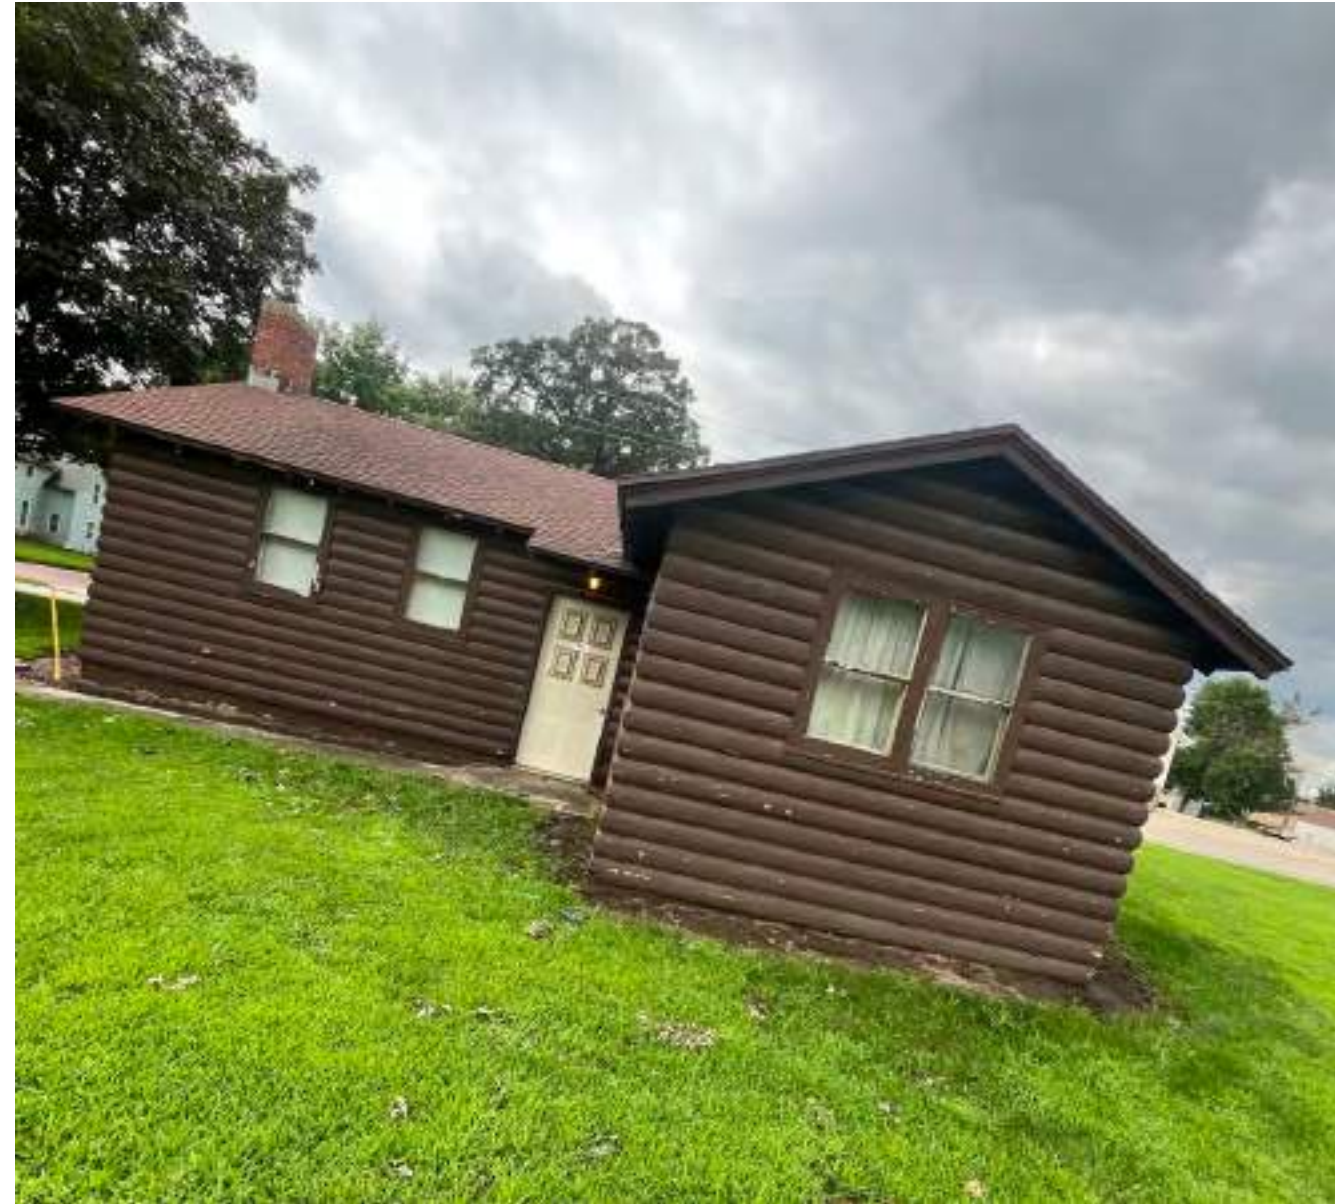
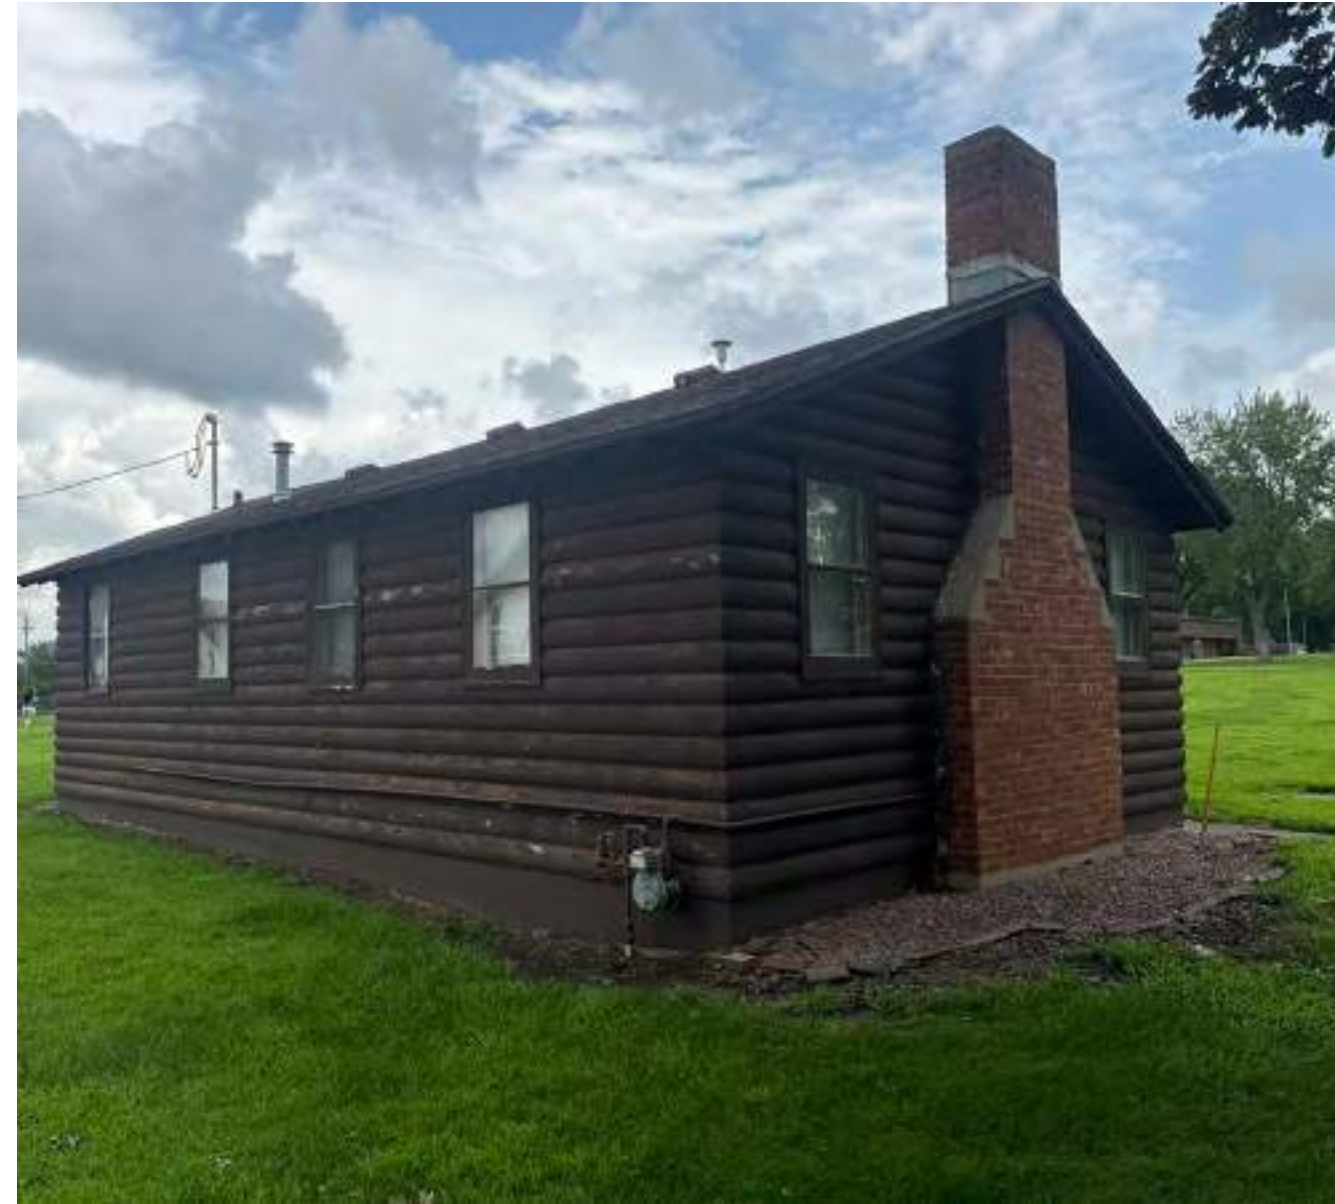
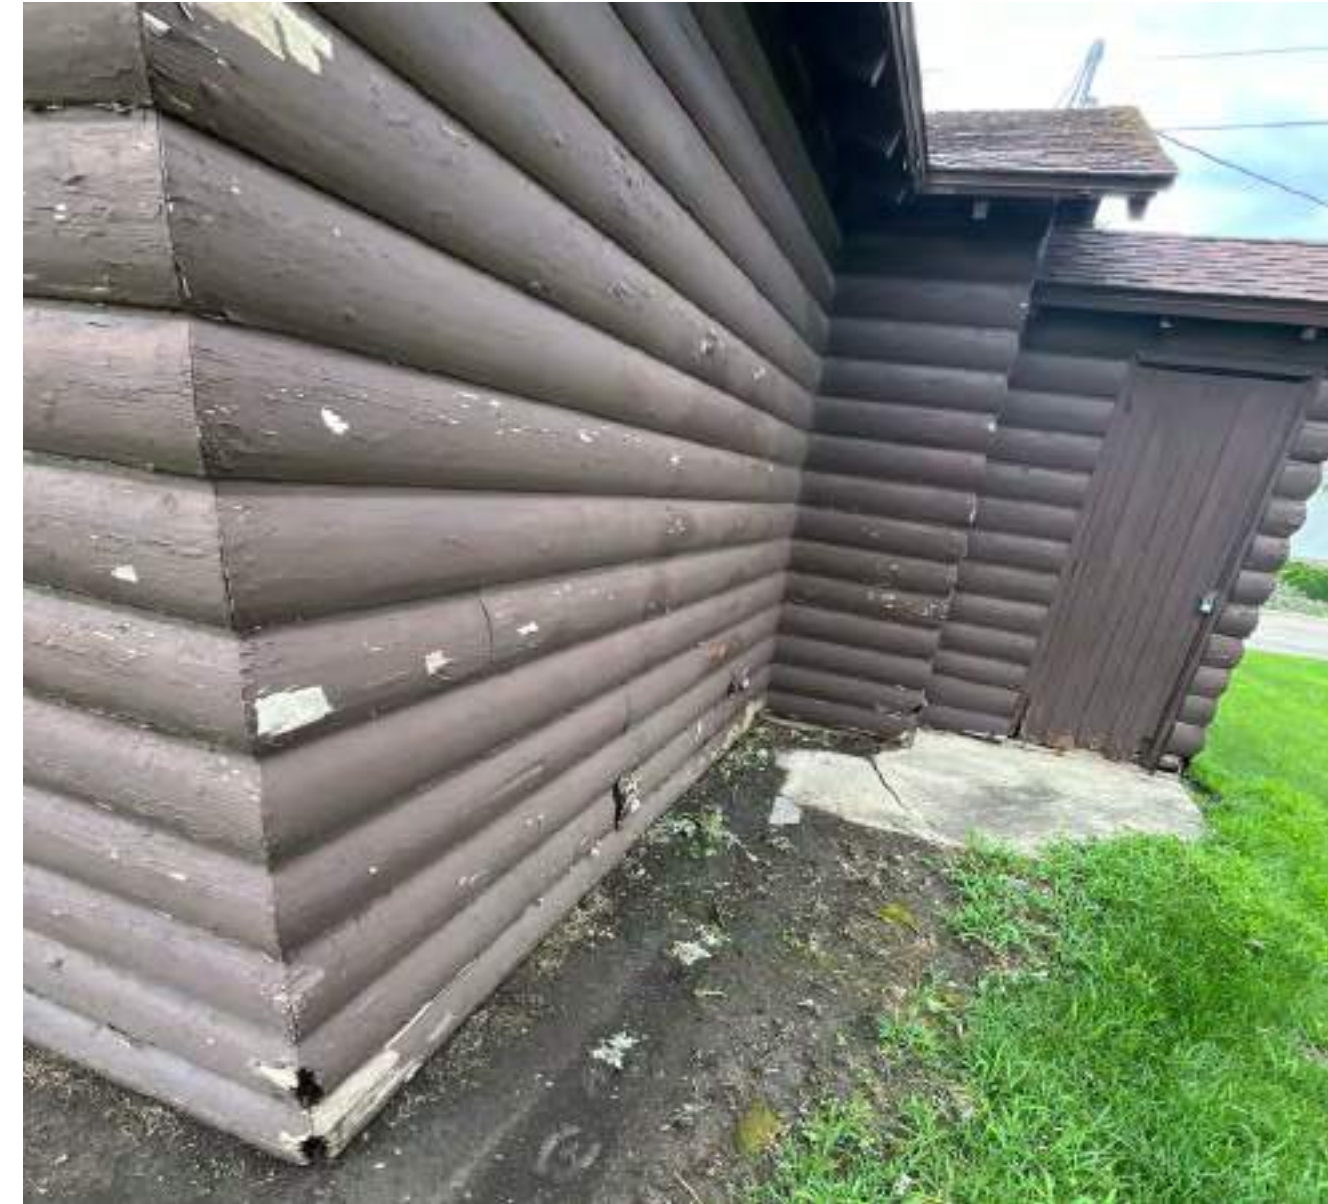
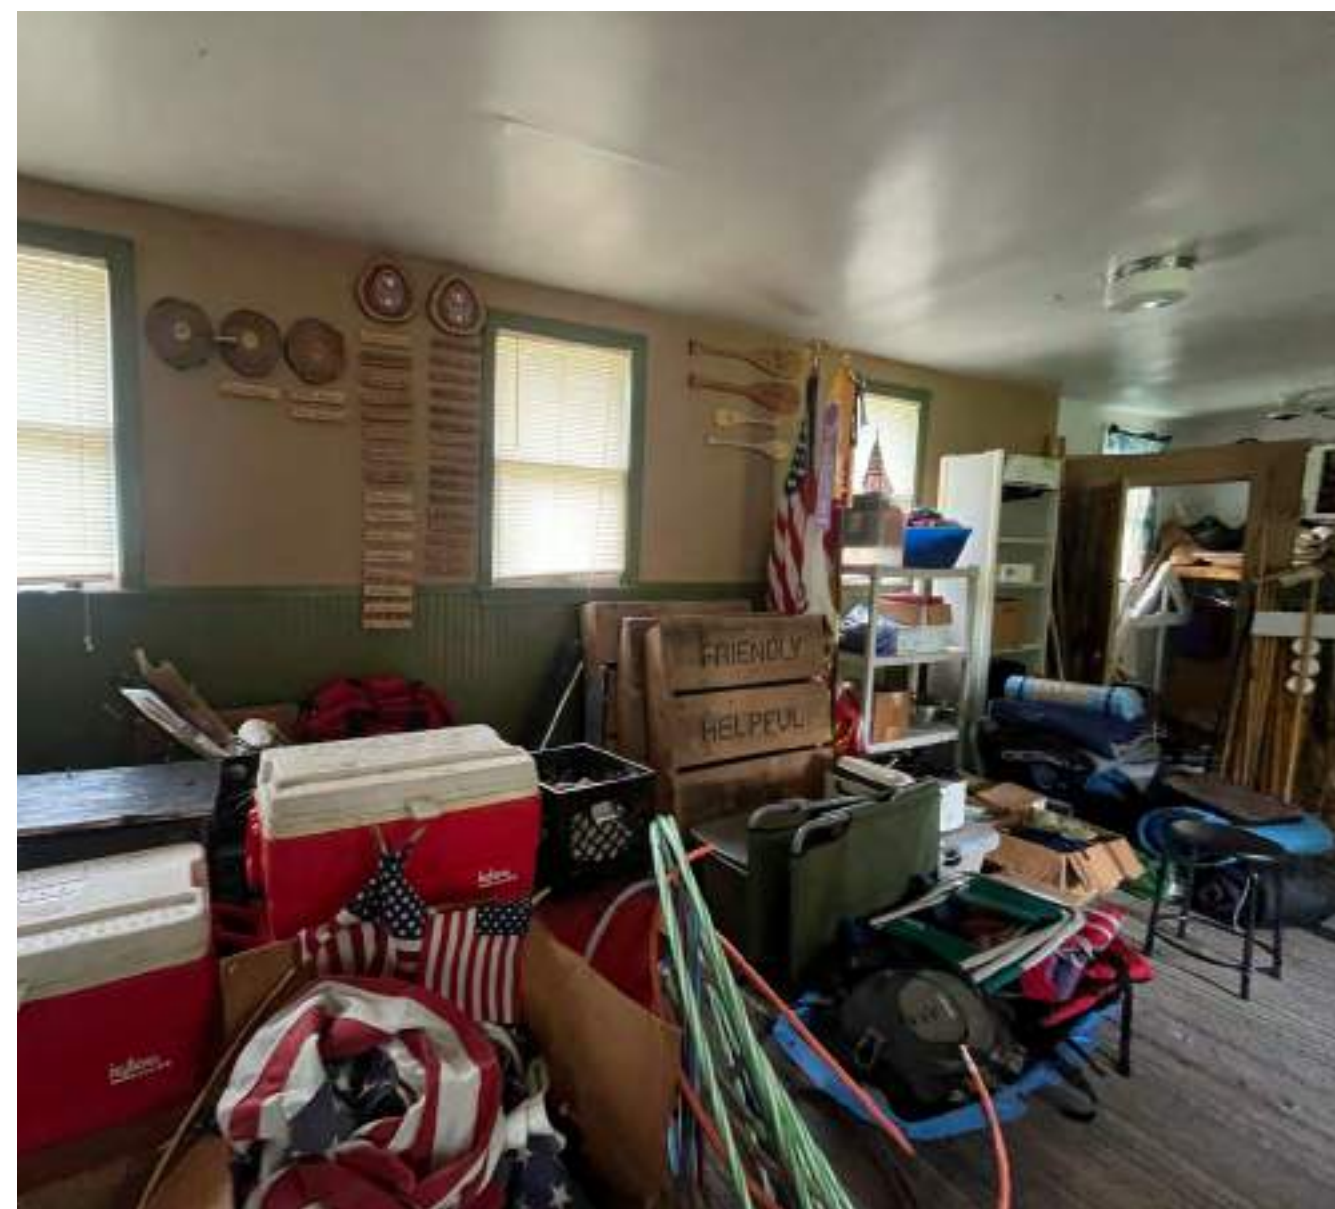
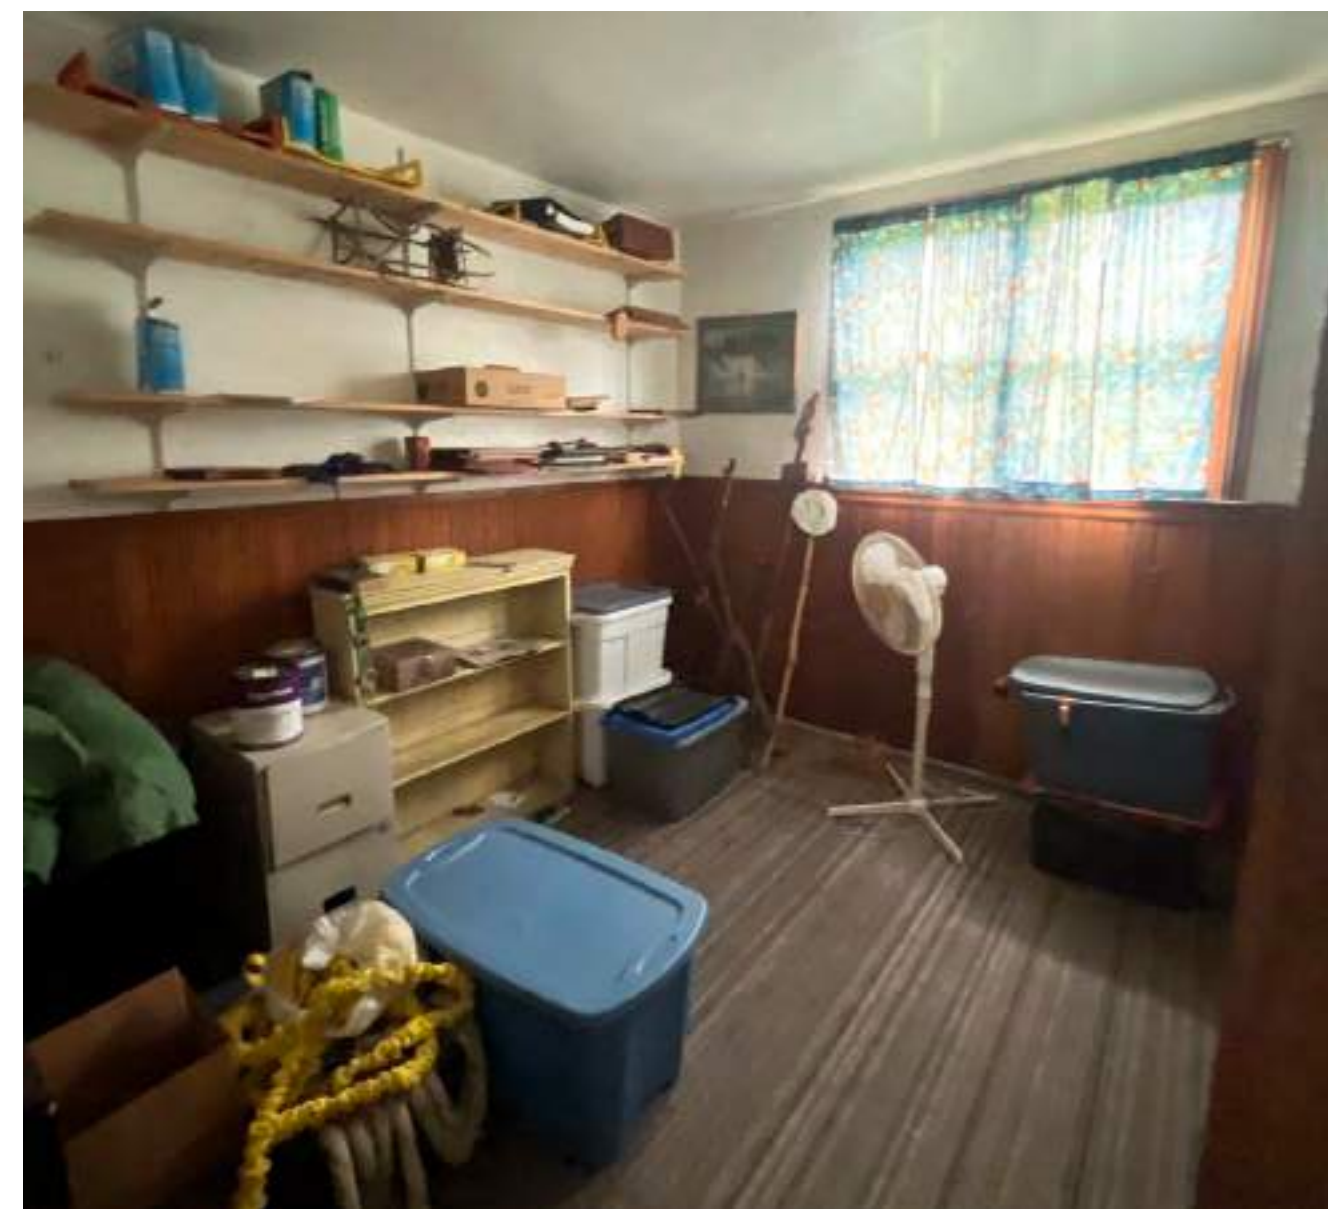
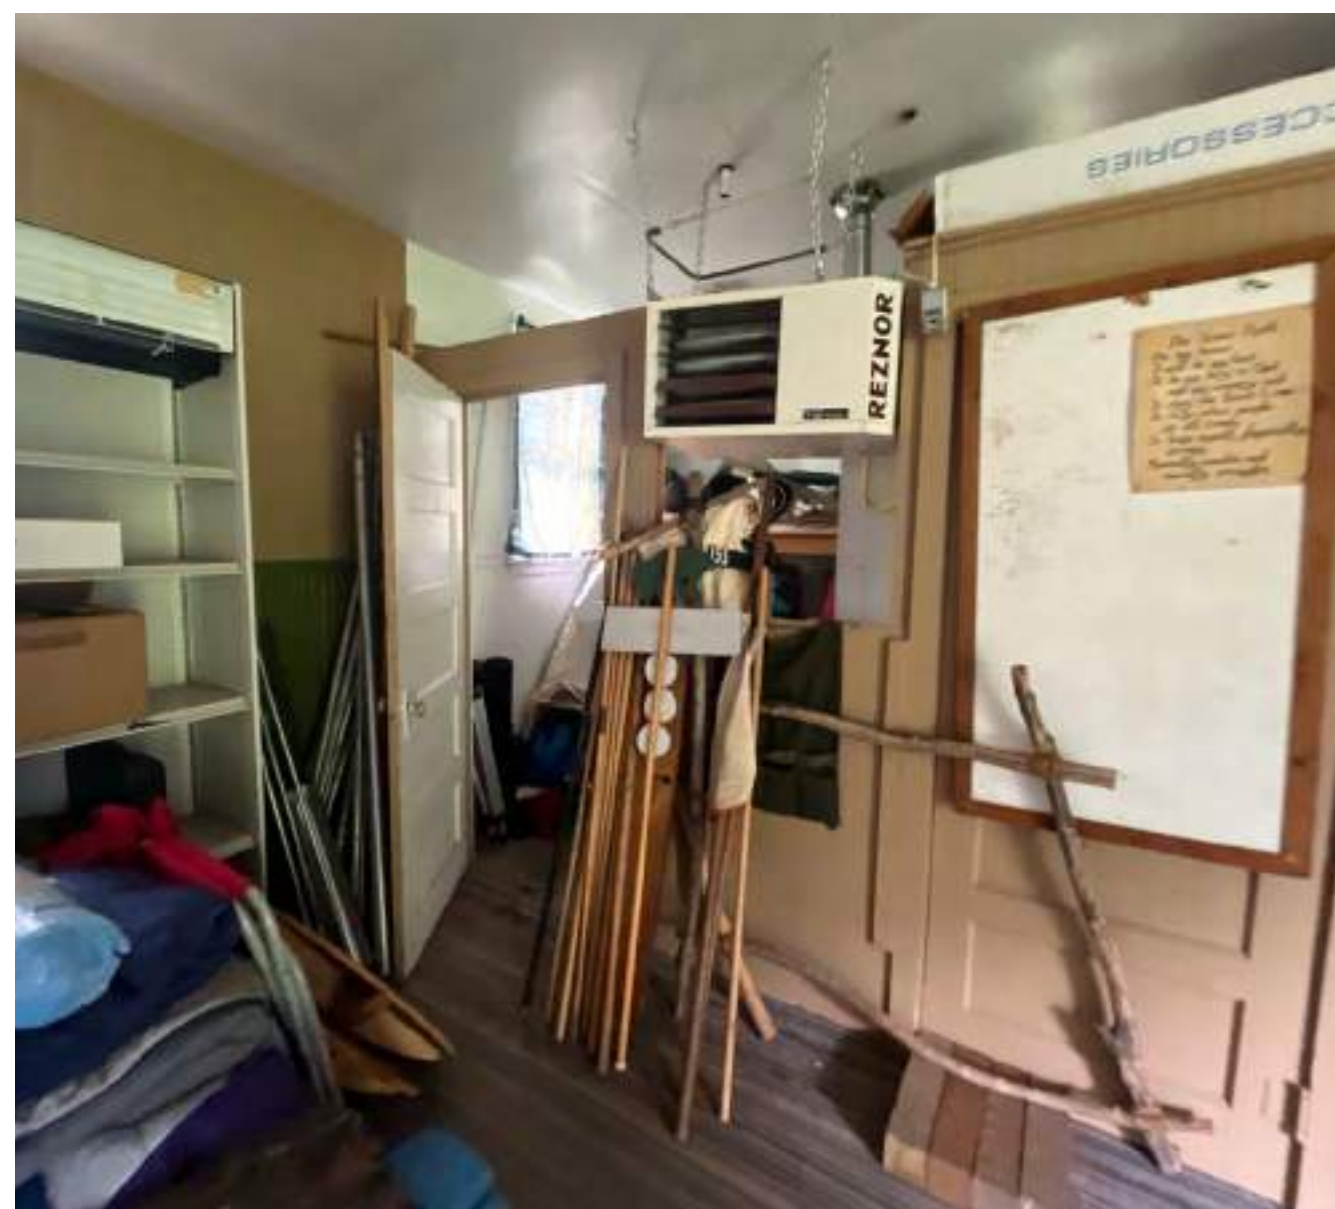
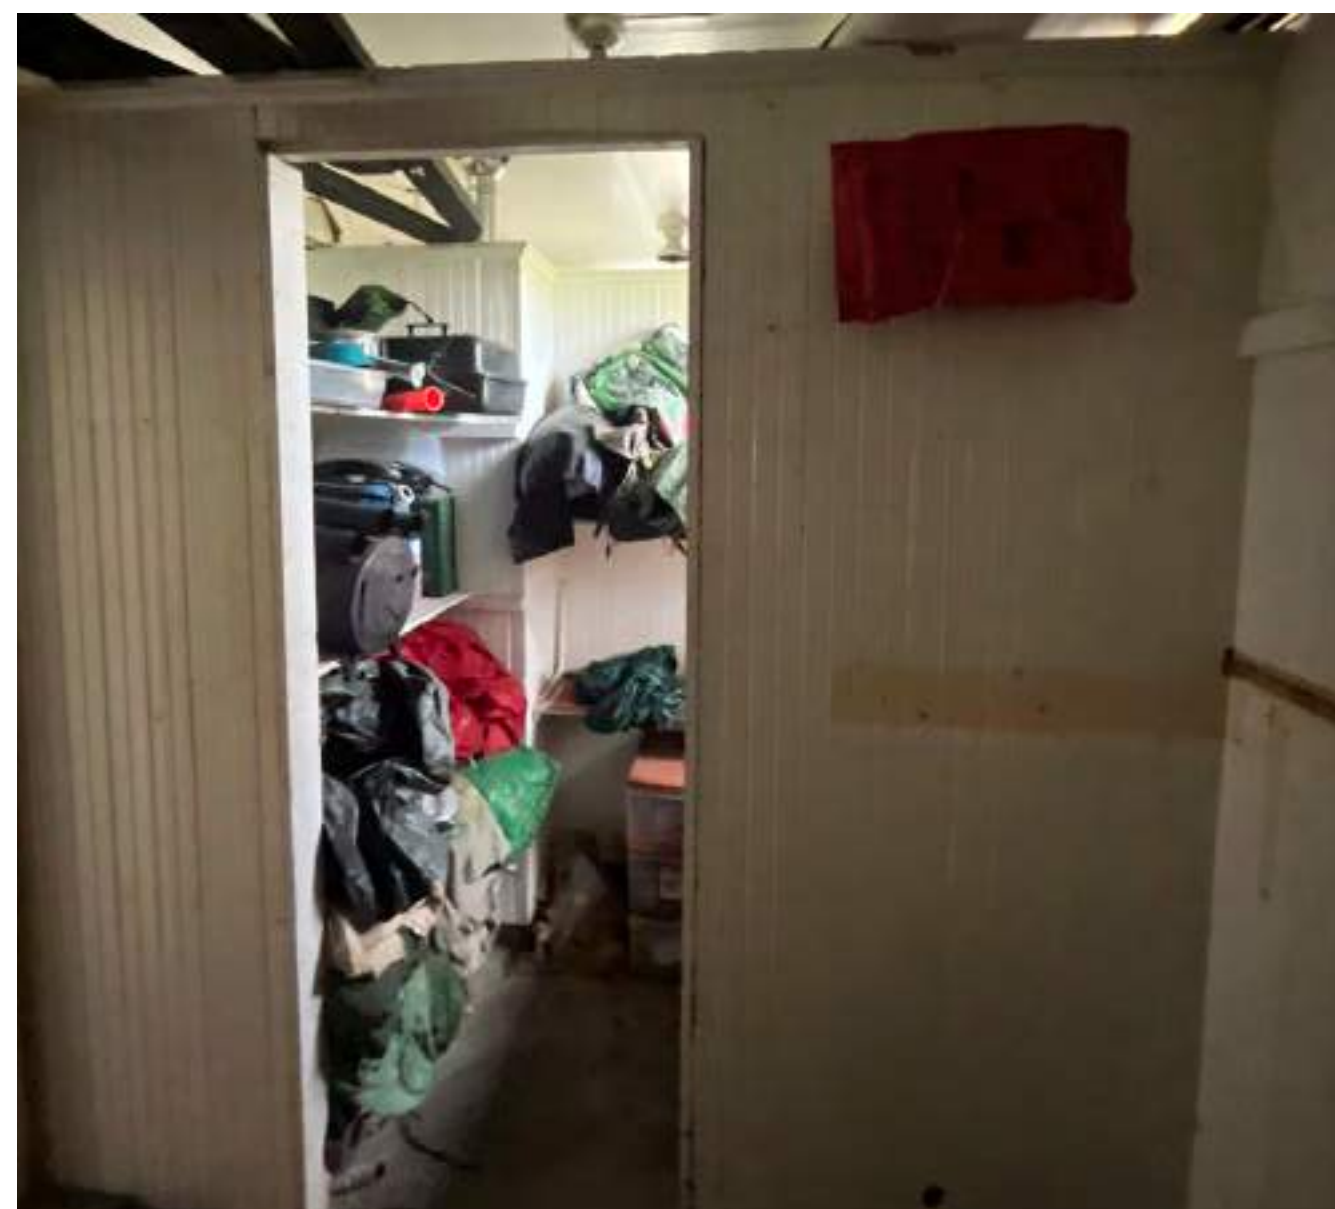
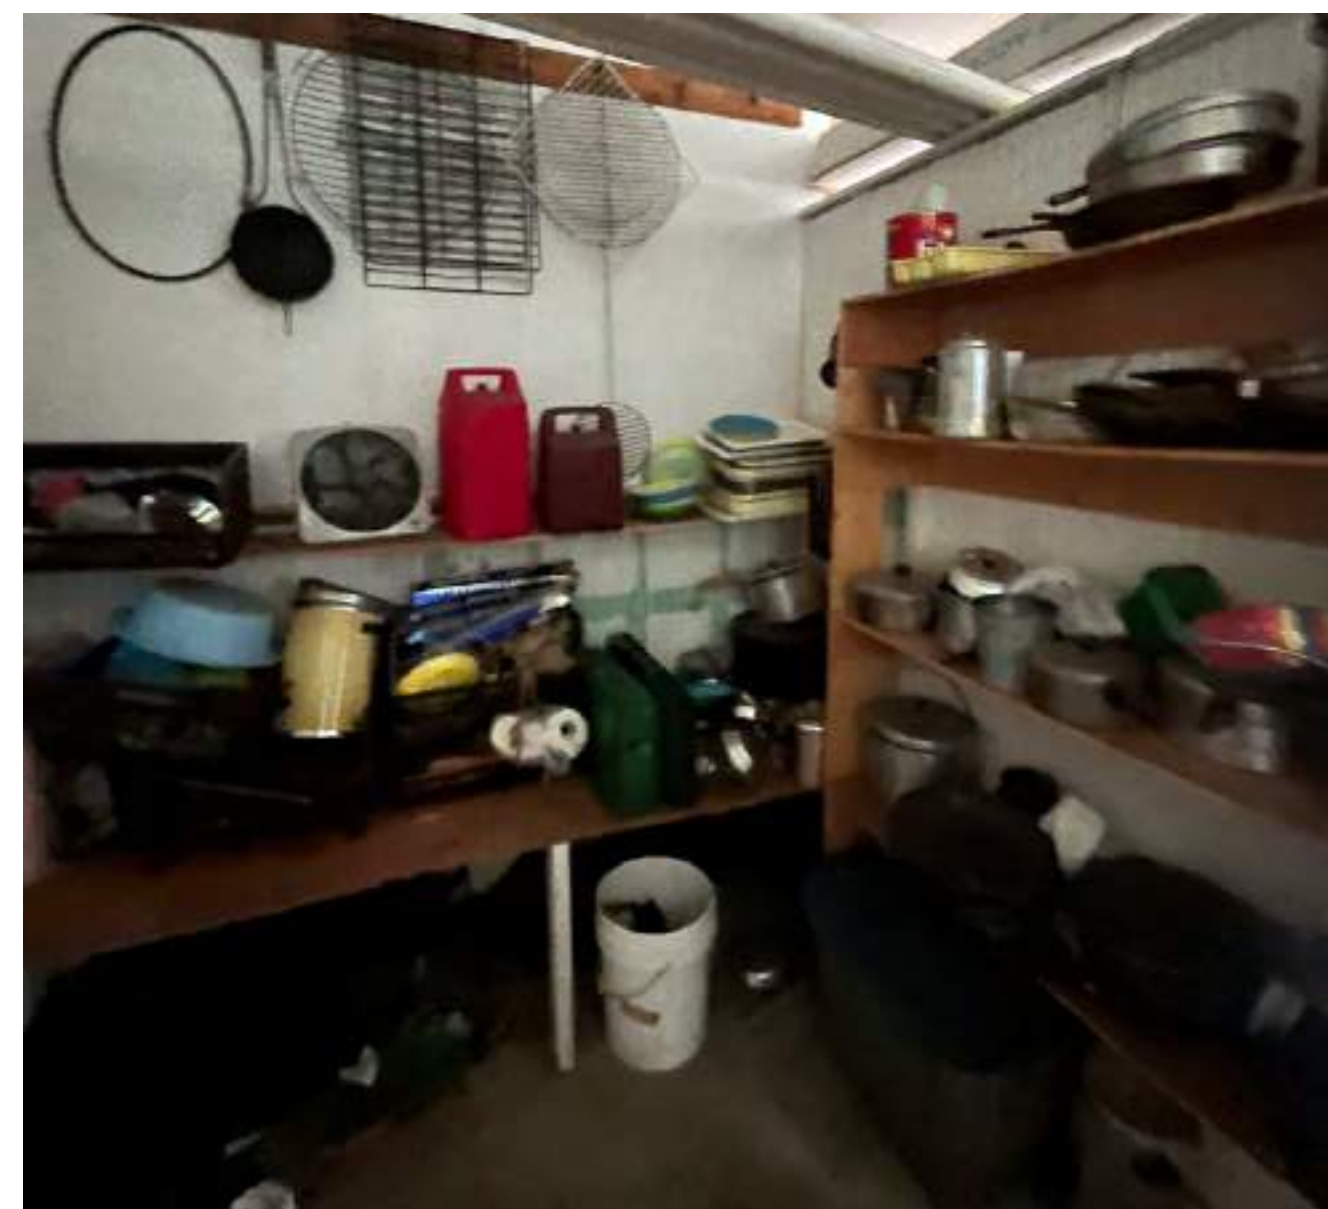
- Interior carpet excessively worn.
- Fireplace has excessive soot buildup.
- Building is used mostly for storage but lacks adequate storage area.
- Interior door missing handle.
- Siding shows moisture issues.
- Exterior paint is peeling in many areas.
- Outdated windows.
- Chimney above the roof lacks tuckpointing.
- Exterior wooden door shows moisture infiltration/rot.
- Interior ceiling is cracking.
- Doors are not ADA-compliant.
- The interior of the building has a "pit" in the floor covered by a sign.
- No restroom within building.
- Chimney shows moisture infiltration.
- Concerns of hazardous material within the building.

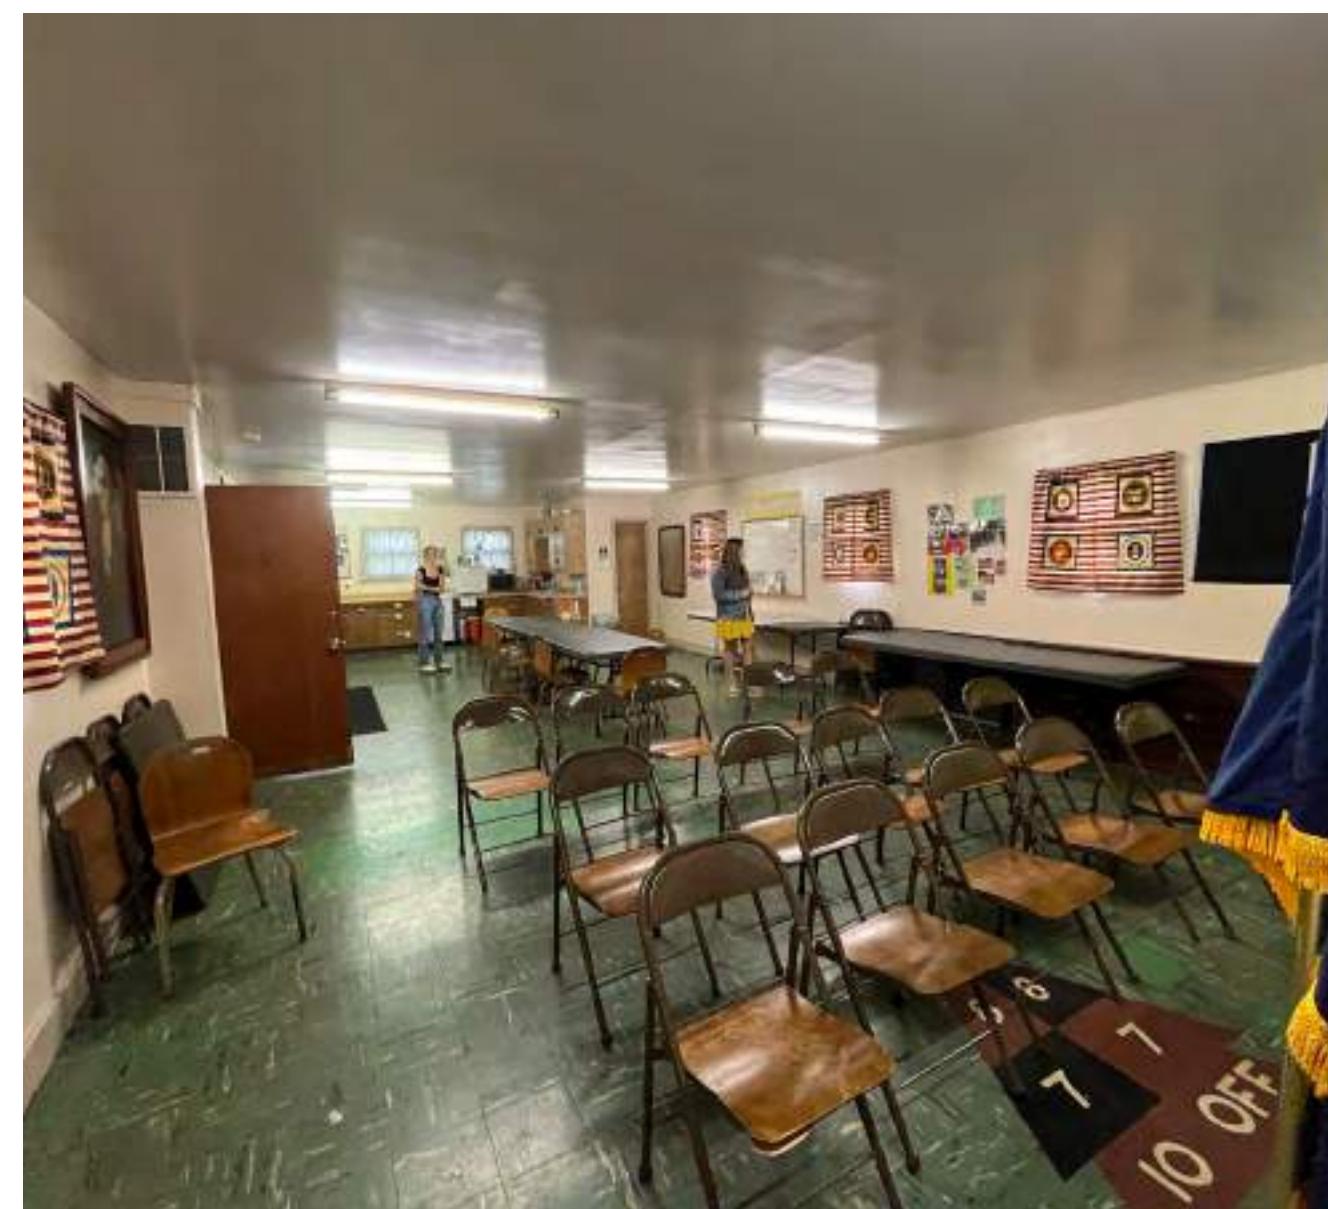
GIRL SCOUT CABIN / VFW

- Concerns of hazardous material within the building.
- Bathroom not ADA-compliant.
- Siding in poor condition and shows moisture issues.
- Exterior paint is peeling in many areas.
- Windows are outdated and in poor condition.
- Roof in poor condition.
- Hole in siding on south side of chimney.
- Chimney shows moisture infiltration.
- Doors do not have ADA-compliant door handles.
- No clearly labeled fire egress.
- Electric code concerns.
- Stove top has no hood.
- Building used for storage though lacks in adequate storage area.
- Building still used for VFW meetings.
- ADA parking outside of building is non-compliant.

- The Girl Scout Cabin / VFW has been around for a long time and is still being used by the girl scouts and VFW as a meeting place. The building in general is in poor condition and shows signs of rot and wear in many areas including the exterior wood siding and trim, windows, roof, chimney, interior materials, and flooring.

- Remove existing flooring, replace with new flooring.
- Re-side building.
- Remove and re-install new windows.
- Remove and install new fascia boards and metal flashing.
- Remove and re-install shingles on roof.
- Clean and re-tuckpoint exterior of brick chimney.
- Install new gutters and downspouts.
- Install ADA compliant door handles.
- Incorporate emergency exit / fire egress plan.
- Install new kitchen counter tops and casework.
- Removal of hazardous materials.
