# City Park Master Plan

CITY OF SHELDON, IOWA

CITY COUNCIL PRESENTATION - DECEMBER 3, 2025

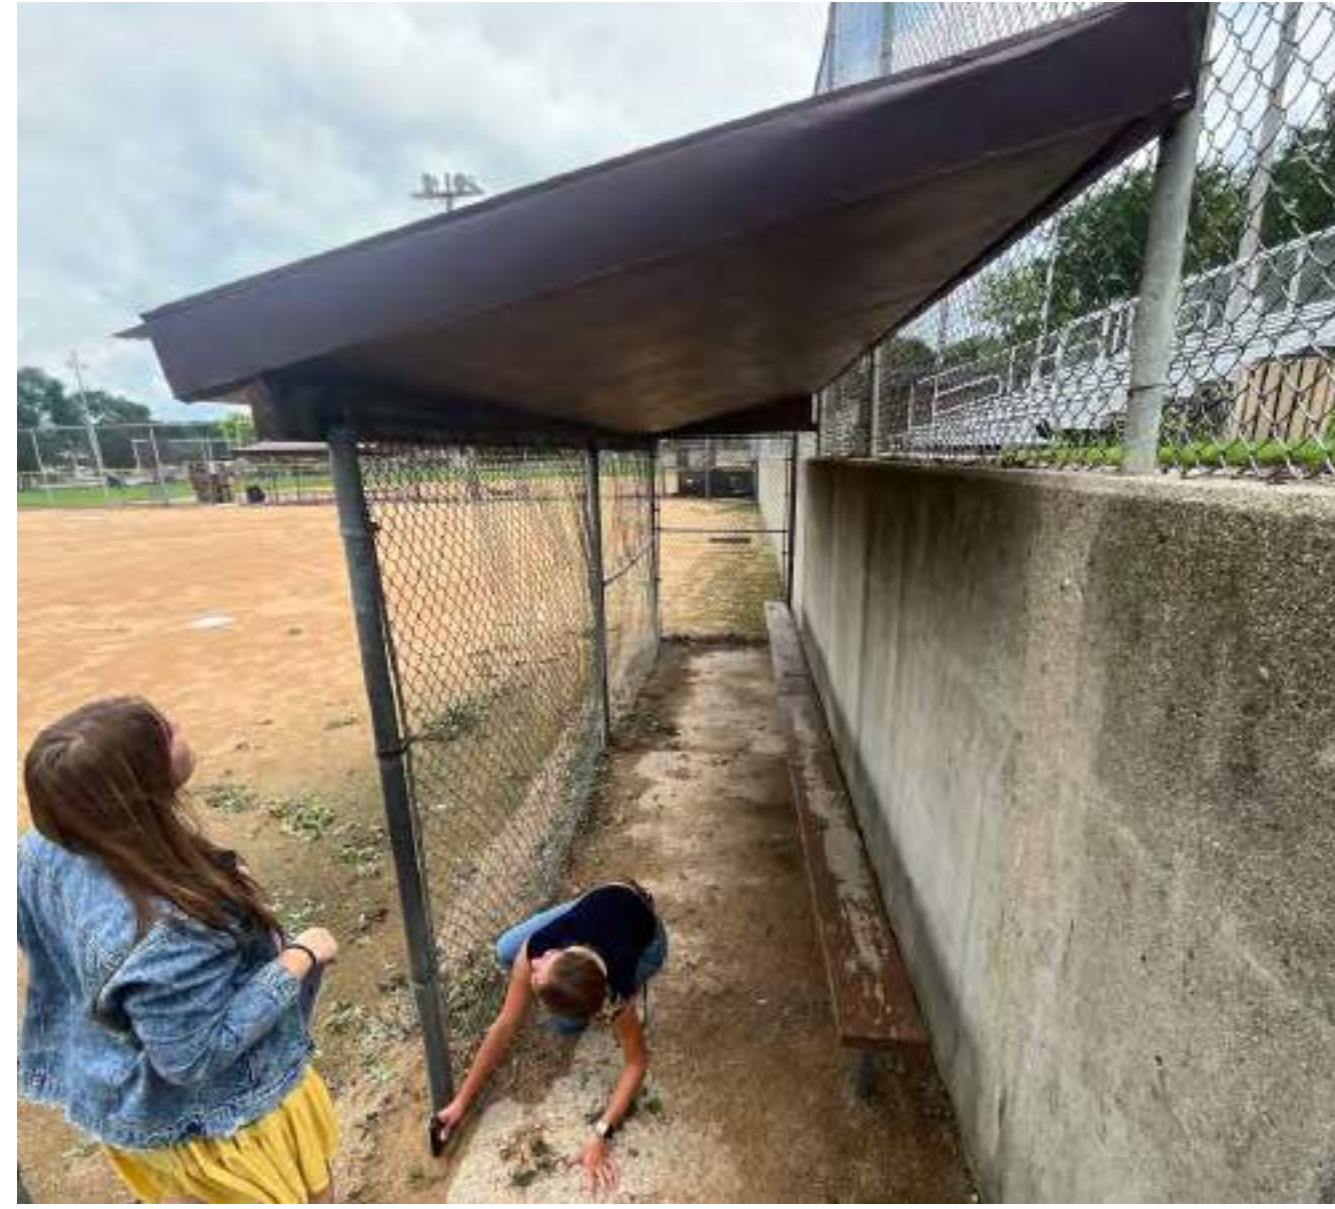
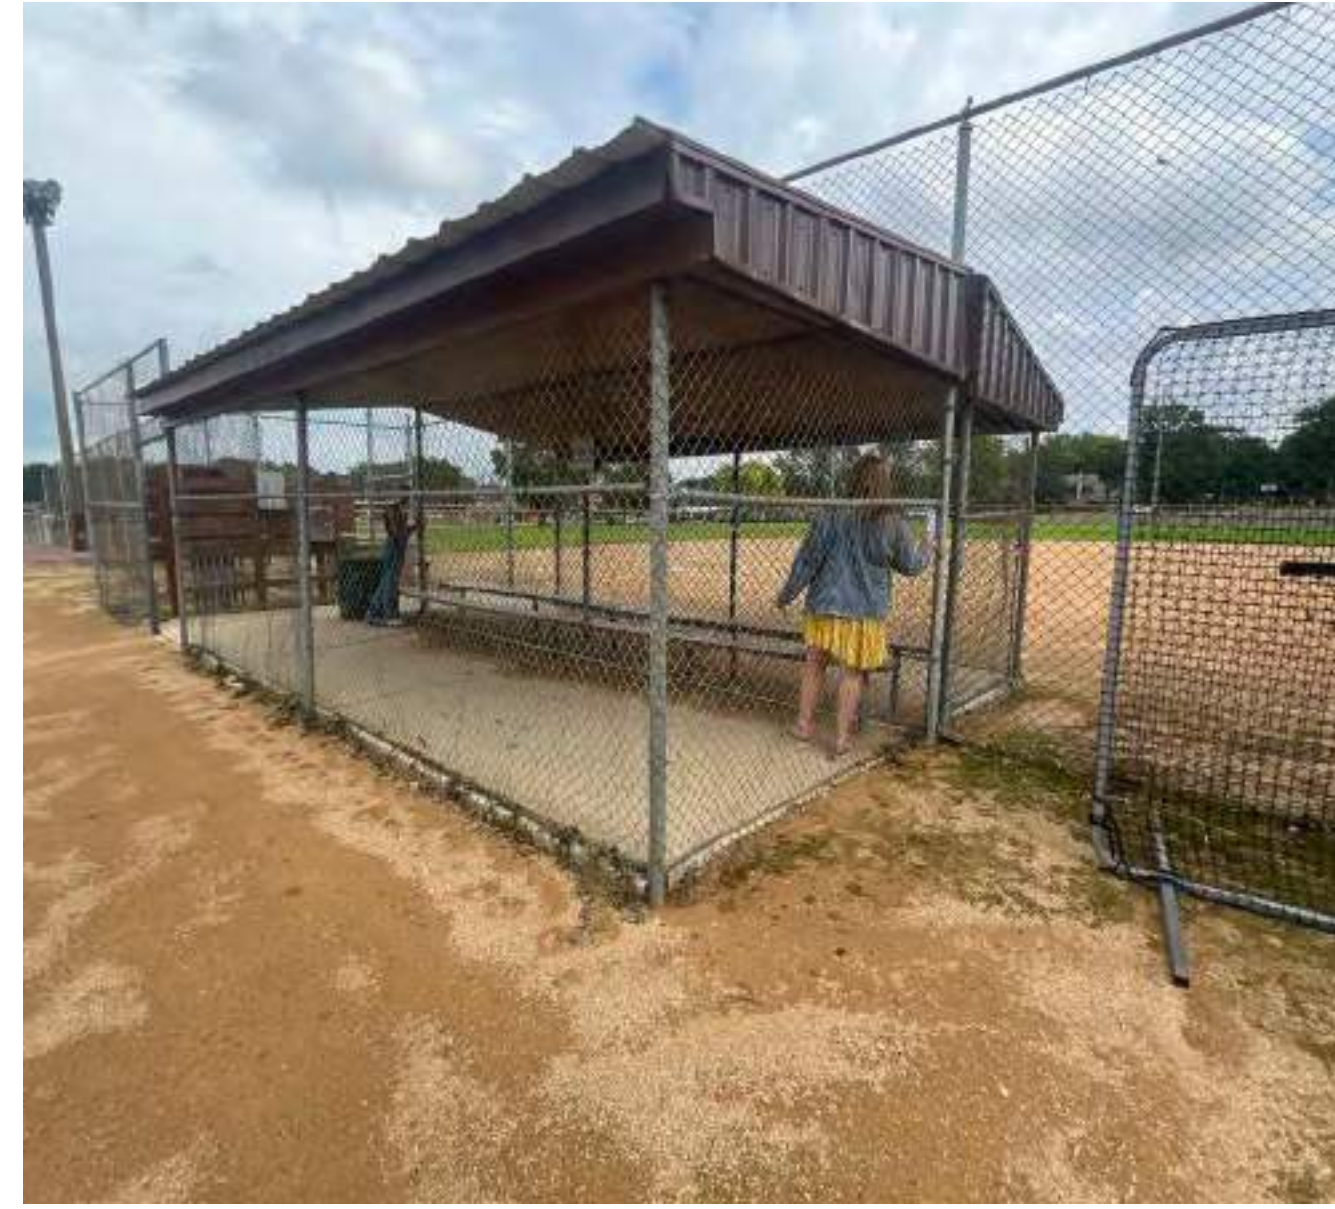
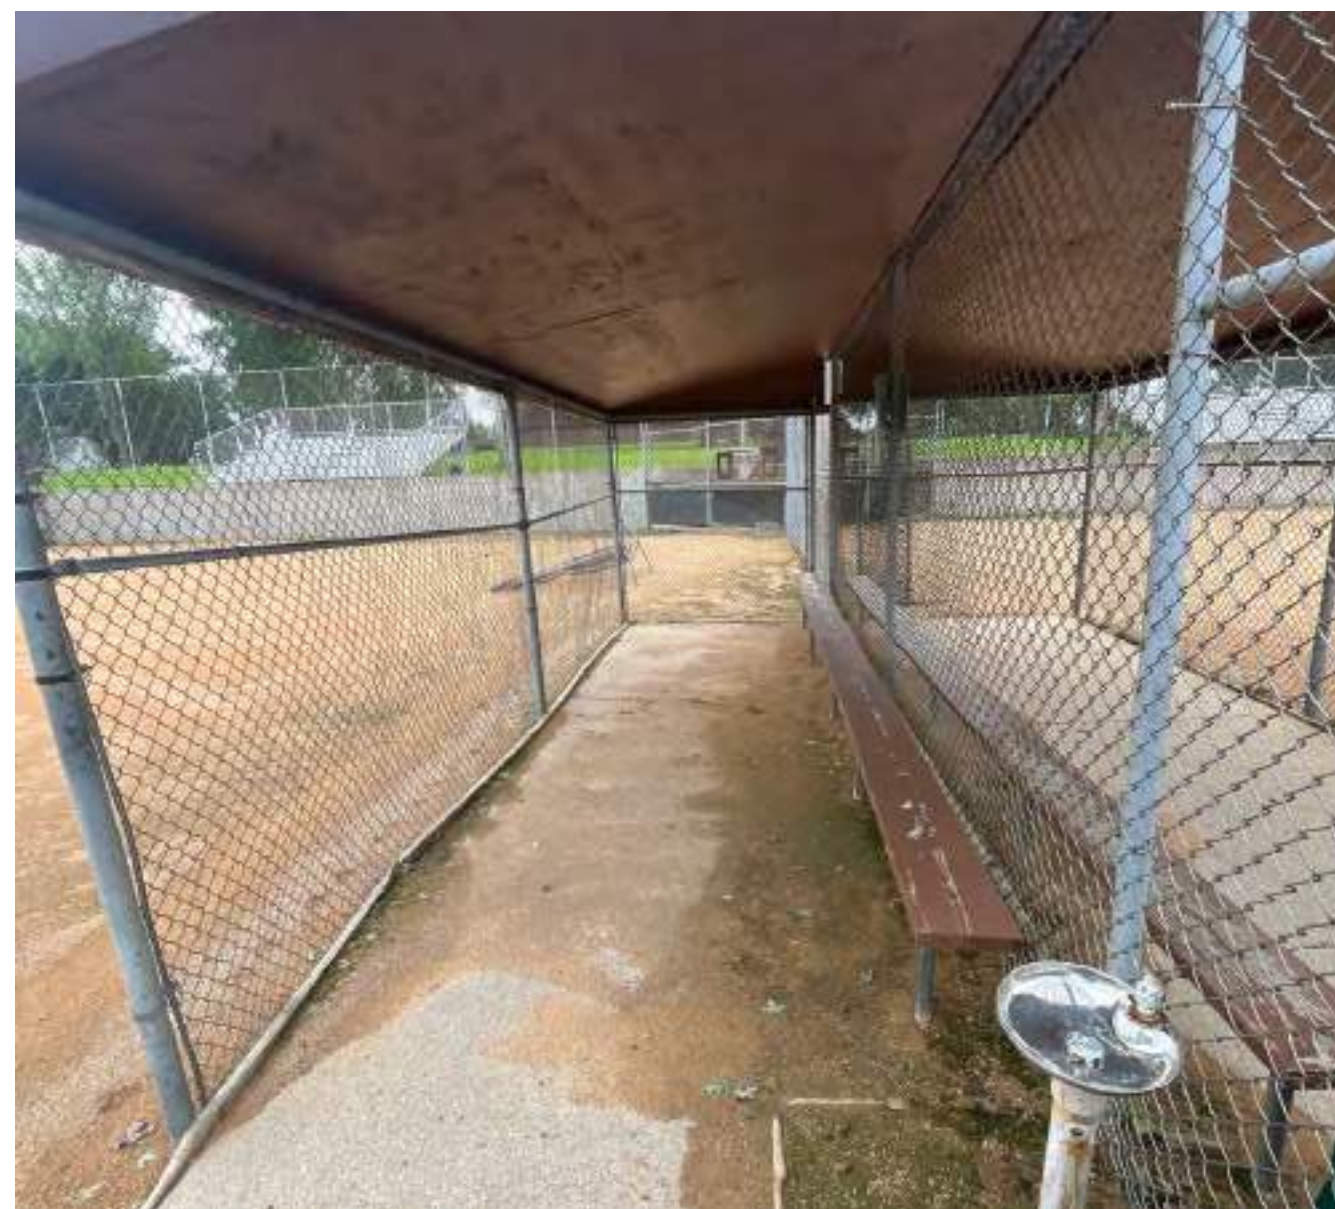
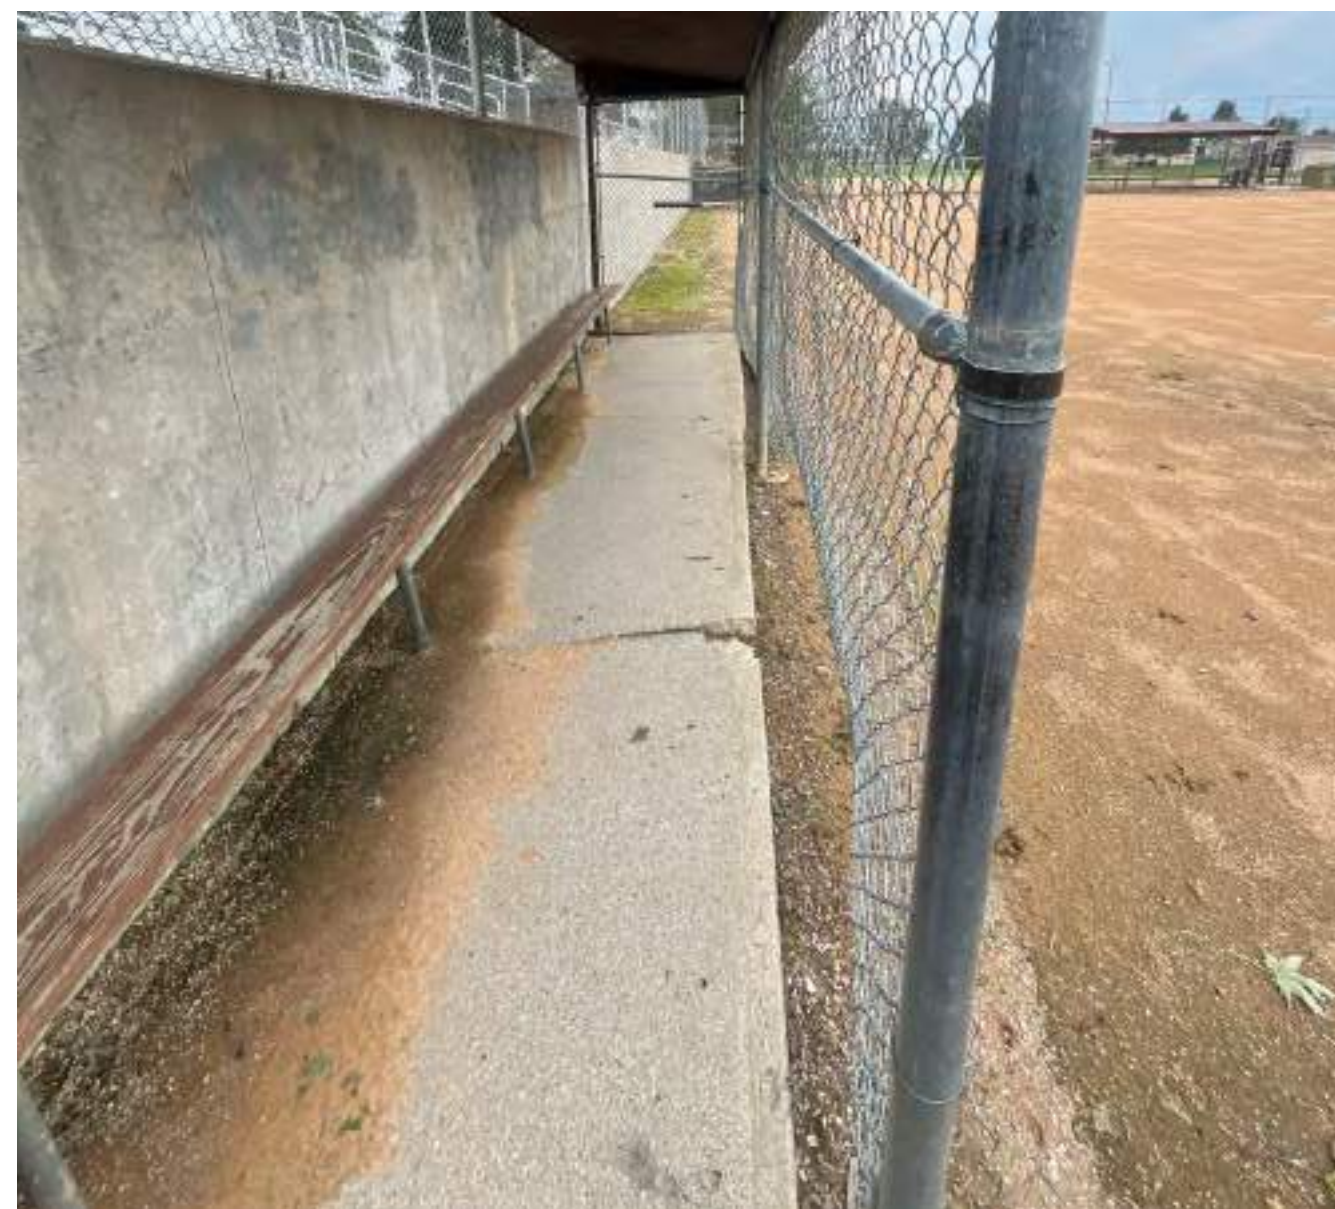
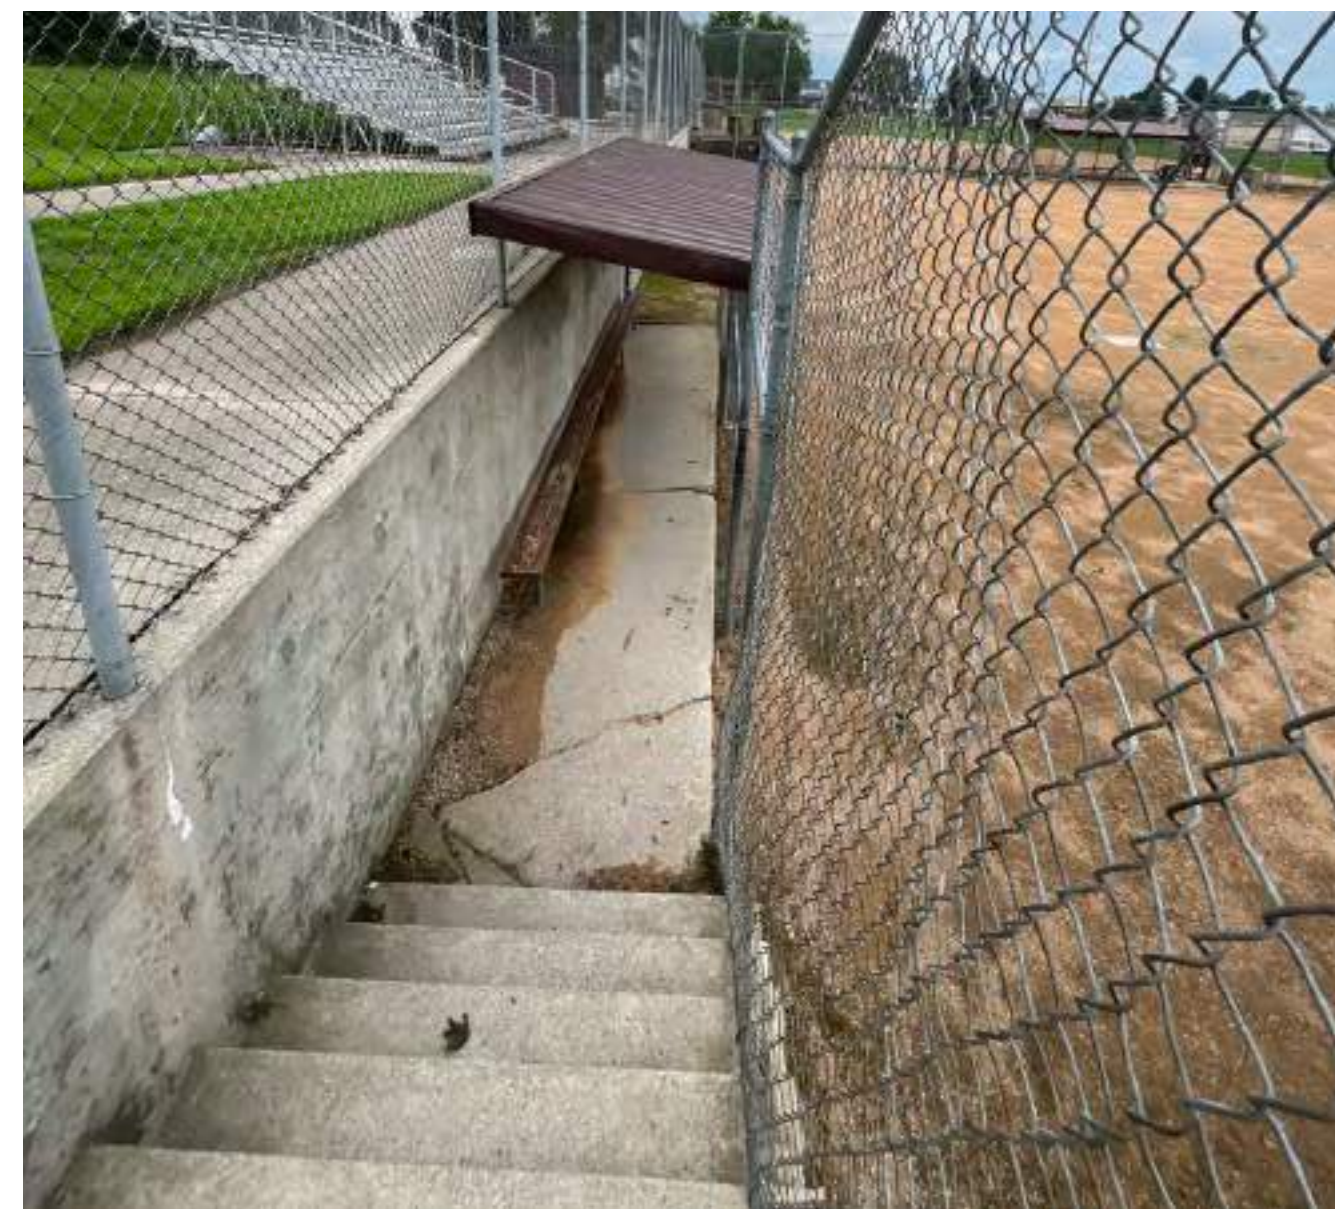
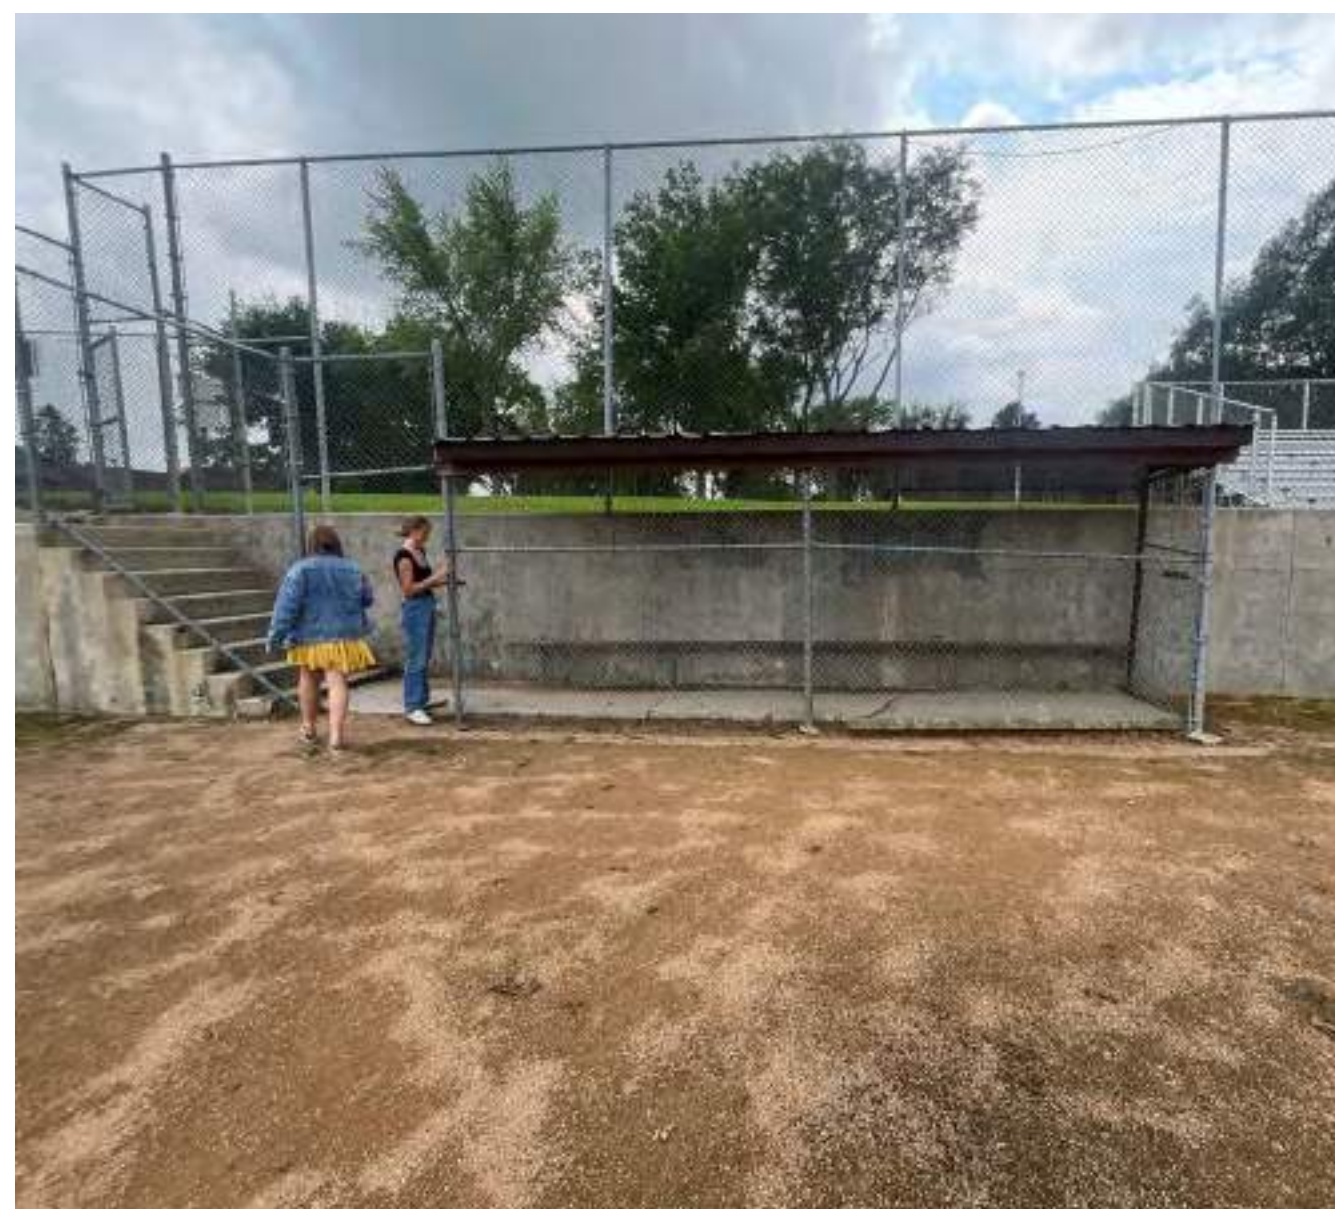
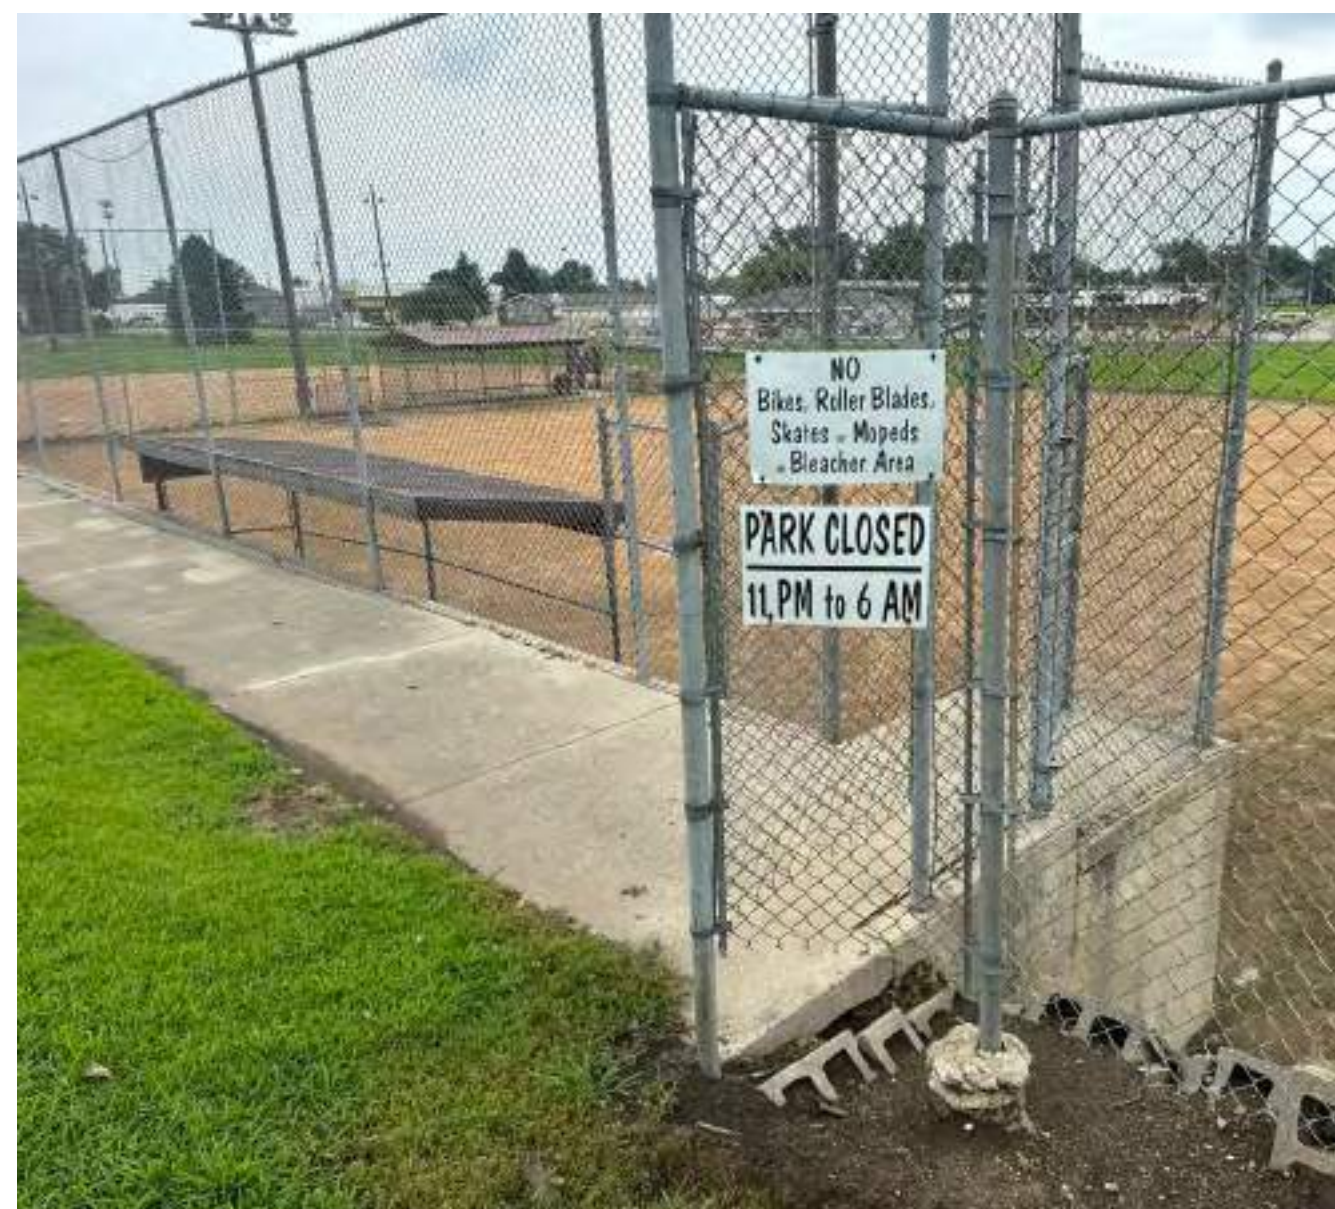
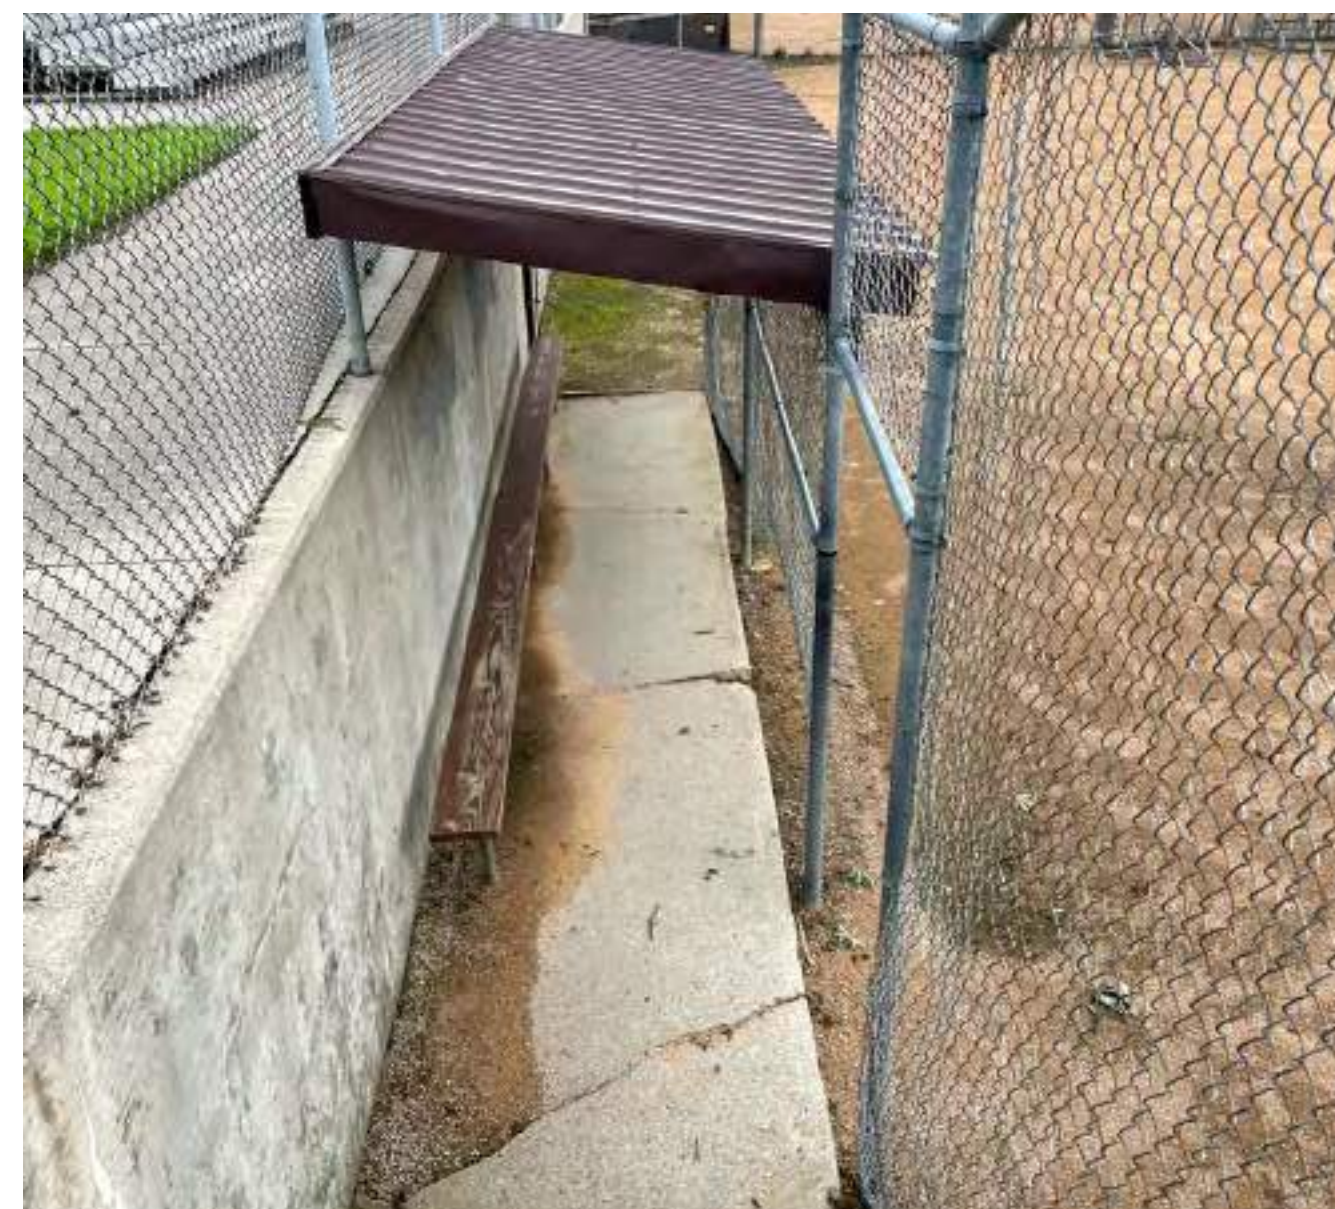
BASEBALL DUGOUTS

- Roofs are in bad condition.
- Chain link fence in poor condition.
- Bench seats are in poor condition and rotting in some places.
- Wood at the announcer stand in rotting and deteriorating.
- Powerbox requires inspection.
- Drinking fountain in poor condition.
- Concrete underneath dugouts in poor condition and slopes towards wall creating standing water and drainage issues.
- Retaining wall behind dugouts in poor condition.
- No ADA access to dugouts.

- The baseball dugouts are in very poor condition and have no ADA access. Dugouts are useable but require further update as they are nearly in disrepair with most amenities requiring updates and repair.

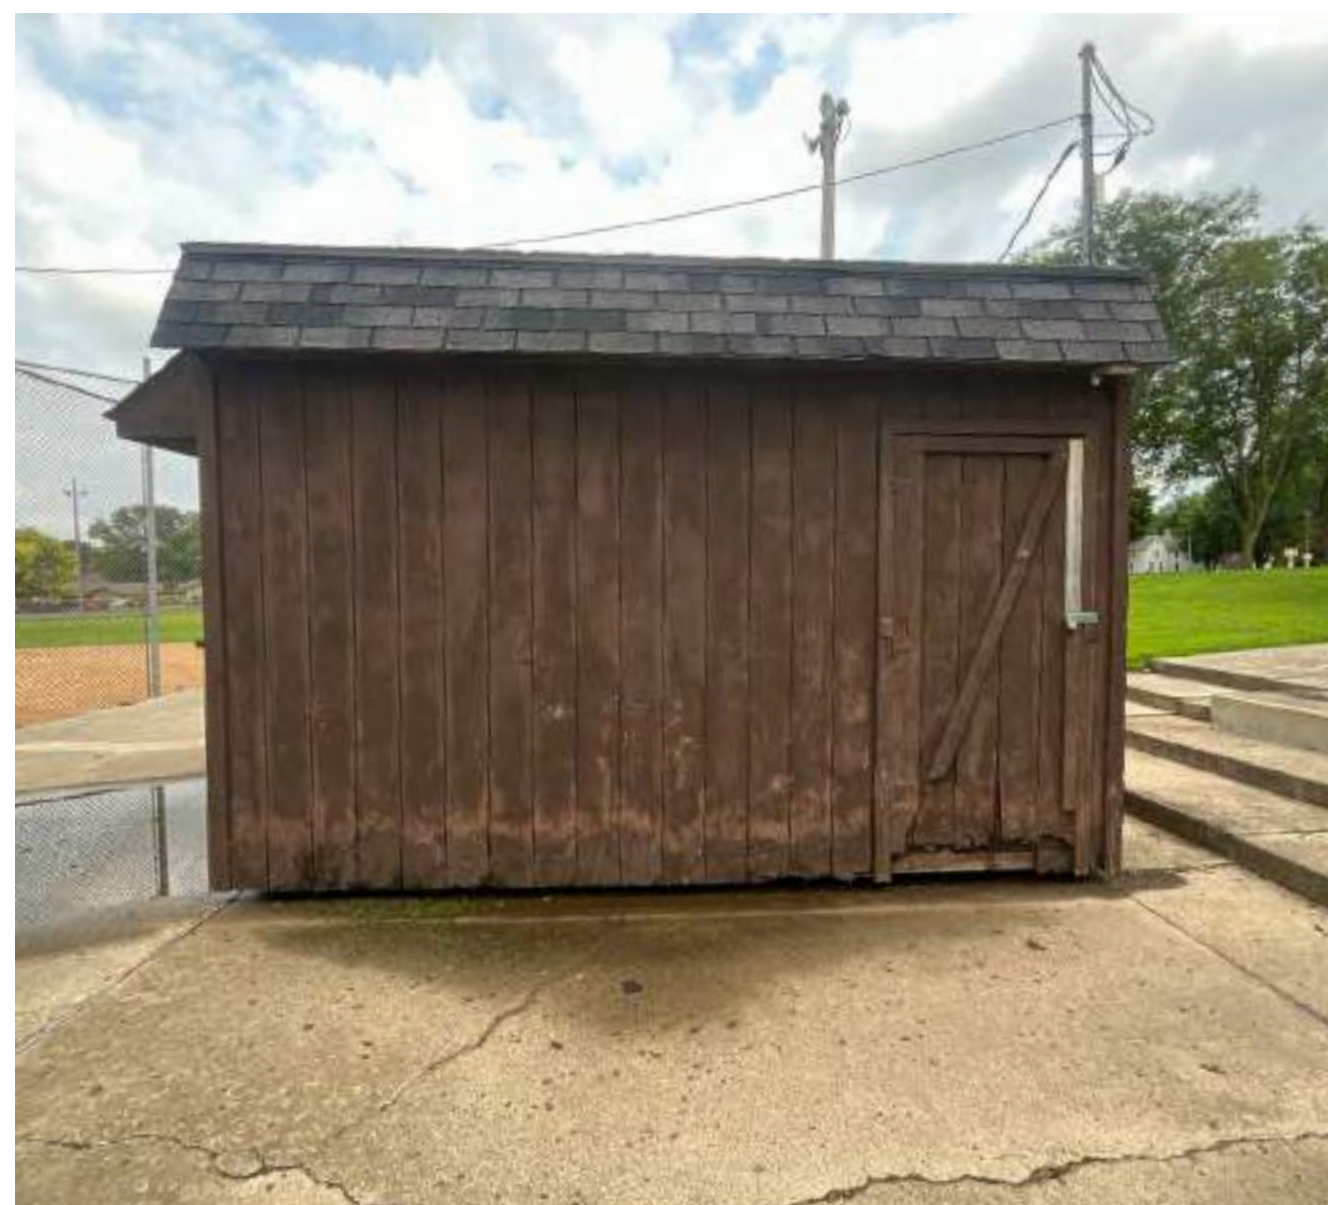
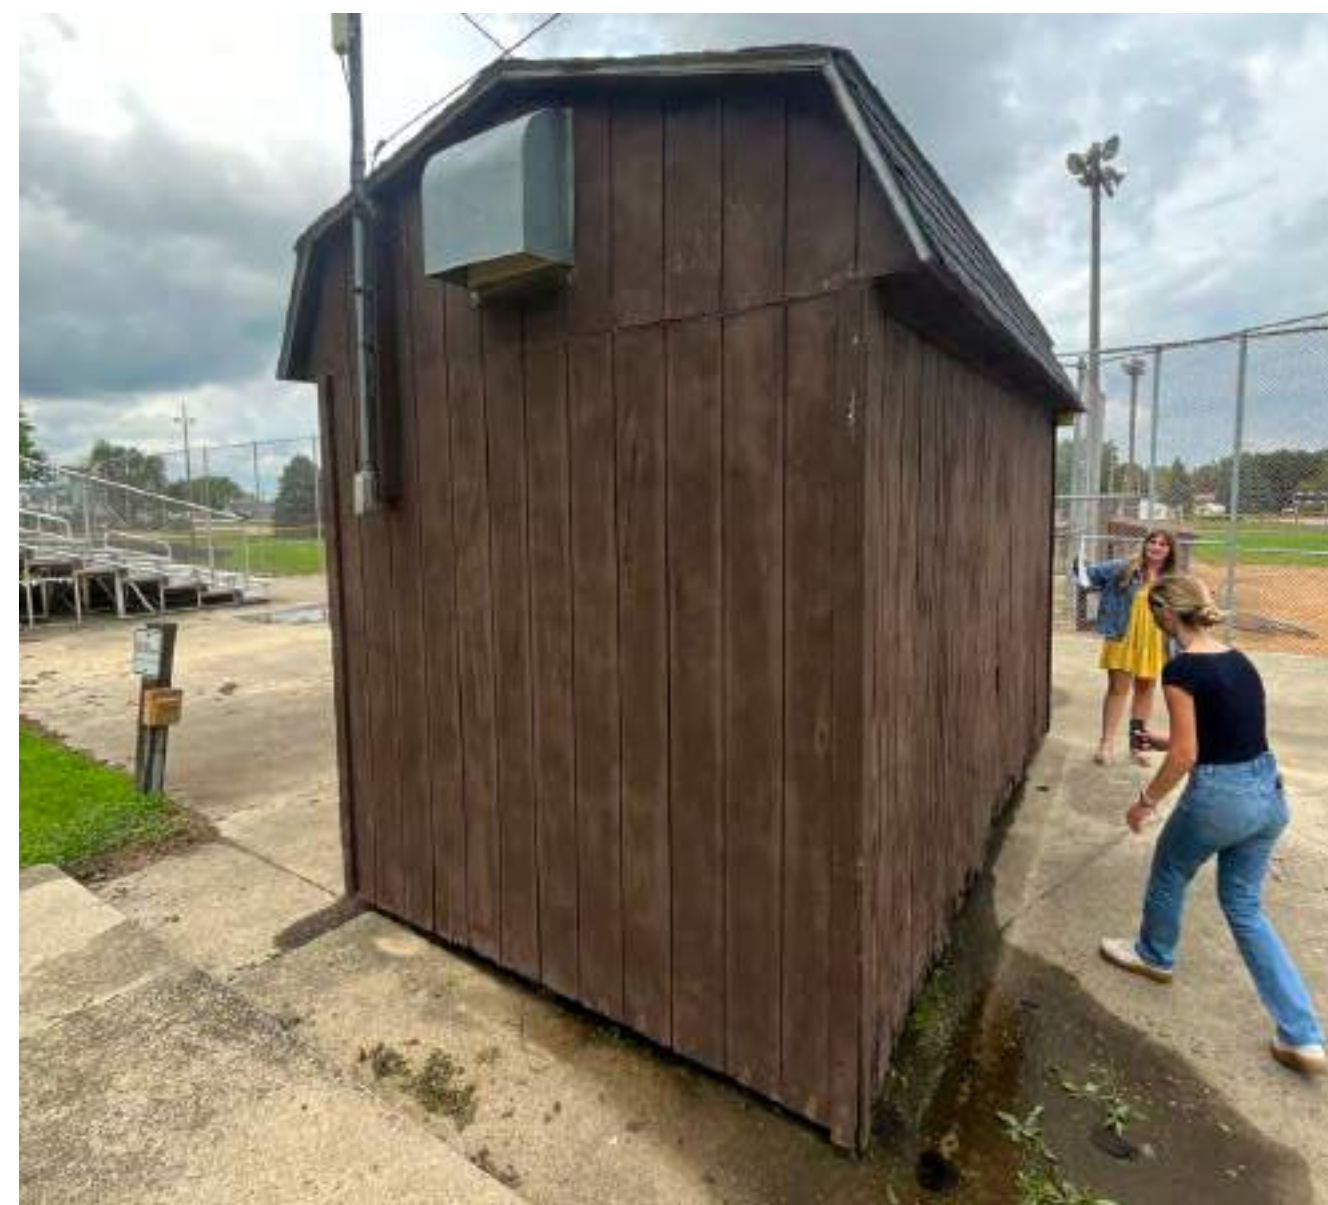
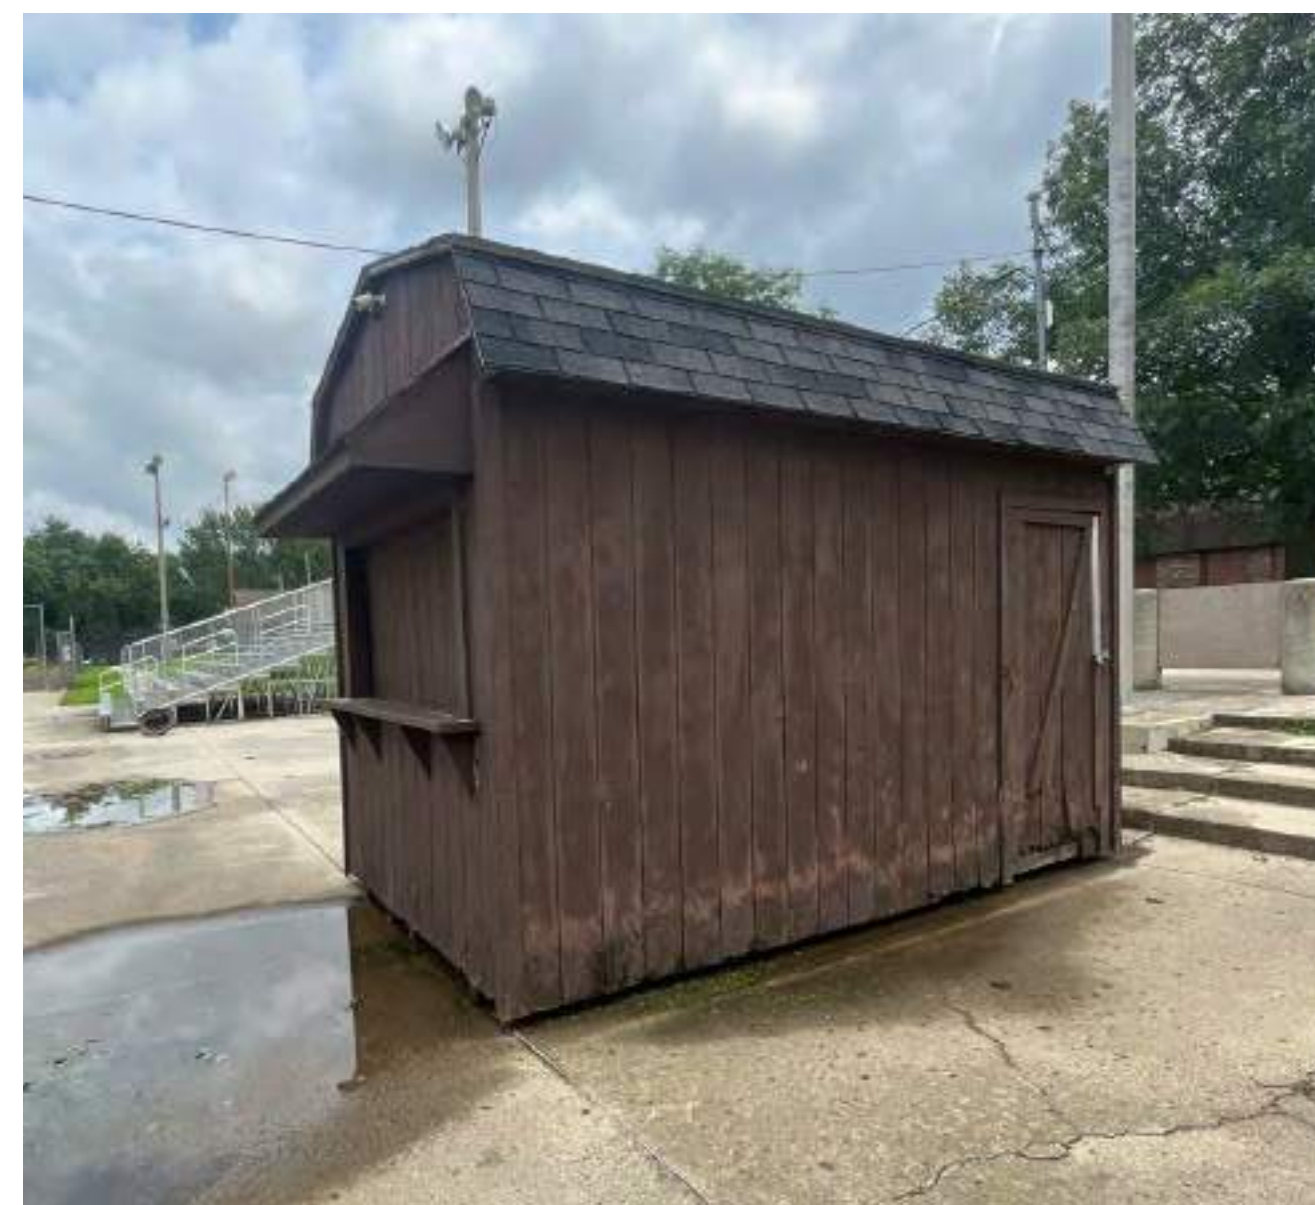
CONCESSION STAND

- Exterior T1-11 sheathing needs replacement.
- Skids at bottom of building show moisture issues.
- Shingles are in poor condition with leaking issues likely present.
- Shingles warped in areas.
- Moisture issues along building base with excessive rotting.
- No accessible route.
- Damaged door at bottom.

#### RECOMMENDATION:

DEMOLISH
